ENGINEERING REPORT

Head Homes Subdivision Drainage Improvements

City of Lebanon Engineering Department

Neel-Schaffer, Inc.

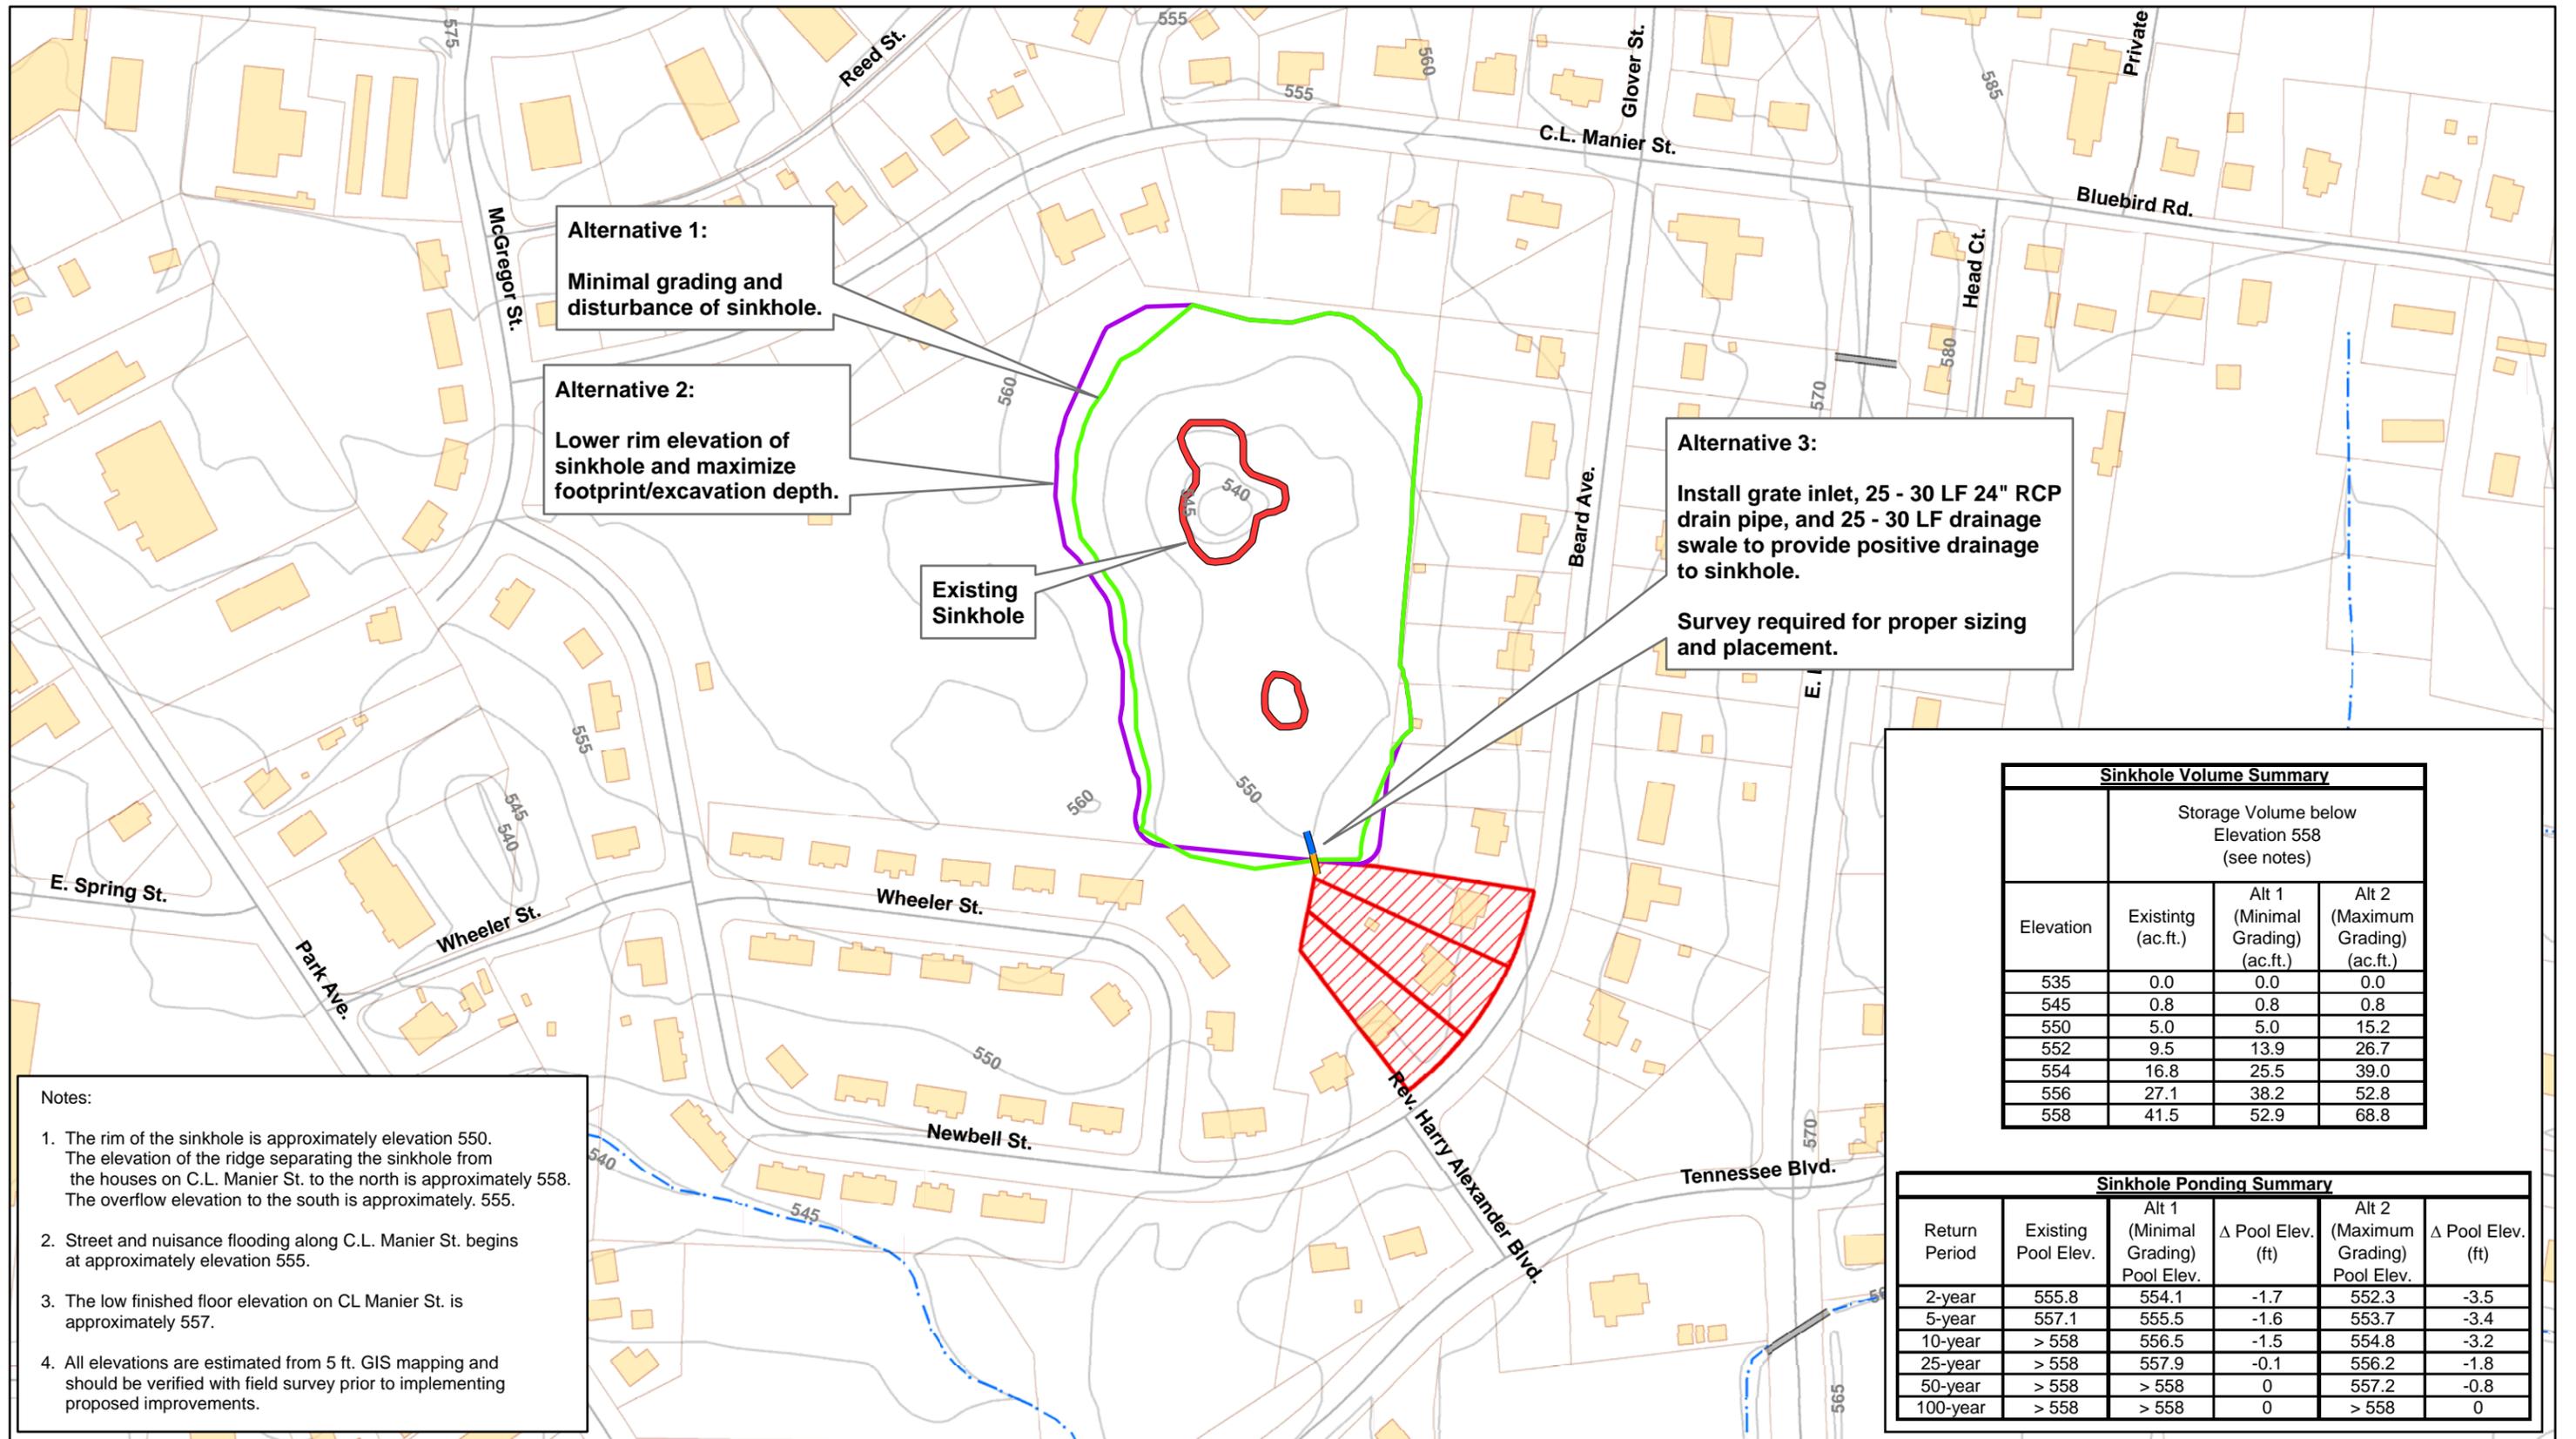
Figure 2

Two alternatives were evaluated to add storm water storage around the sinkhole on the Church of God property. The first alternative consists of minimal excavation and disturbance of the sinkhole, and will add approximately 11.4 acre-feet of storage. The second alternative consists of aggressive excavation and lowering of the sinkhole throat (inlet) elevation. The second alternative will add approximately 27.3 acre-feet of storage.

In addition to the two alternatives for excavating the area around the sinkhole, a third alternative was analyzed for the property at 222 Beard Avenue, consisting of installing a surface drain and 30 linear feet of 24-inch RCP that will penetrate beneath the berm and drain into a proposed 30-foot-long swale that will create positive drainage toward the sinkhole. This alternative will only reduce nuisance flooding for this residence, and is not intended to solve regional flooding issues in this project area.

- Notes:
- The rim of the sinkhole is approximately elevation 550. The elevation of the ridge separating the sinkhole from the houses on C.L. Manier St. to the north is approximately 558. The overflow elevation to the south is approximately, 555.
 - Street and nuisance flooding along C.L. Manier St. begins at approximately elevation 555.
 - The low finished floor elevation on CL Manier St. is approximately 557.
 - All elevations are estimated from 5 ft. GIS mapping and should be verified with field survey prior to implementing proposed improvements.

Better reduction in flood levels is achieved with the more aggressive alternative 2, but it should be noted that neither of the alternatives may be feasible due to property acquisition constraints and unknown subsurface conditions. Therefore, it is recommended to investigate the possibility of acquiring a drainage easement from the Church of God. It should be emphasized during property negotiations that upon completion of the excavation activities for either alternative, the property could still be utilized for various purposes such as picnic and recreational areas, and can be enhanced with landscaping to hide the sinkhole.

If property acquisition is determined to be feasible, it is recommended to perform a geotechnical analysis prior to performing any construction activities. If test borings indicate that karst topography is present within the proposed excavation zone, then it is not recommended to perform the excavation project due to the possibility of damaging the sinkhole and causing cave-ins.

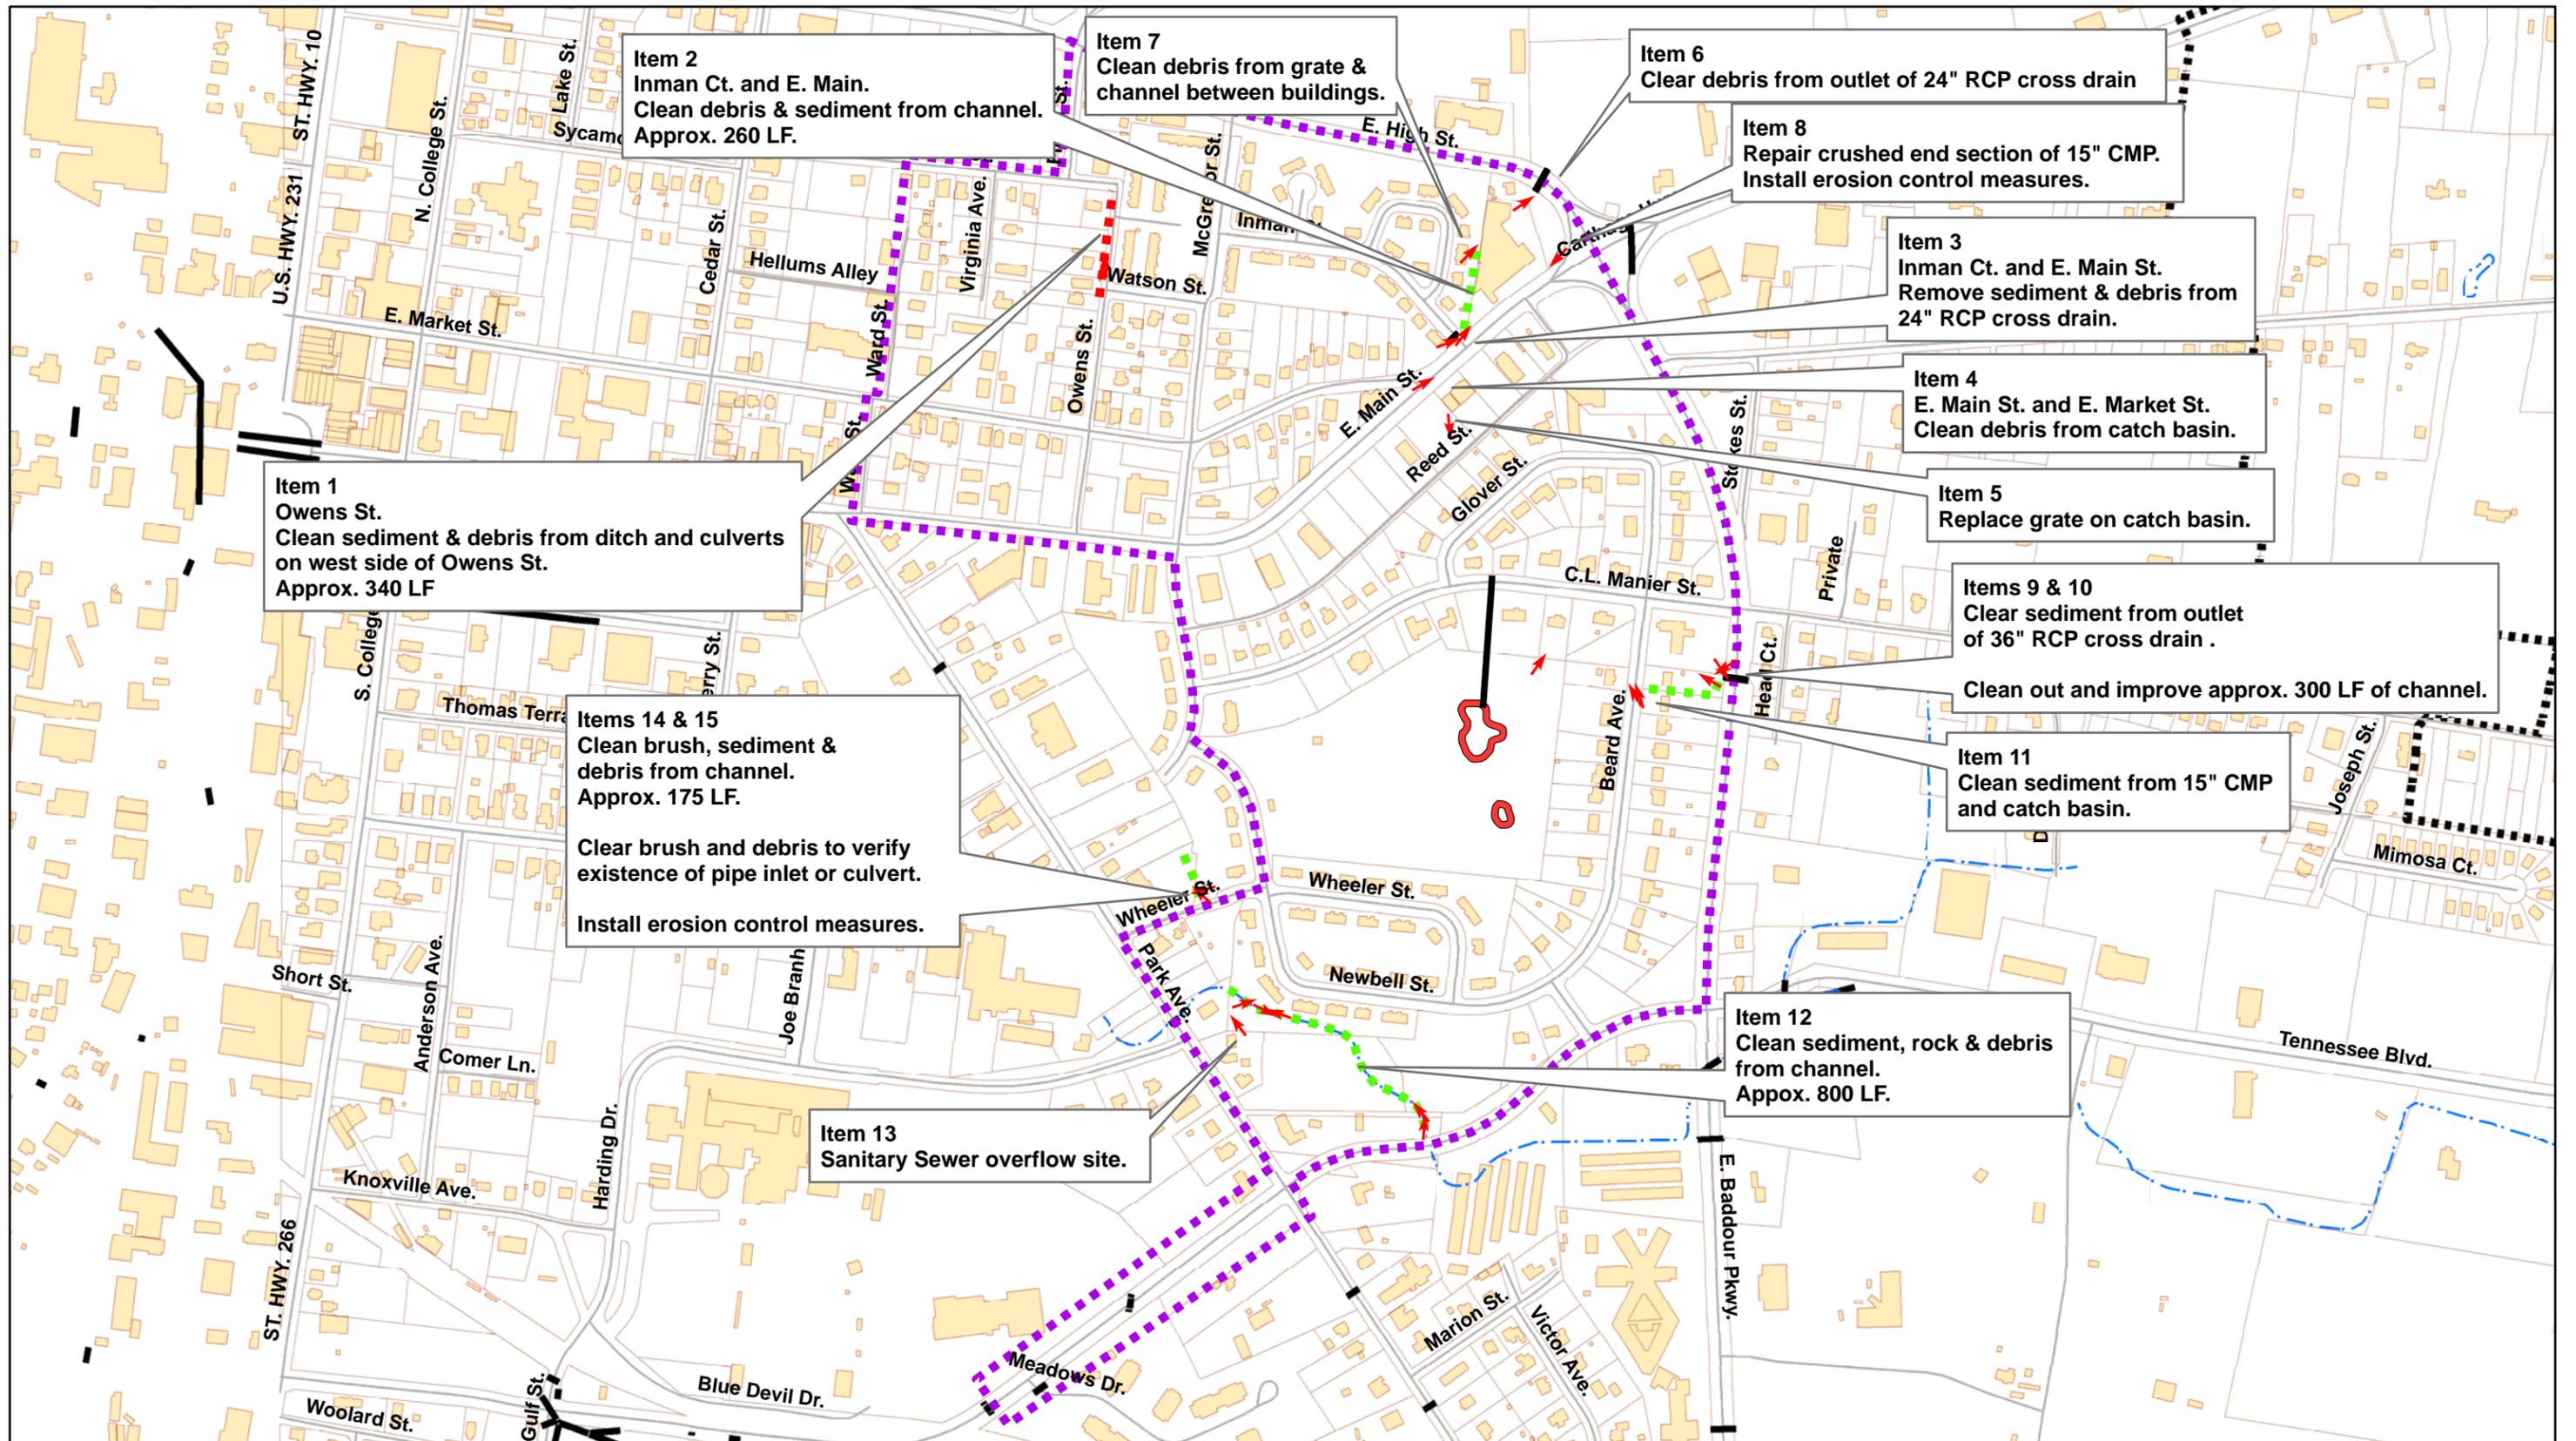
Figure 3

Item 1
Owens St.
Clean sediment & debris from ditch and culverts on west side of Owens St.
Approx. 340 LF

Items 14 & 15
Clean brush, sediment & debris from channel.
Approx. 175 LF.

Item 13
Sanitary Sewer overflow site.

Item 2
Inman Ct. and E. Main.
Clean debris & sediment from channel.
Approx. 260 LF.

Item 7
Clean debris from grate & channel between buildings.

Item 6
Clear debris from outlet of 24" RCP cross drain

Item 8
Repair crushed end section of 15" CMP.
Install erosion control measures.

Item 3
Inman Ct. and E. Main St.
Remove sediment & debris from 24" RCP cross drain.

Item 4
E. Main St. and E. Market St.
Clean debris from catch basin.

Item 5
Replace grate on catch basin.

Items 9 & 10
Clear sediment from outlet of 36" RCP cross drain .

Item 11
Clean sediment from 15" CMP and catch basin.

Item 12
Clean sediment, rock & debris from channel.
Approx. 800 LF.

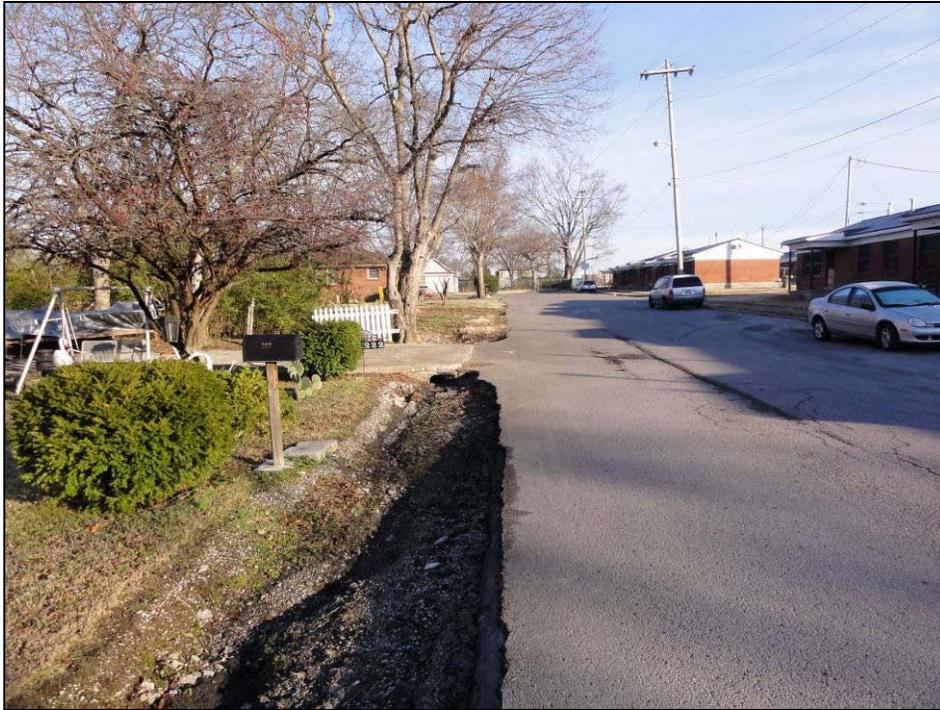
Looking north from 222 N. Owens St. Picture 1878.

Item 1 – Owens St. from Sycamore St. to Watson St. Clean sediment and debris from approx. 340 LF of roadside ditch and culverts on the west side of Owens St. Repair eroded subgrade & pavement. Install erosion control measures.

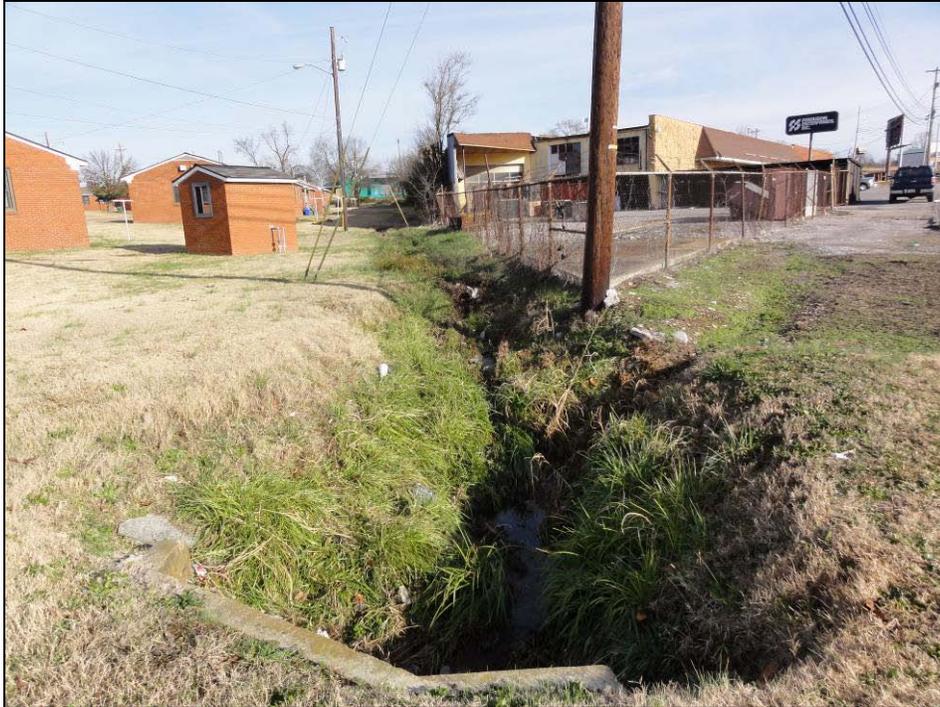
Item 2 – Inman Ct. and E. Main St. looking northeast. Clean debris and sediment from approx. 260 LF of channel. Picture 1892.

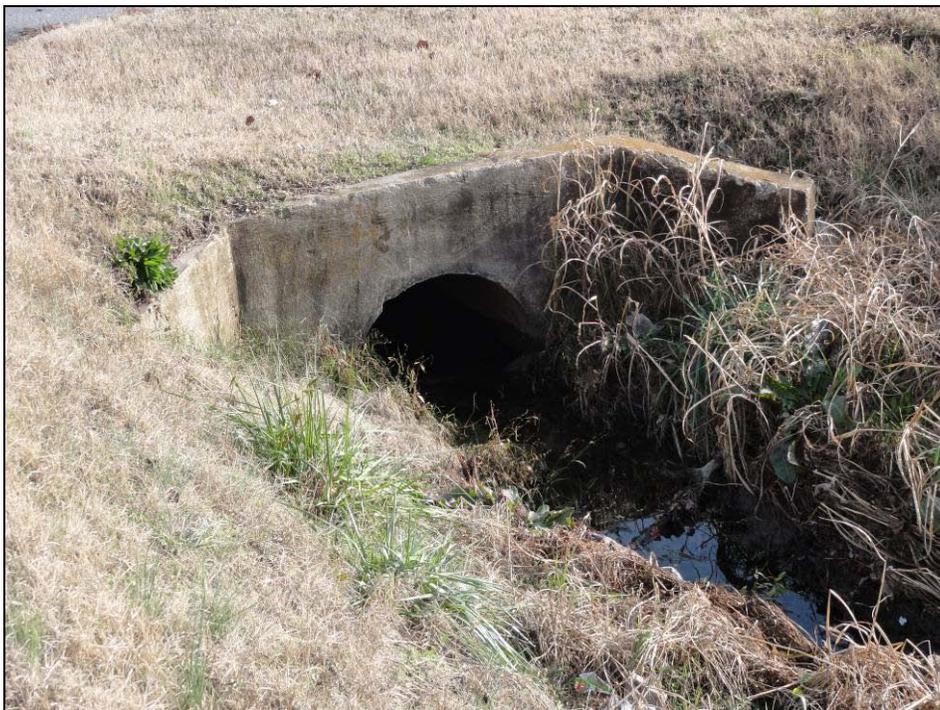
Item 3 – Inman Ct. and E. Main St. looking northeast. Remove sediment and debris from 24” RCP cross drain . Picture 1894.

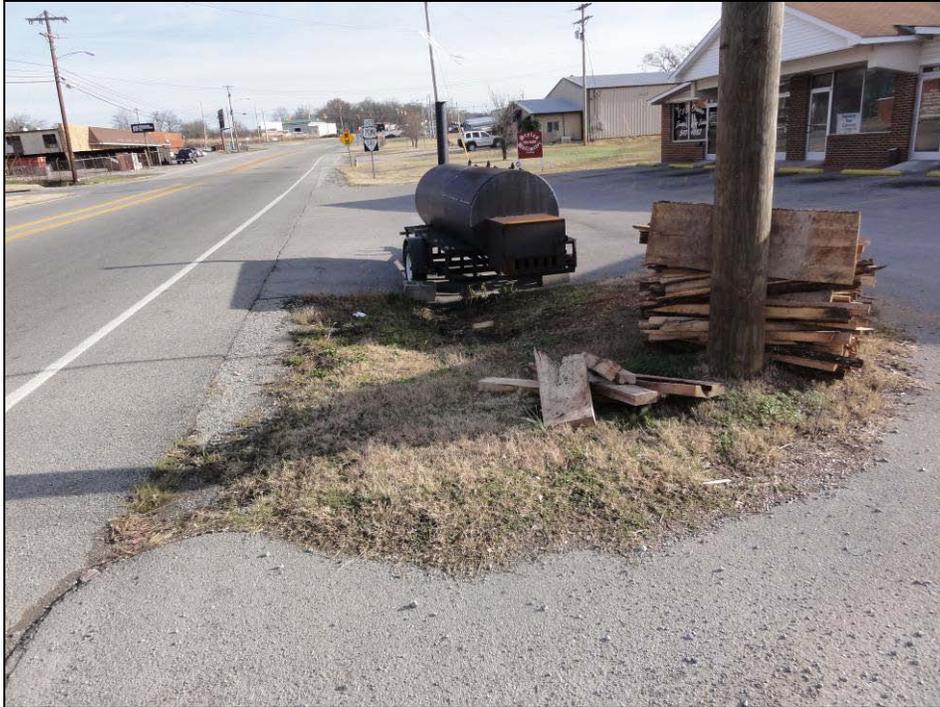
Item 4 – E. Main St. and E. Market St. Clean debris from catch basin on south side of E. Main St. Picture 1897.

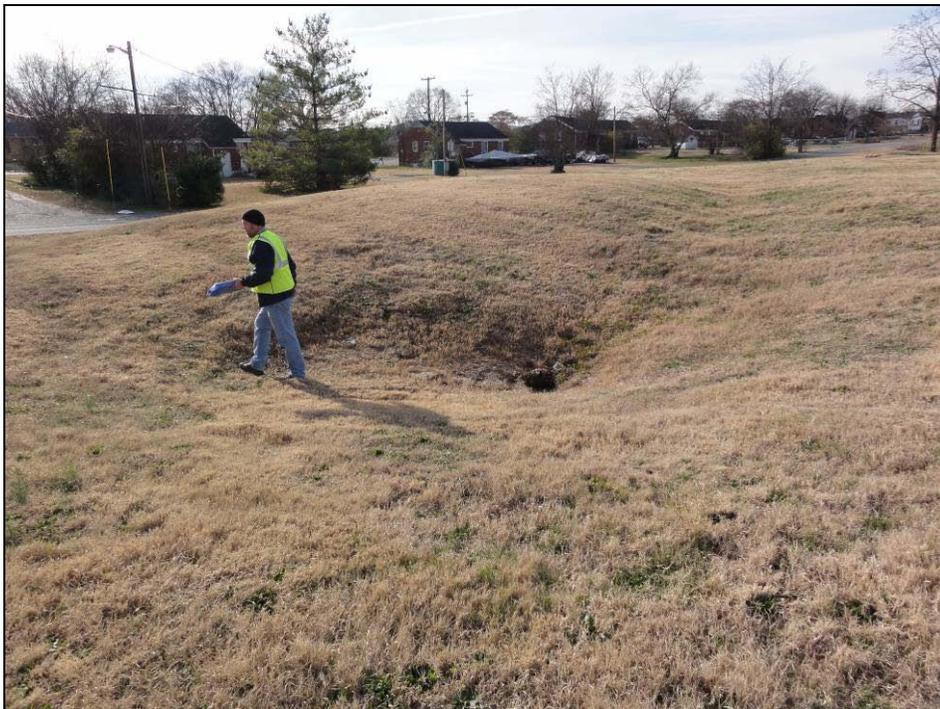
Item 5 – Between E. Main St. and Reed St. Replace grate on catch basin. Picture 1898.

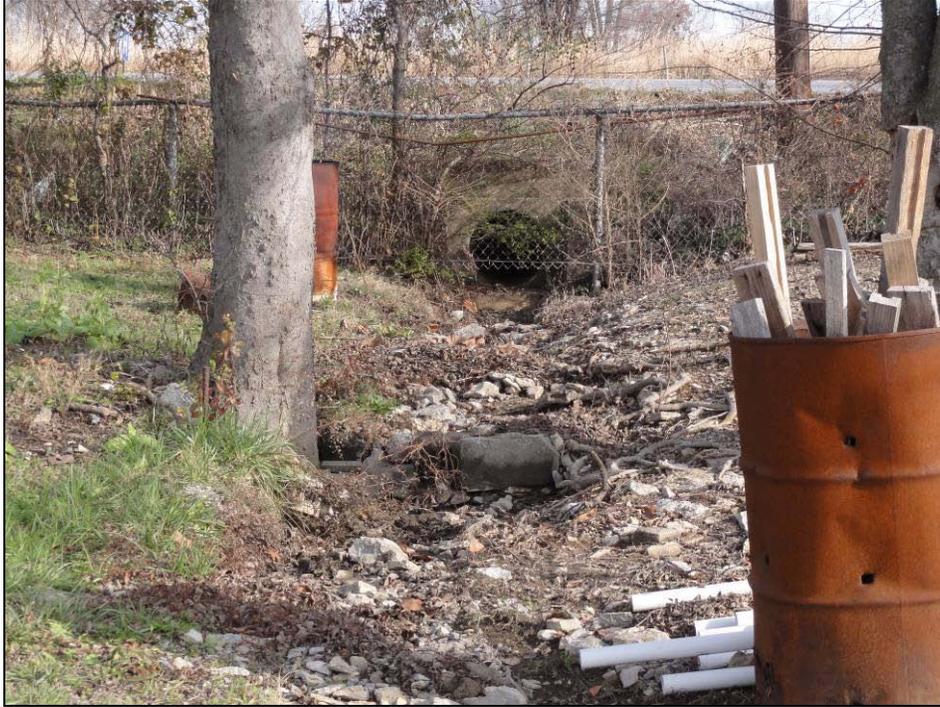
Item 6 – E. High St. north of E. Main St. Clear debris from outlet of 24” RCP cross drain under E. High St. Culvert drains onto private property at 713 E. Main St. Picture 1902.

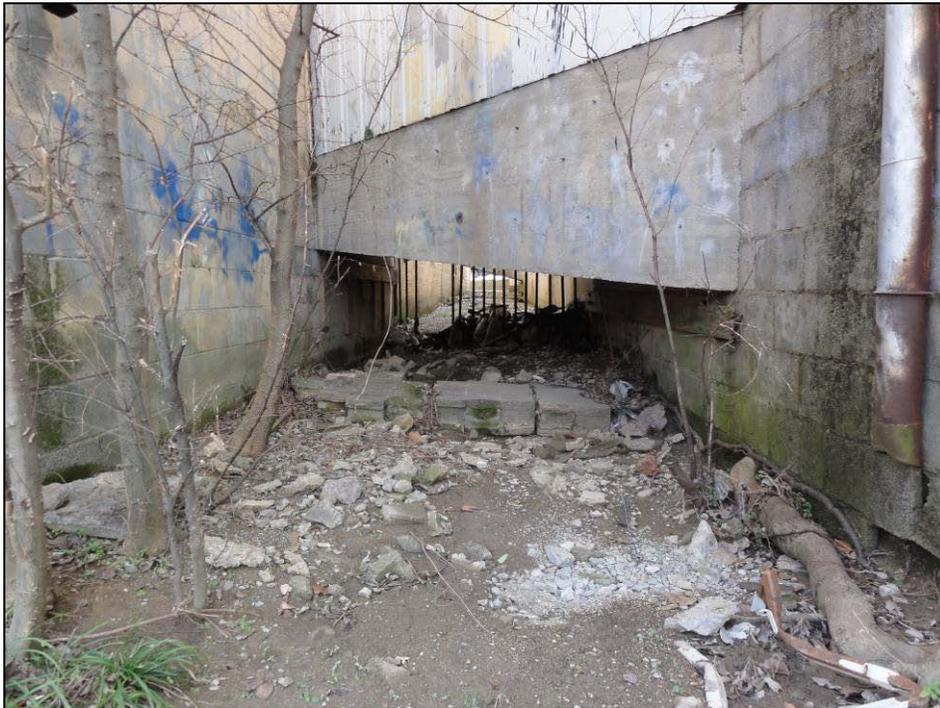
Item 7 – 713 E. Main St. Clean debris from grate and channel between buildings. Channel receives drainage from the 24” RCP cross drain under E. High St. shown in Item 6. Picture 1906.

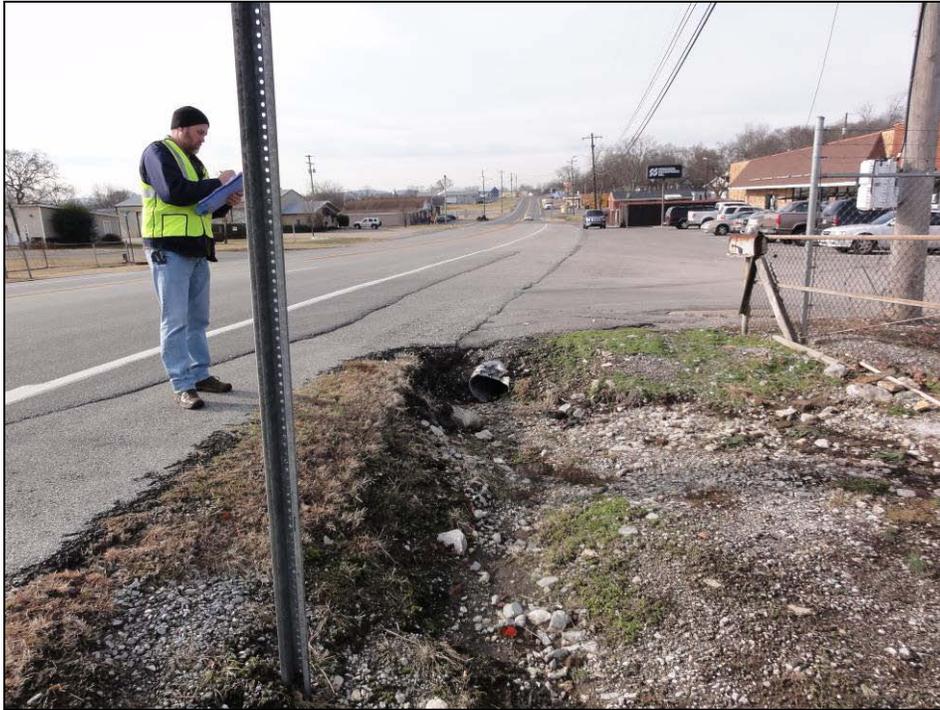
Item 8 – 713 E. Main St. Repair crushed end section of 15” CMP. Install erosion control measures. Picture 1908.

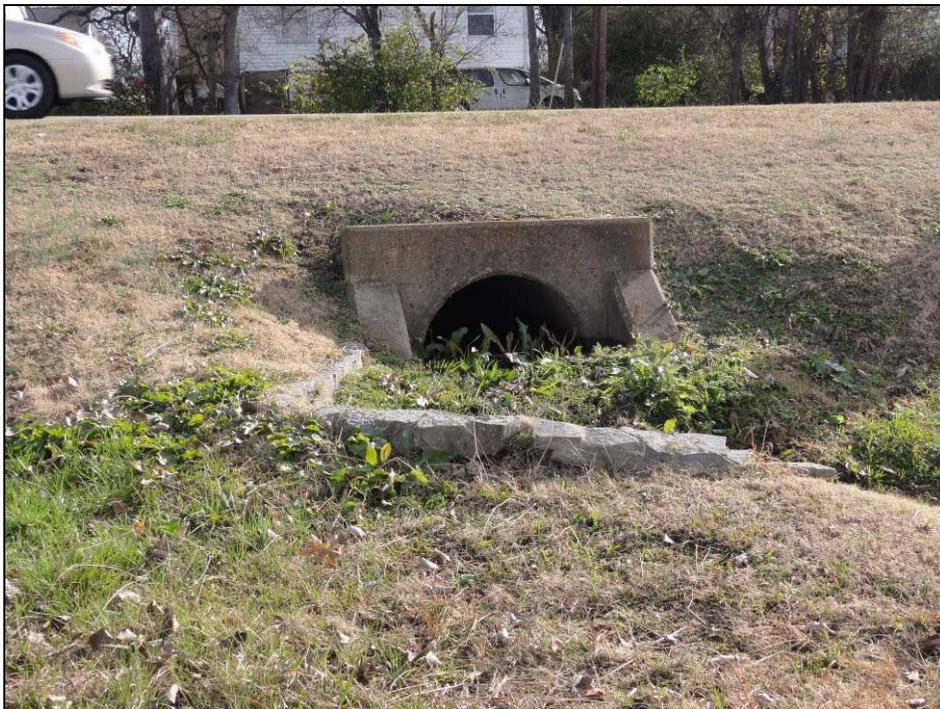
Item 9 – E Baddour Pkwy. south of C.L. Maier St. Clear sediment from outlet of 36” RCP cross drain . Picture 1910.

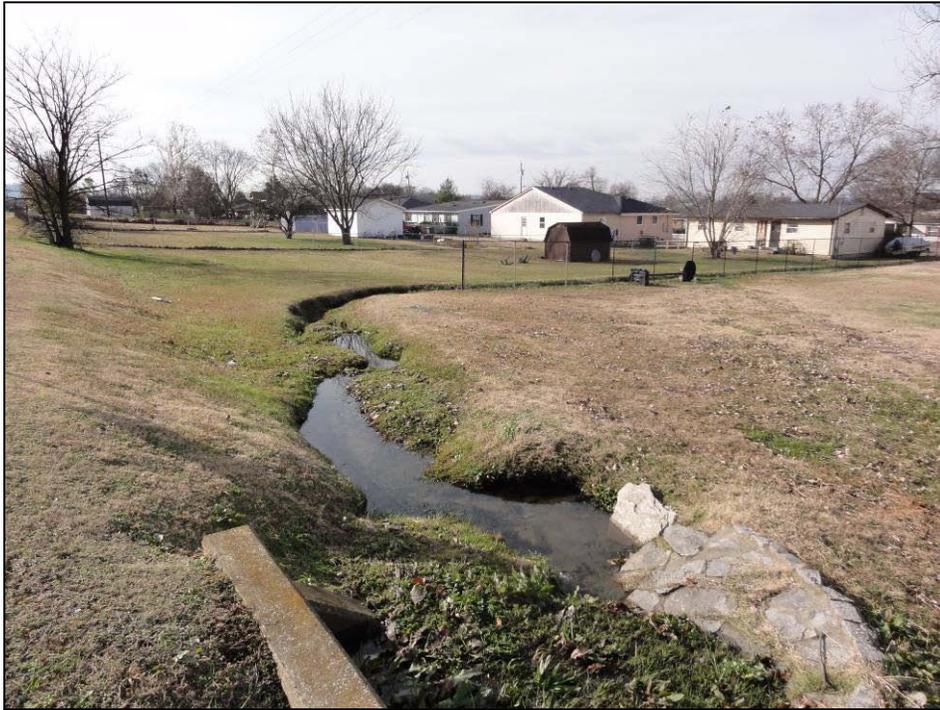
Looking south from cross drain outlet. Picture 1911.

Item 10 –203 Beard Ave. Clean out and improve approx. 300 LF of channel from 36” RCP cross drain under E. Baddour Pkwy. to Beard Ave.

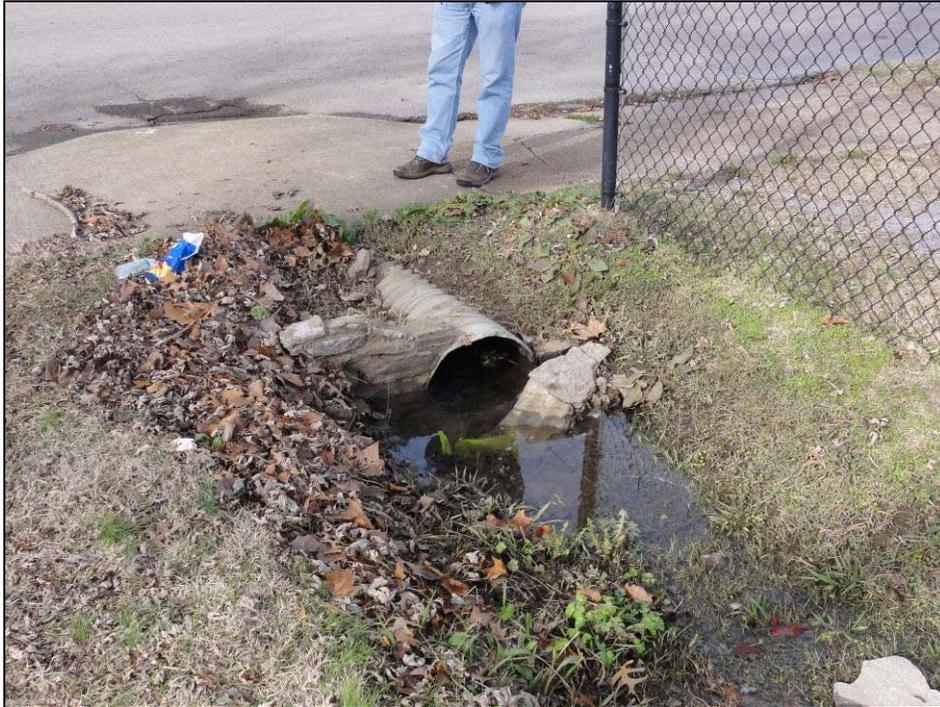
15” CMP. Picture 1938.

Item 11 –203 Beard Ave. Clean sediment from 15” CMP and catch basin.

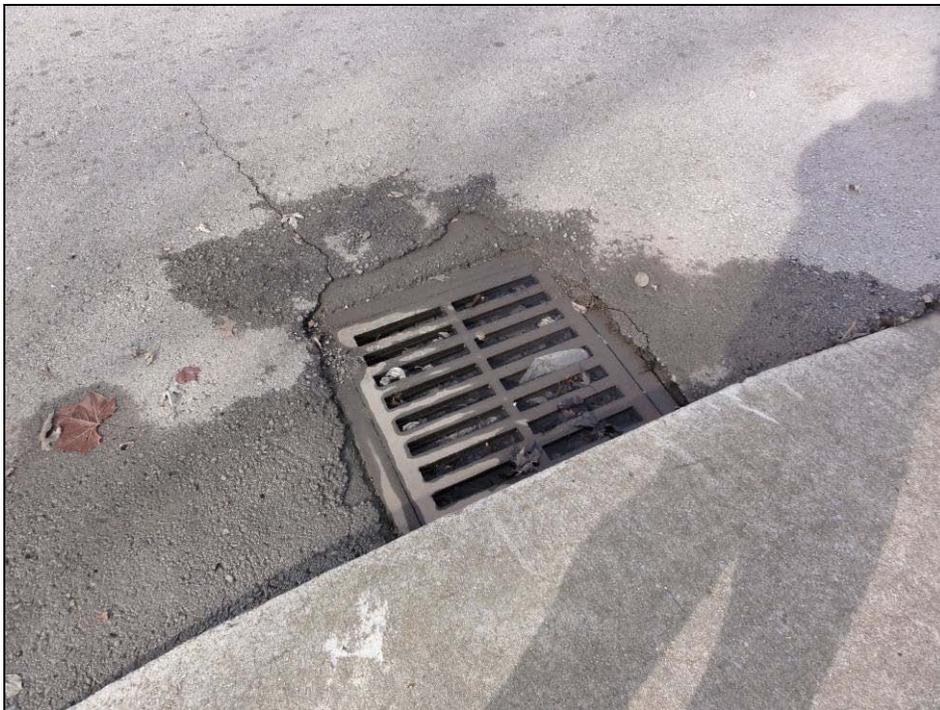
Catch basin choked with sediment and debris. Picture 1939.

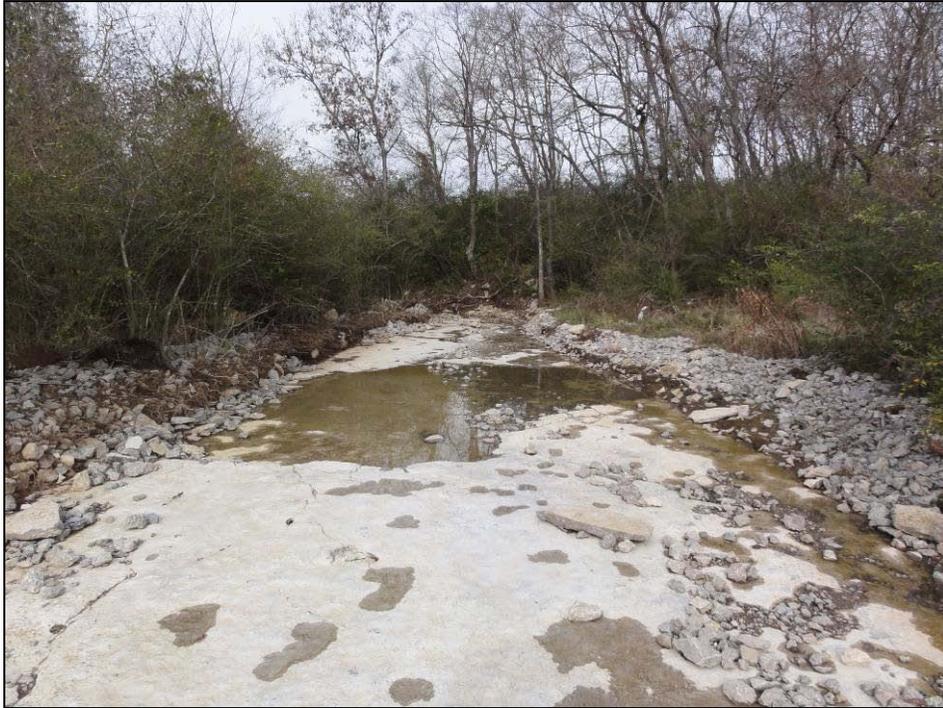
Looking north from Tennessee Blv. Picture 1984.

Item 12 –Tennessee Blvd. to Park Ave. Clean sediment, rock and debris from approx. 800 LF of channel.

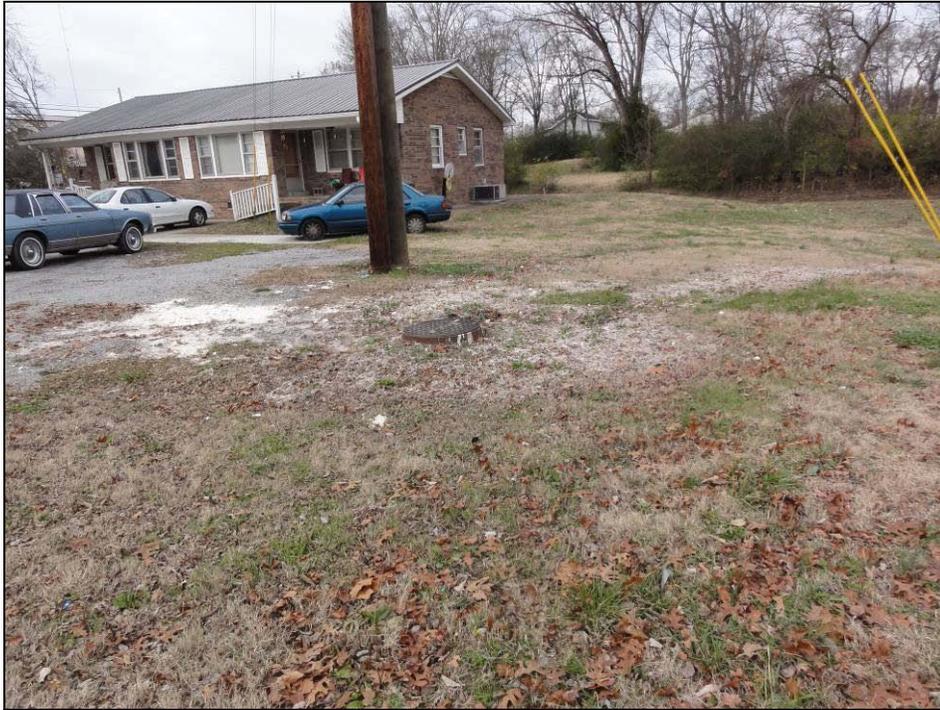
Item 13 – Adjacent to 521 Park Ave. Sanitary Sewer overflow site. Picture 2000.

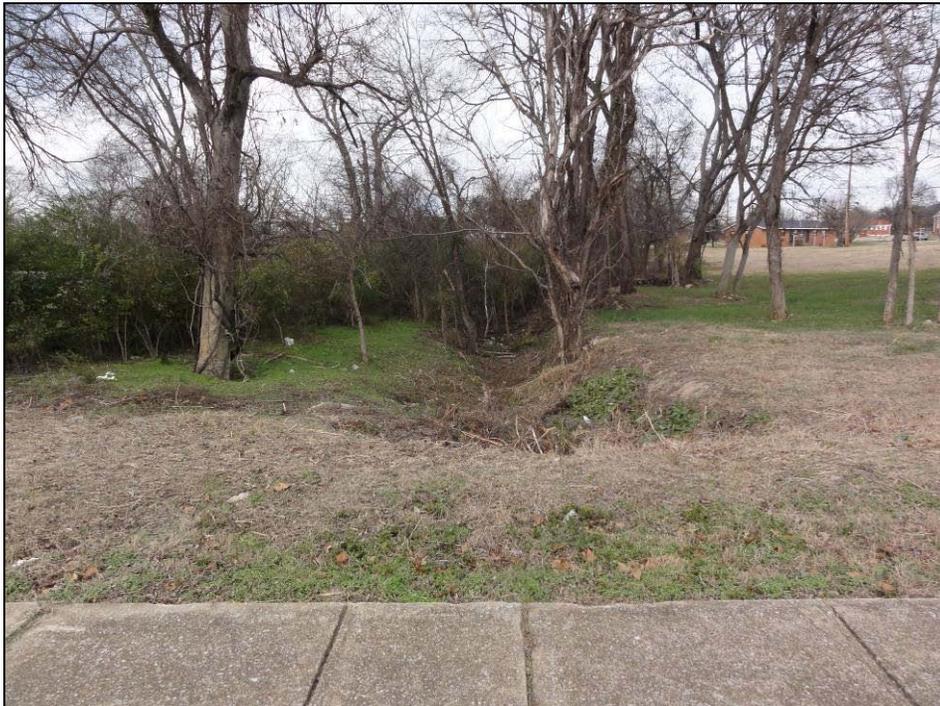
Item 14 – Wheeler St. between Park Ave. and Newbell St. Clean brush, sediment and debris from approx. 175 LF of channel. View is looking north from Wheeler St. Picture 2002.

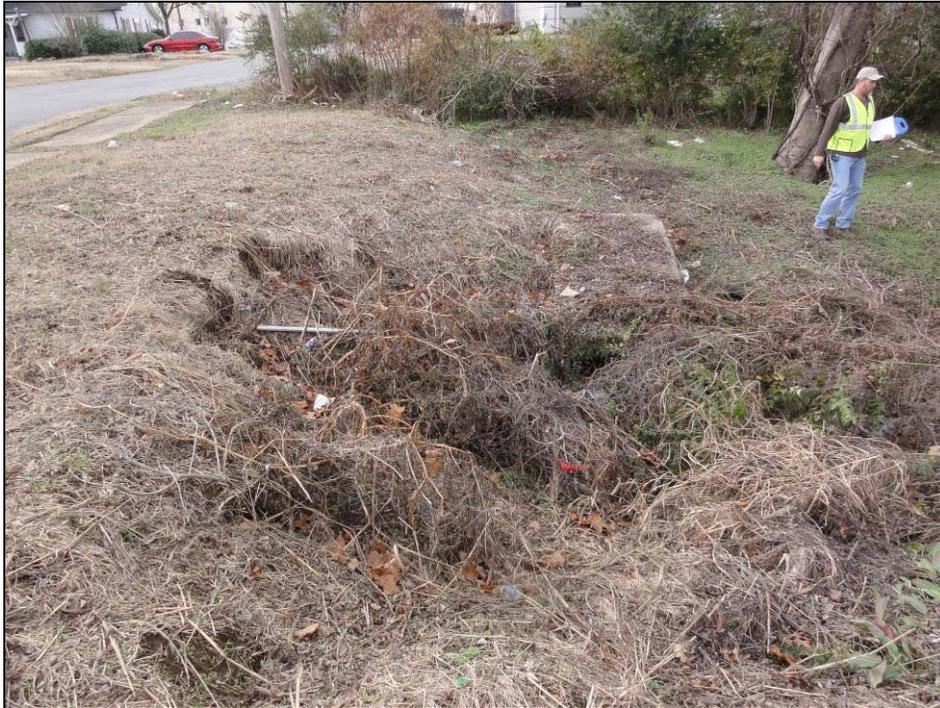
Item 15 – Wheeler St. between Park Ave. and Newbell St. No culvert found at this location. Possible sink hole. Clear brush and debris to verify existence of pipe inlet or culvert. Install erosion control measures. Picture 2004.

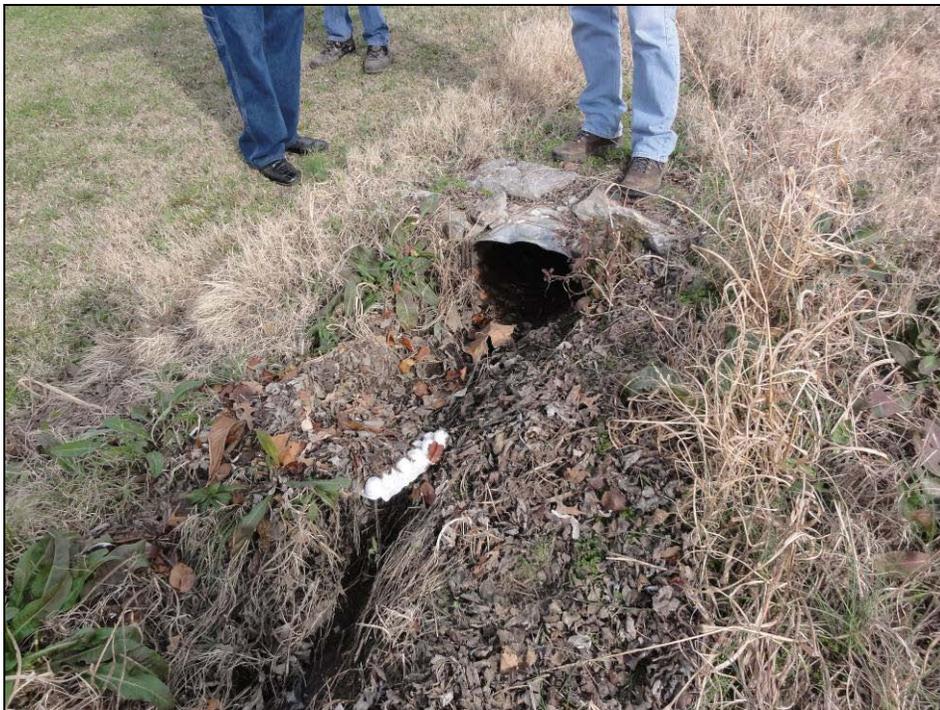
Item 16 – 630 C.L. Manier St. Clean debris from outlet of 15” CMP. Picture 2011.
