## ENGINEERING REPORT

### U.S. Highway 231 (North Cumberland Street) Drainage Improvements

**City of Lebanon Engineering Department**

**Neel-Schaffer, Inc.**

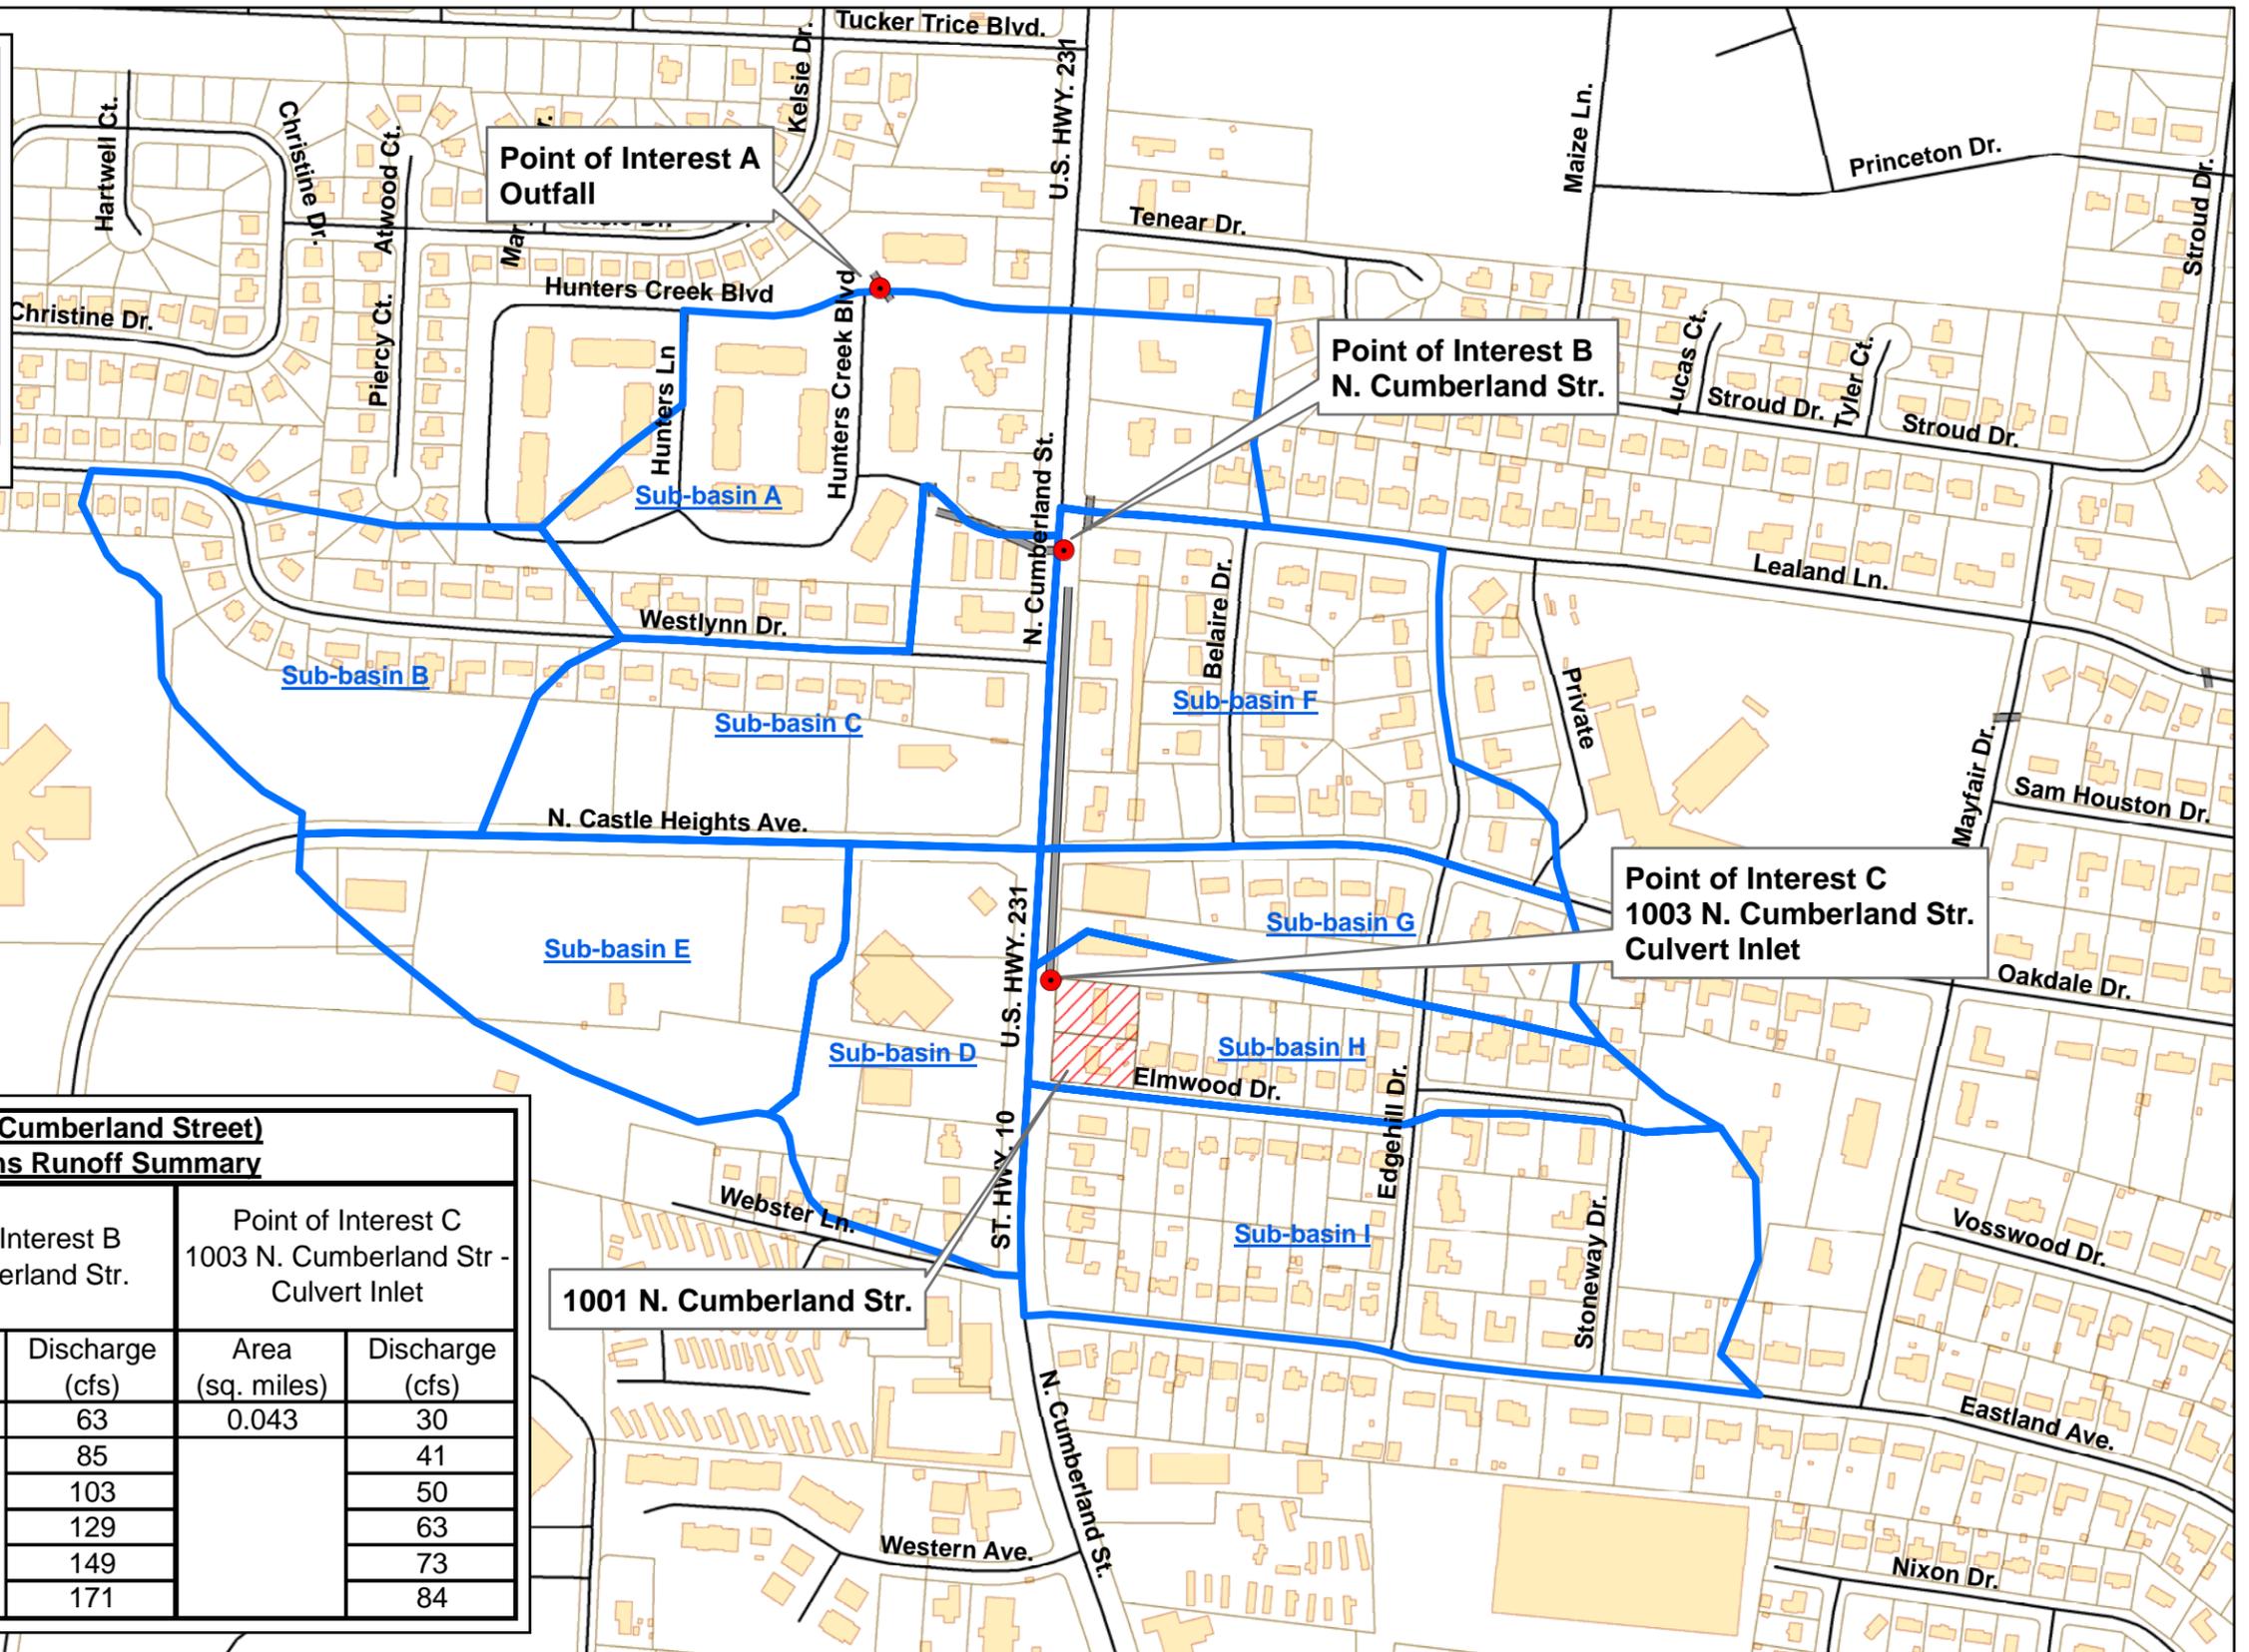
**Figure 1**

**Hydrology  
Results**

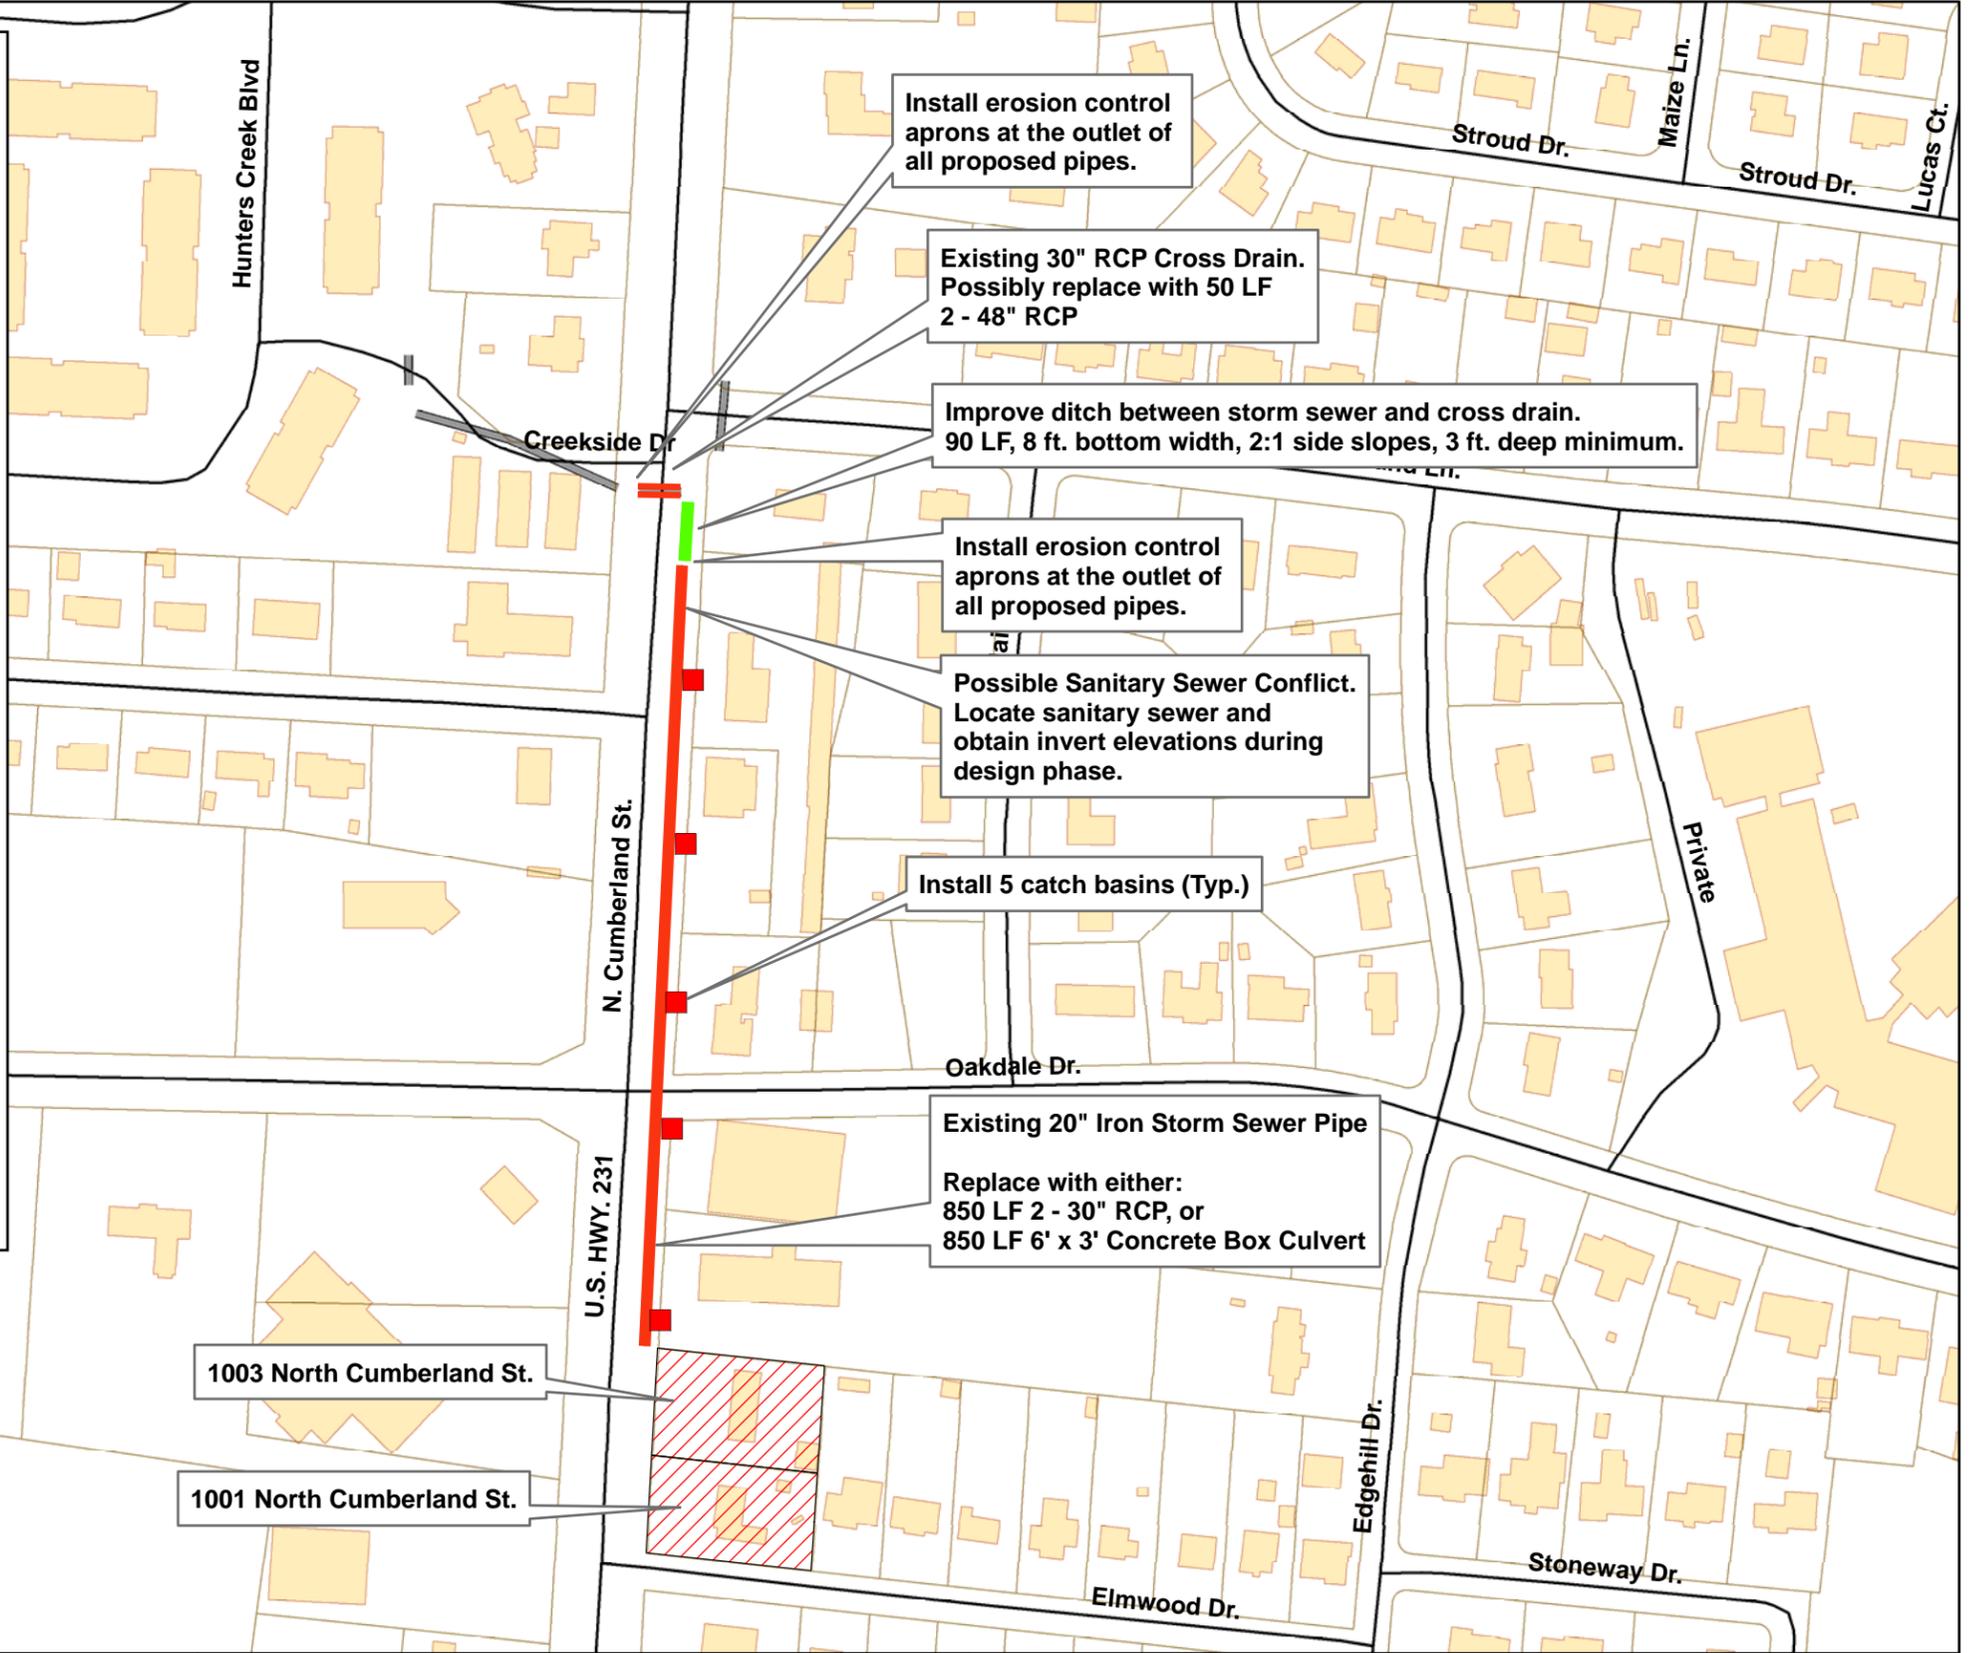
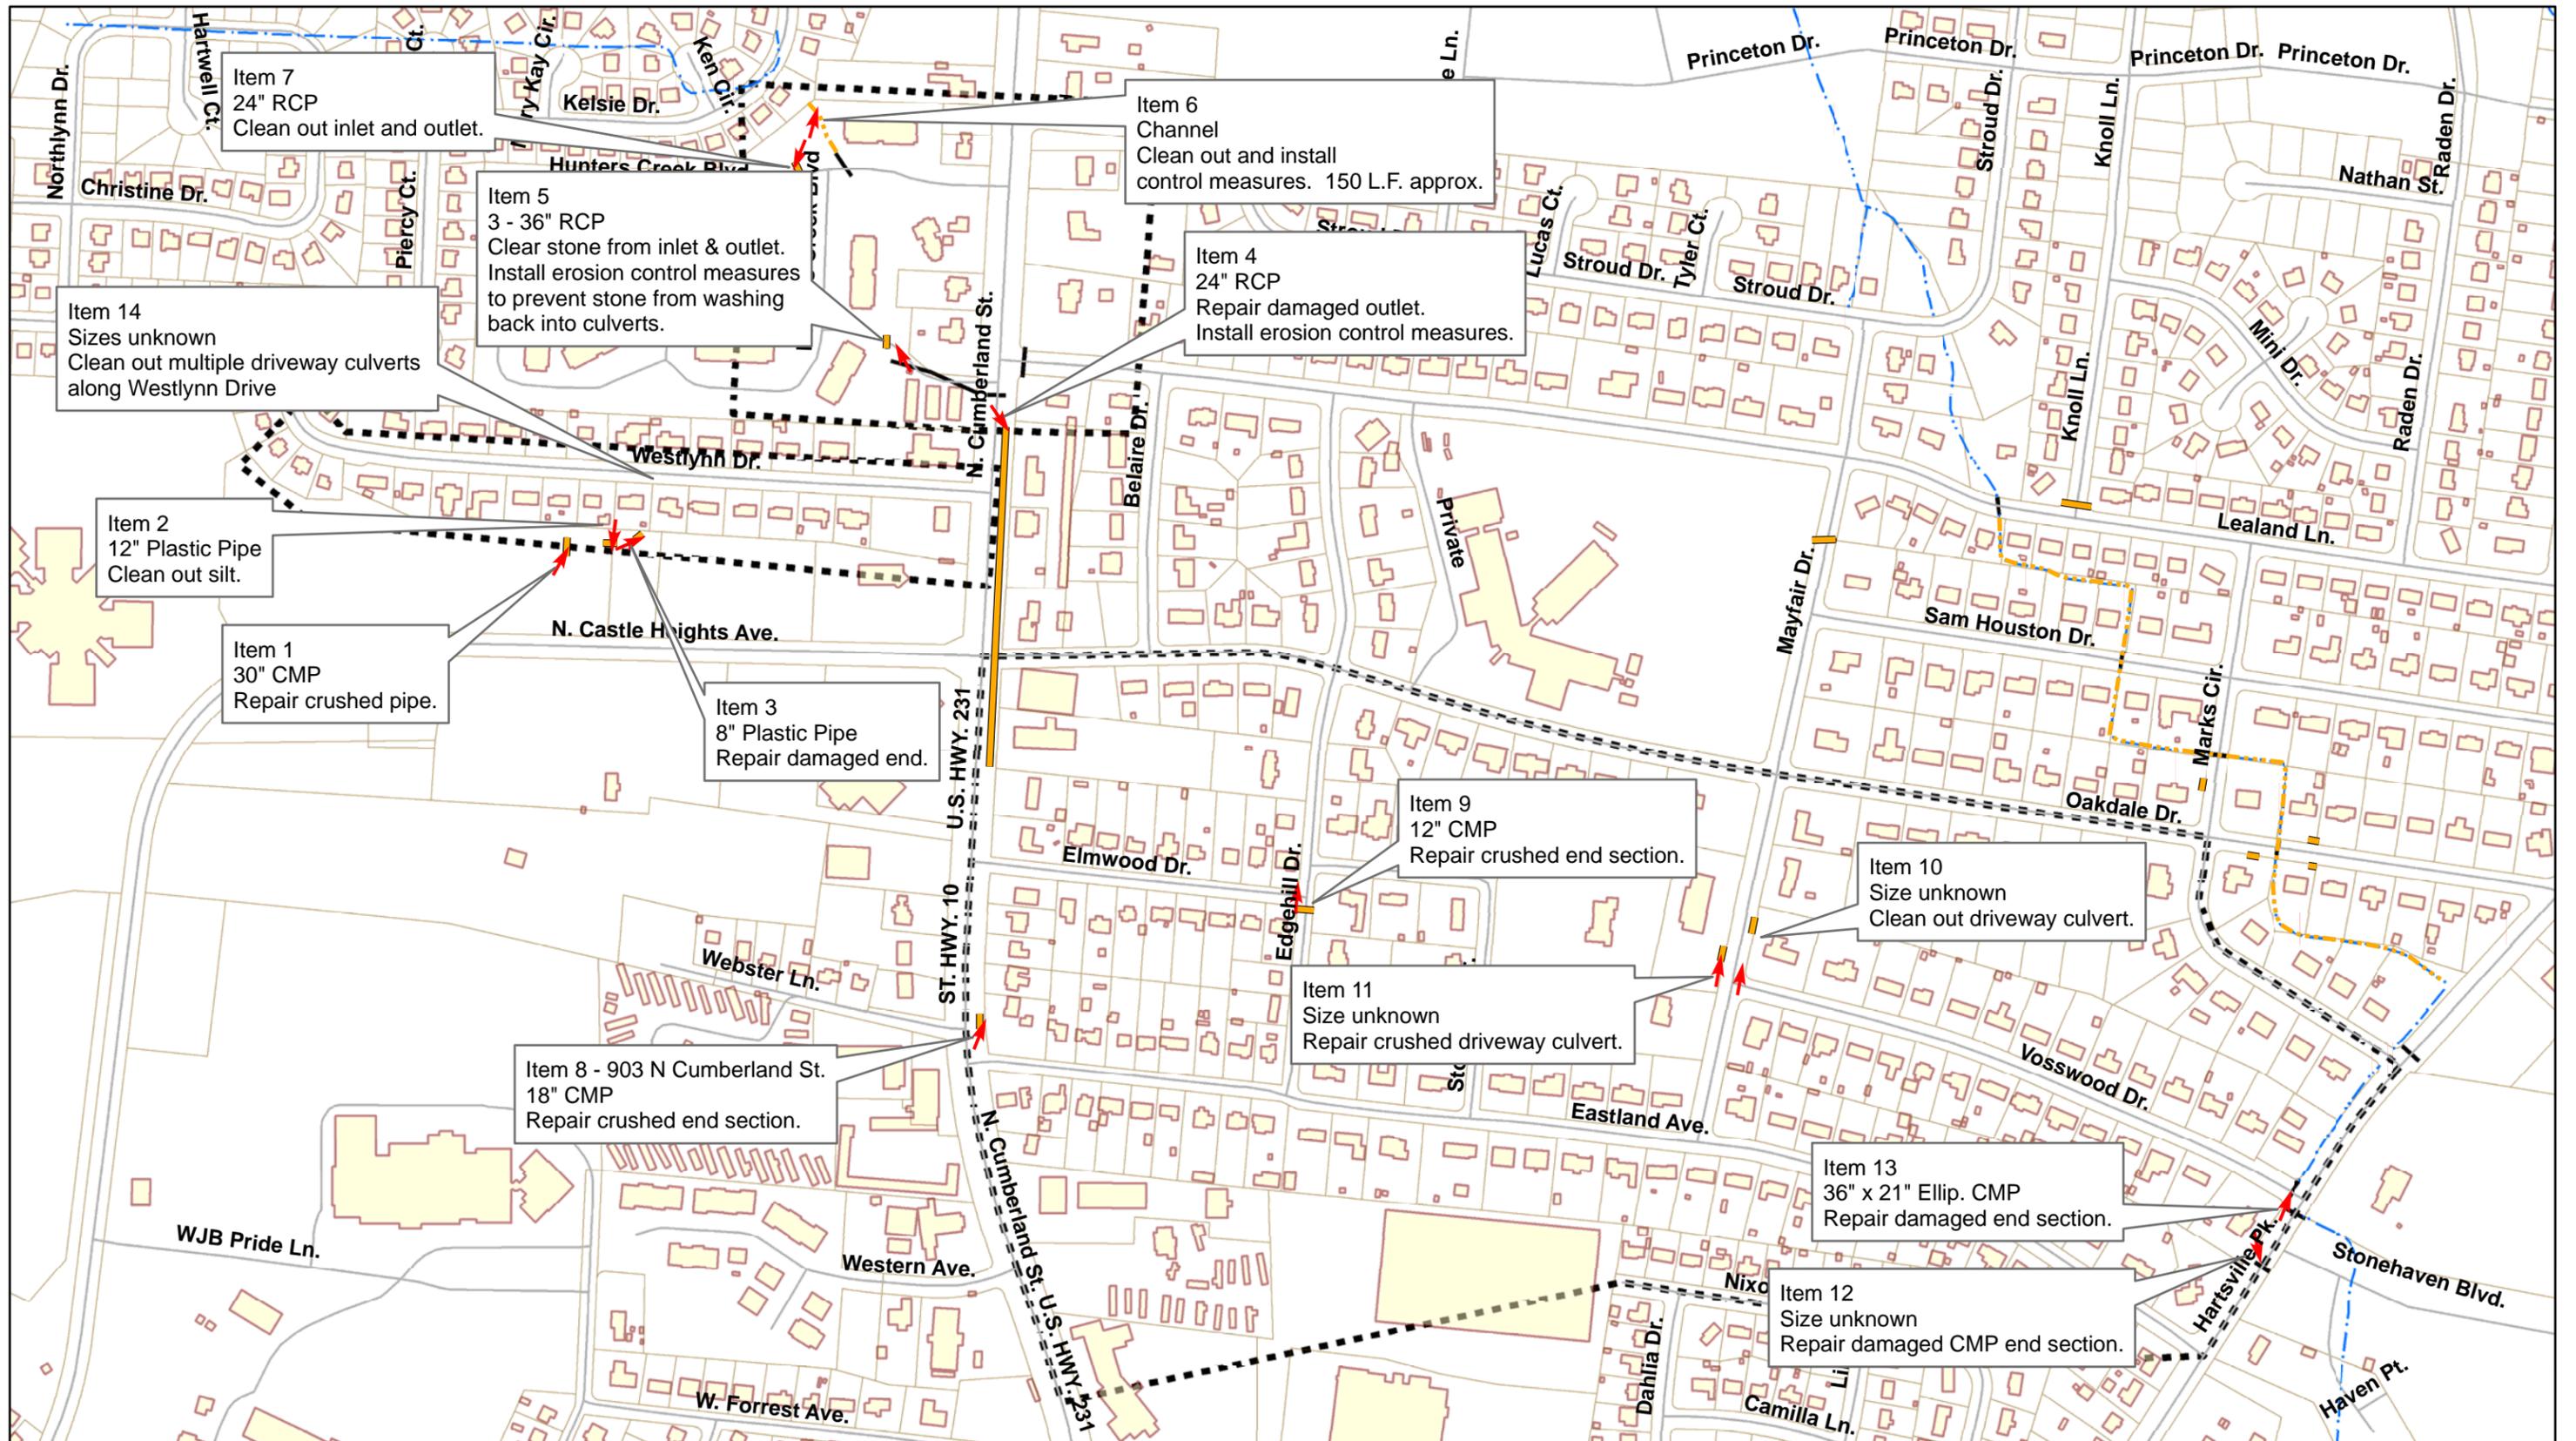
**Figure 3**

In addition to the recommended structural improvements, numerous routine maintenance issues were found throughout the study area during the field reconnaissance. Examples of required maintenance items include removing sediment buildup from culvert inlets, removing excess vegetation and debris from culvert inlets, and installing erosion control measures. While correcting these deficiencies will not solve flooding problems, it is critical to correct them sooner, rather than later, so that the drainage system can function as designed and conditions do not worsen, leading to possible flooding problems in the future. In addition, it is important to note that areas identified as requiring remediation should be regularly scheduled for maintenance by City crews to prevent future buildup of debris and sediment. A map showing locations identified as requiring maintenance is included as Figure 3. In addition, a document containing captioned photographs of each maintenance location is included as Appendix A, with locations and orientations of each photograph indicated with red arrows on Figure 3. A preliminary cost estimate for the proposed maintenance items are shown below:

**Infrastructure  
Maintenance Locations**

<b>Infrastructure Maintenance Items (See Figure 3)</b>	<b>Preliminary Estimated Project Cost</b>
1. Culvert end repair at eight locations (Items 1, 3, 4, 8, 9, 11, 12, 13)	\$ 8,000.00
2. Debris/sediment removal from culvert ends – at least seven locations (Items 2, 5, 7, 10, 14-multiple)	\$ 3,500.00
3. Debris/sediment removal from channel at one locations (Item 6) – 150 L.F.	\$ 750.00
4. Install erosion control measures at three locations (Items 4, 5, 6)	\$ 4,000.00
<b>Total Maintenance Cost</b>	<b>\$ 16,250.00</b>

Although many steps will have to be taken prior to implementing structural drainage improvements in the study area, including survey and design; the infrastructure maintenance items discussed above and shown in Figure 3 can be performed by City crews immediately.

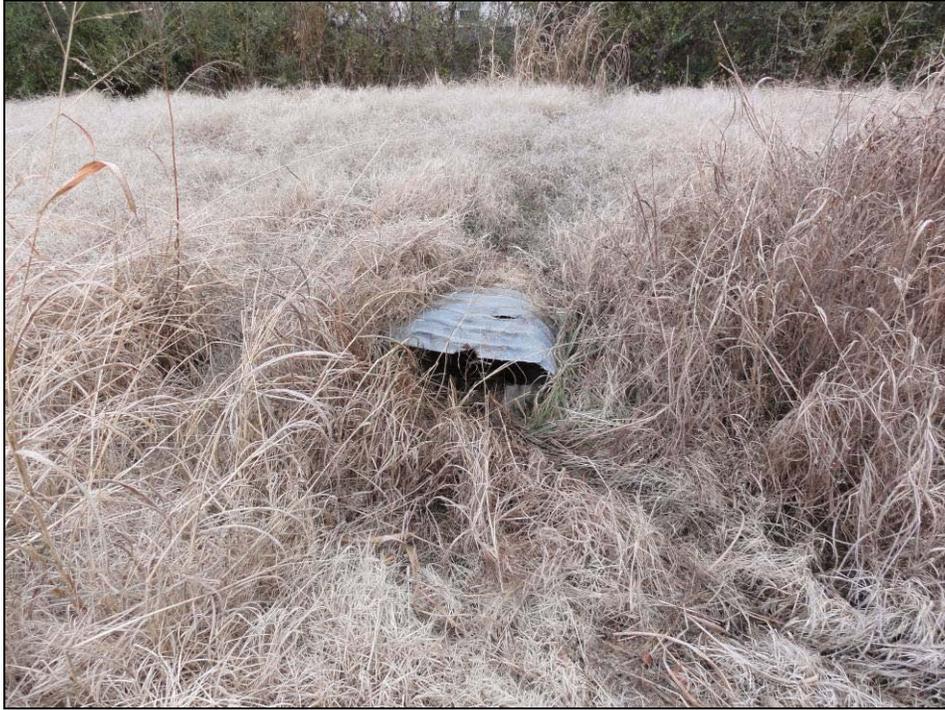
**Item 1 - Detention area between N. Castle Heights Ave. and Westlynn Dr. Repair crushed inlet of 30" CMP. Picture 1638.**

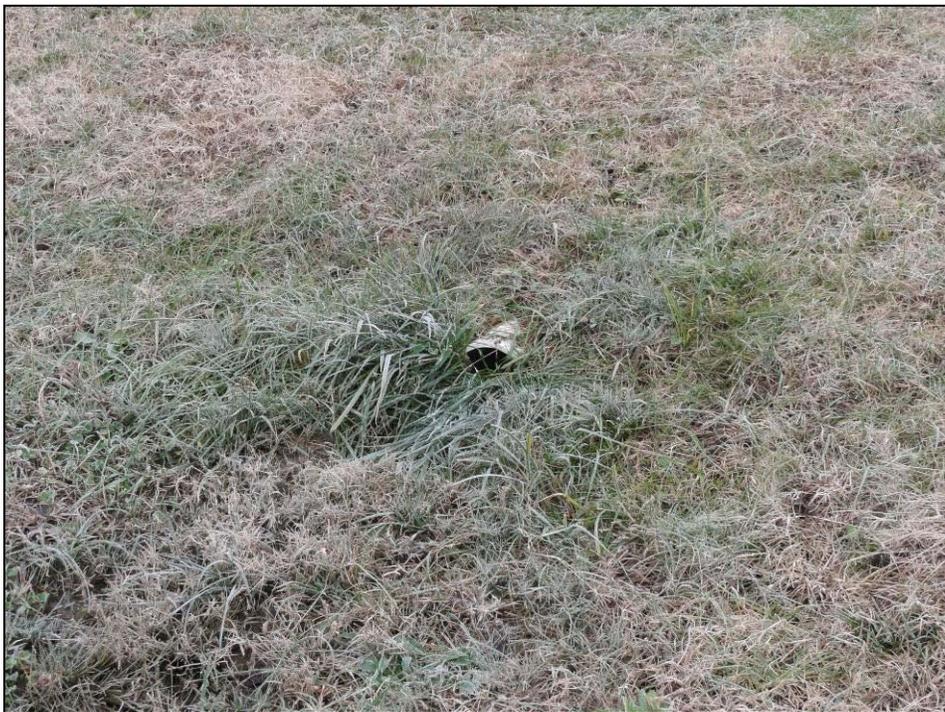
**Item 2 – Detention area between N. Castle Heights Ave. and Westlynn Dr. Clean silt from 12" plastic pipe. Picture 1641.**

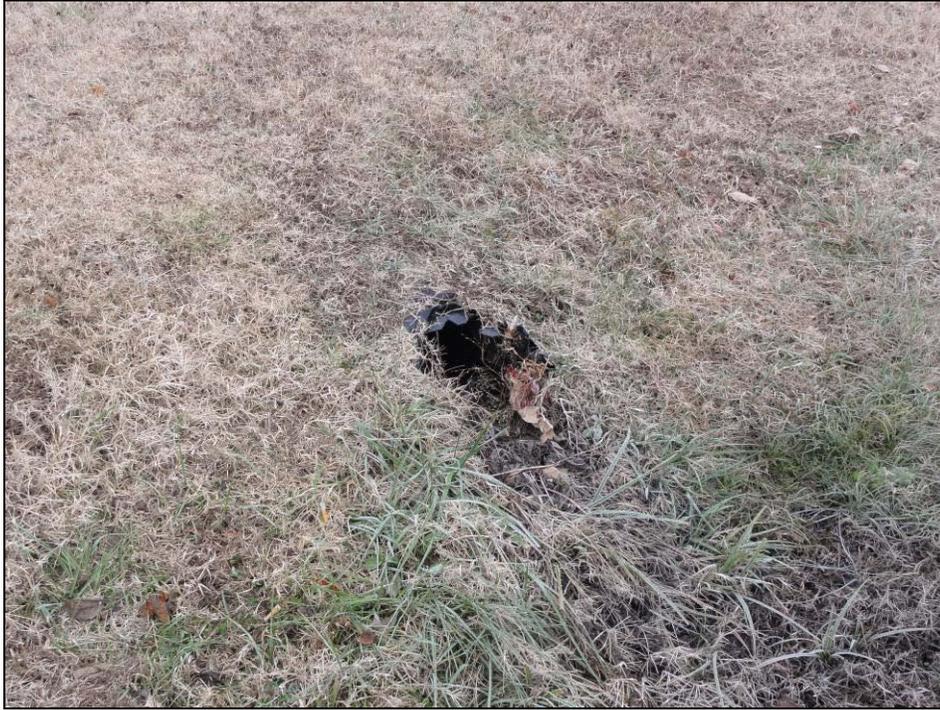
**Item 3 – Detention area between N. Castle Heights Ave. and Westlynn Dr. Repair damaged end of 8” plastic pipe. Picture 1642.**

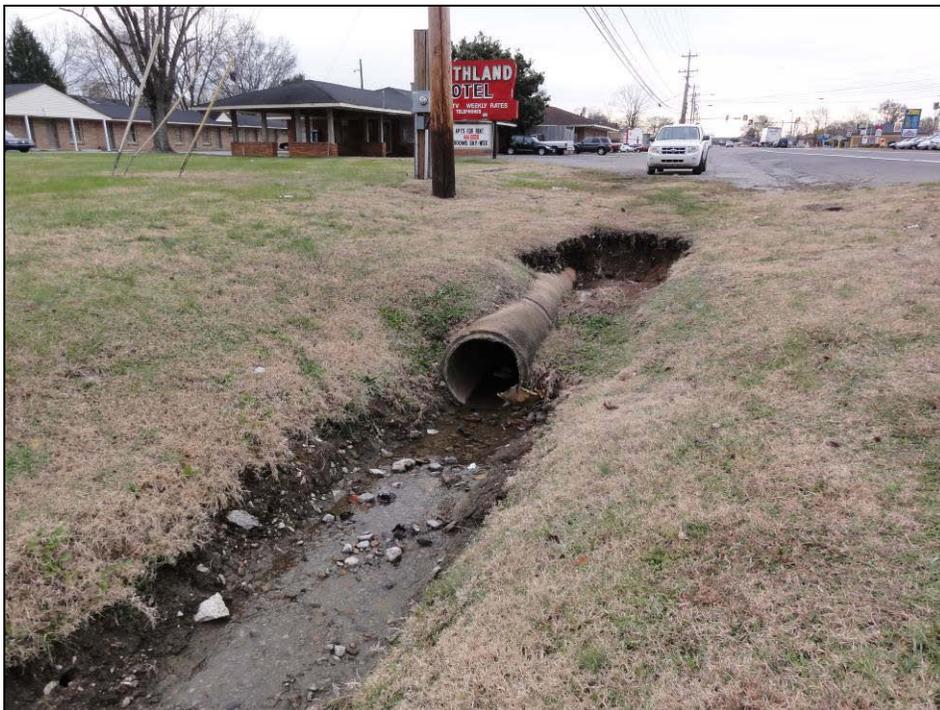
**Item 4 – 1107 N. Cumberland St. Repair damaged outlet of 24” RCP and install erosion control measures. Picture 1663.**

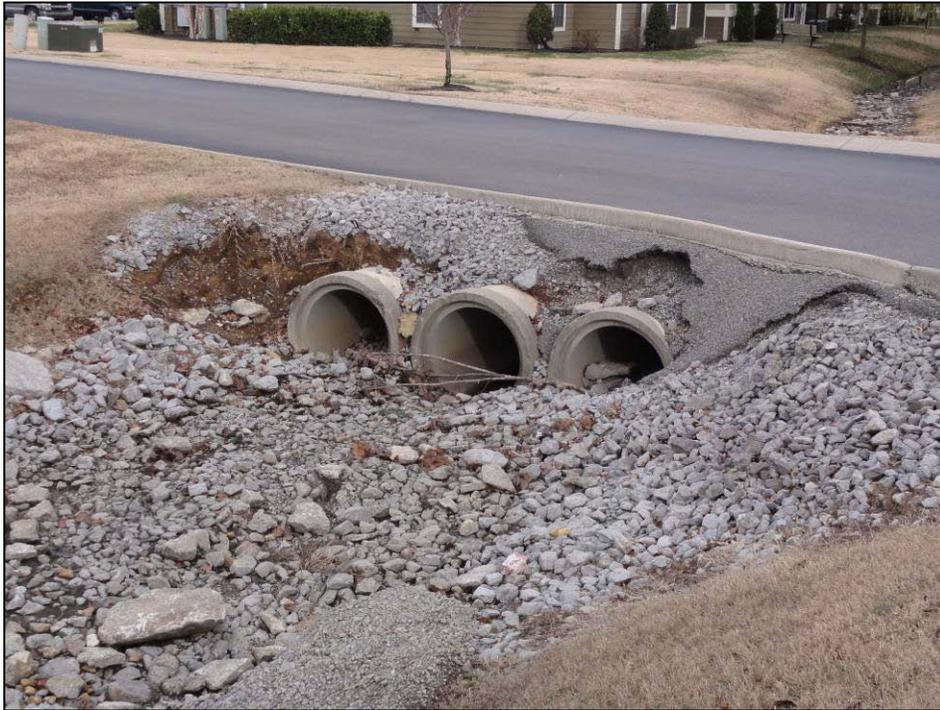
**Item 5 – Creekside Dr. 36” RCP’s. Clear stone from inlet and outlet and install erosion control measures to prevent stone from washing back into culverts. Picture 1672.**

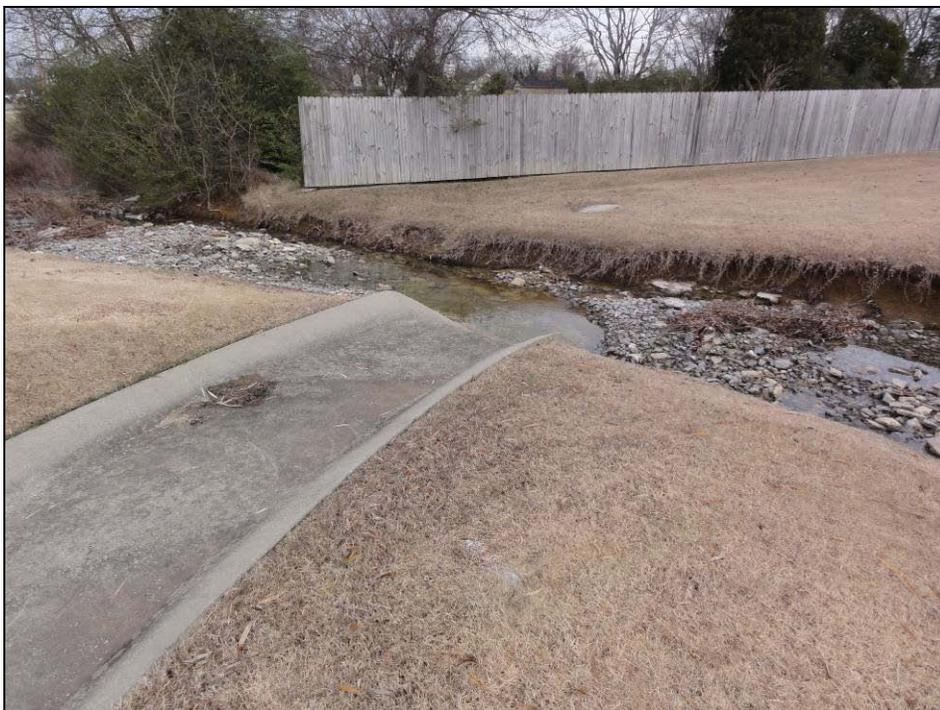
**Item 6 – Channel at detention area outlet, north of Hunters Creek Blvd. and south of Kelsie Dr. Approximately 150 l.f. of channel clean out. Provide erosion control measures on unstable banks. Picture 1681.**

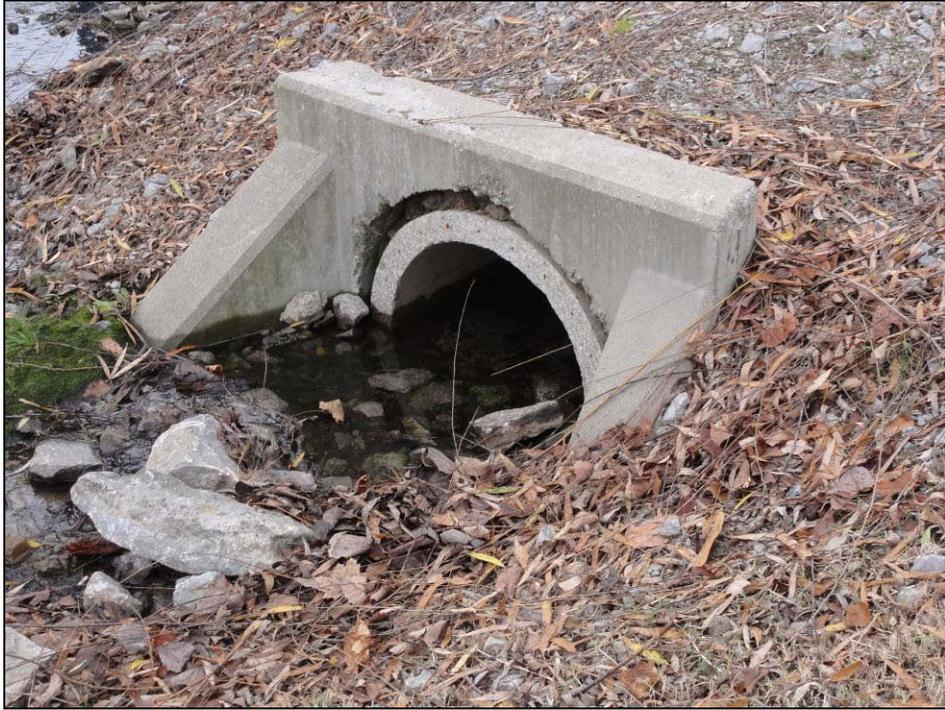
**Item 7 – Hunters Creek Blvd. Clean out inlet and outlet of 24” RCP. Picture 1683.**

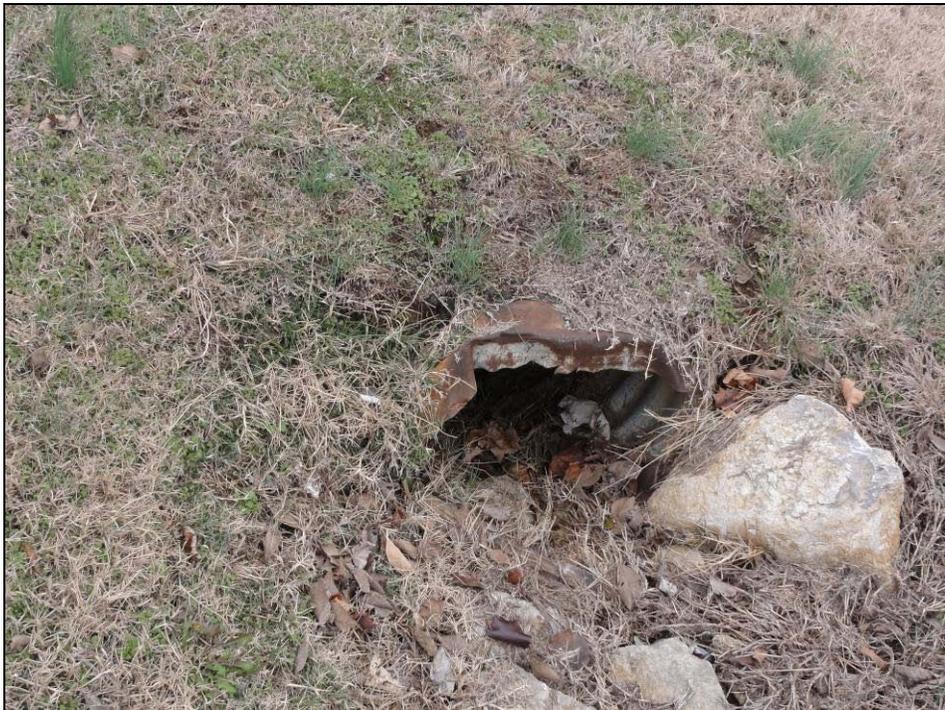
**Item 8 – 903 N. Cumberland St. Repair crushed end section of 18” CMP driveway culvert. Picture 1698.**

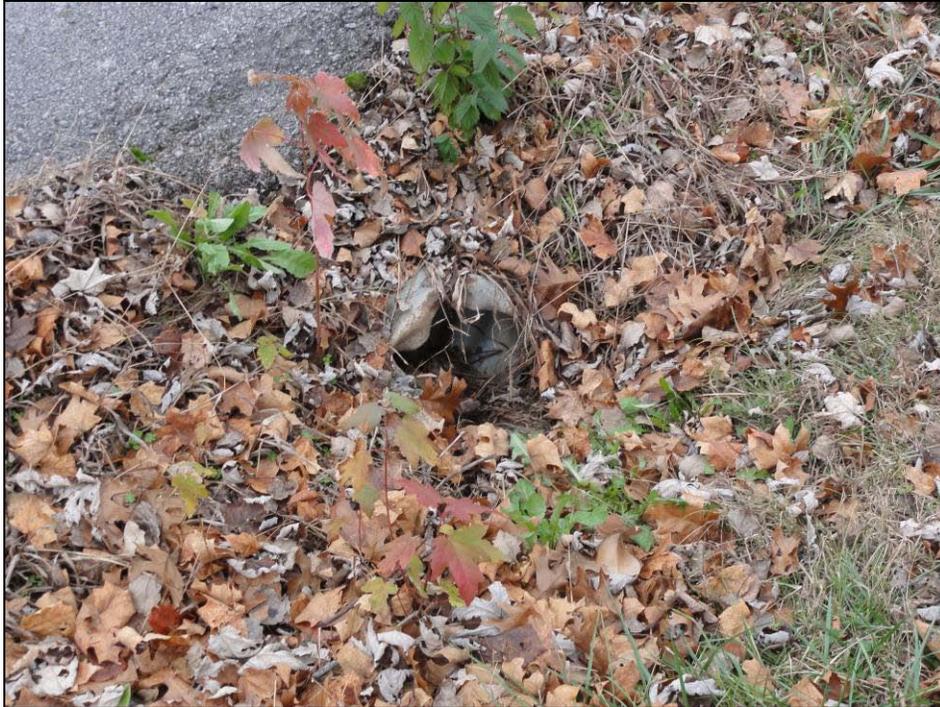
**Item 9 – Elmwood Dr. and Edgehill Dr. Repair crushed end section of 12” CMP. Picture 1704.**

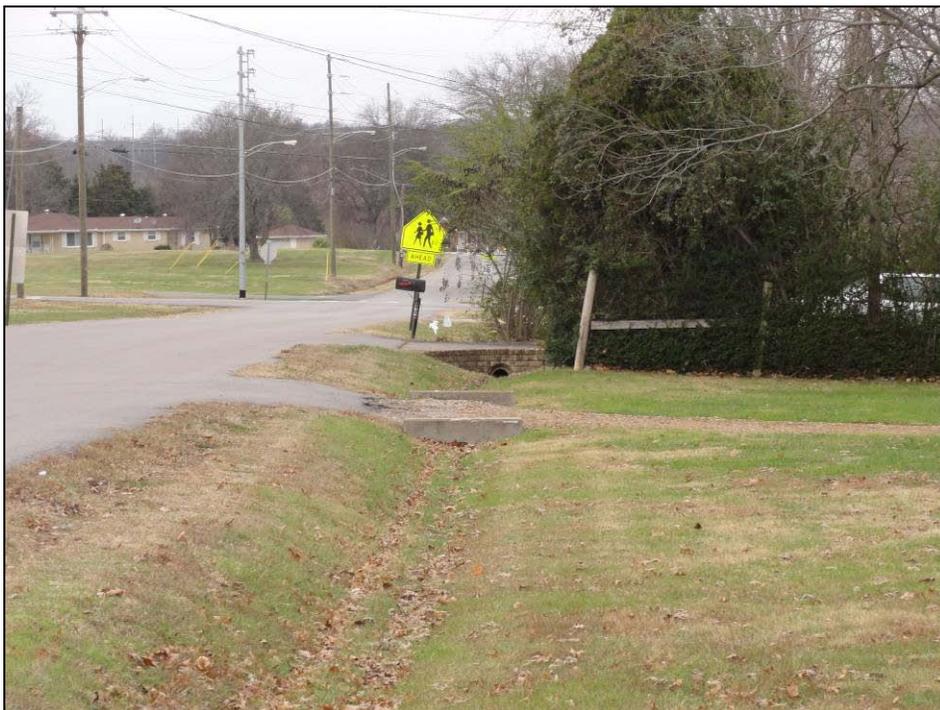
**Item 10 – Looking north along Mayfair Dr. from Vosswood Dr. Clean out silt blocking driveway culvert. Picture 1730.**

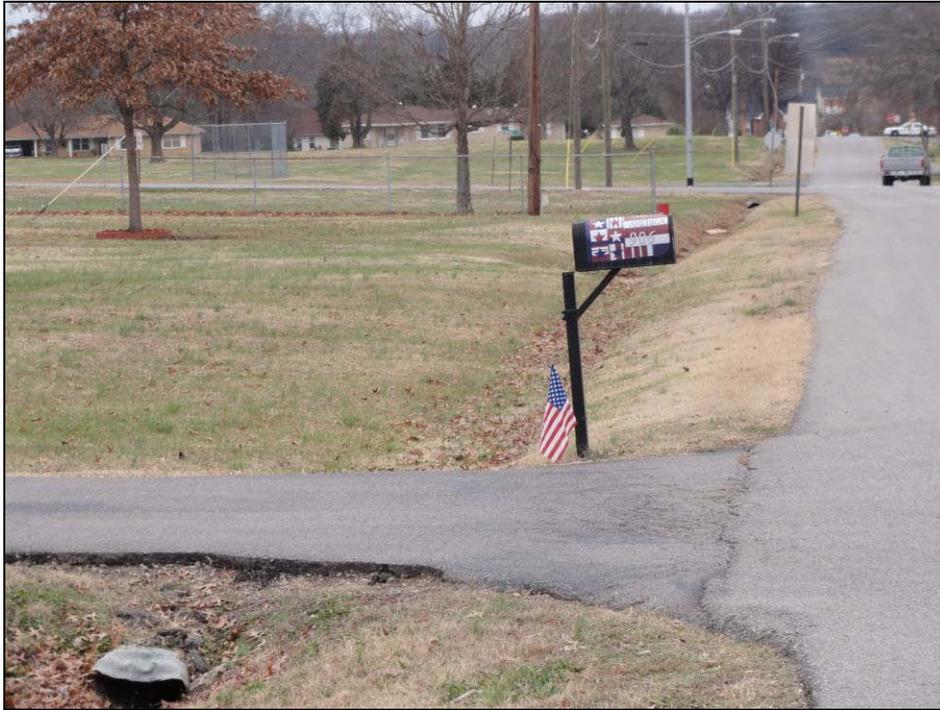
**Item 11 – 906 Mayfair Dr. Looking north along Mayfair Dr. Repair crushed driveway culvert inlet. Picture 1731.**

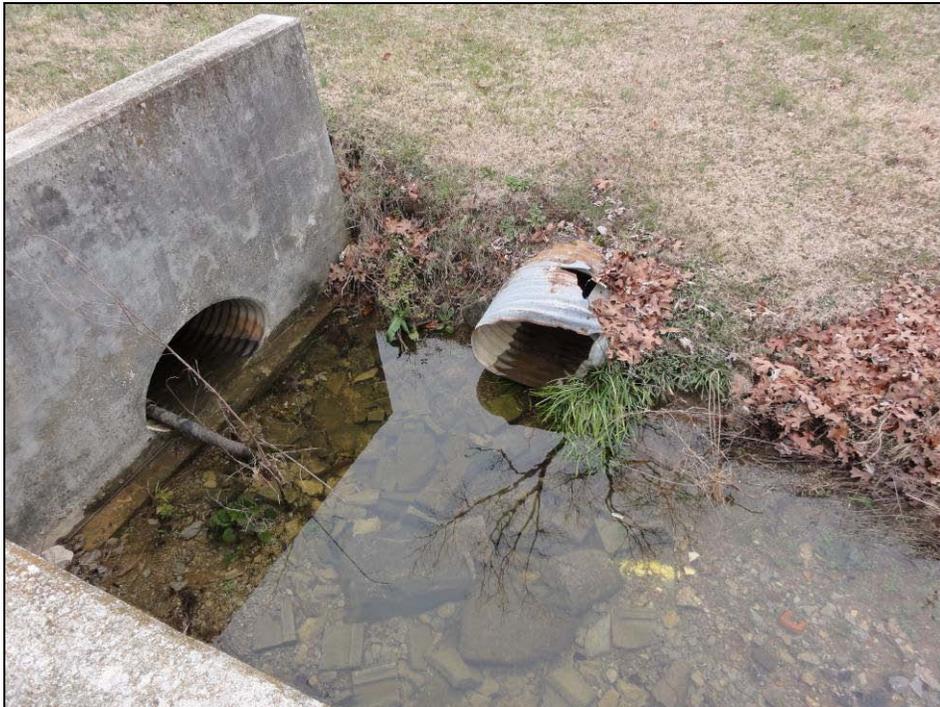
**Item 12 – Adjacent to Hartsville Pike south of Vosswood Dr. Repair damaged CMP Outlet. Picture 1739.**

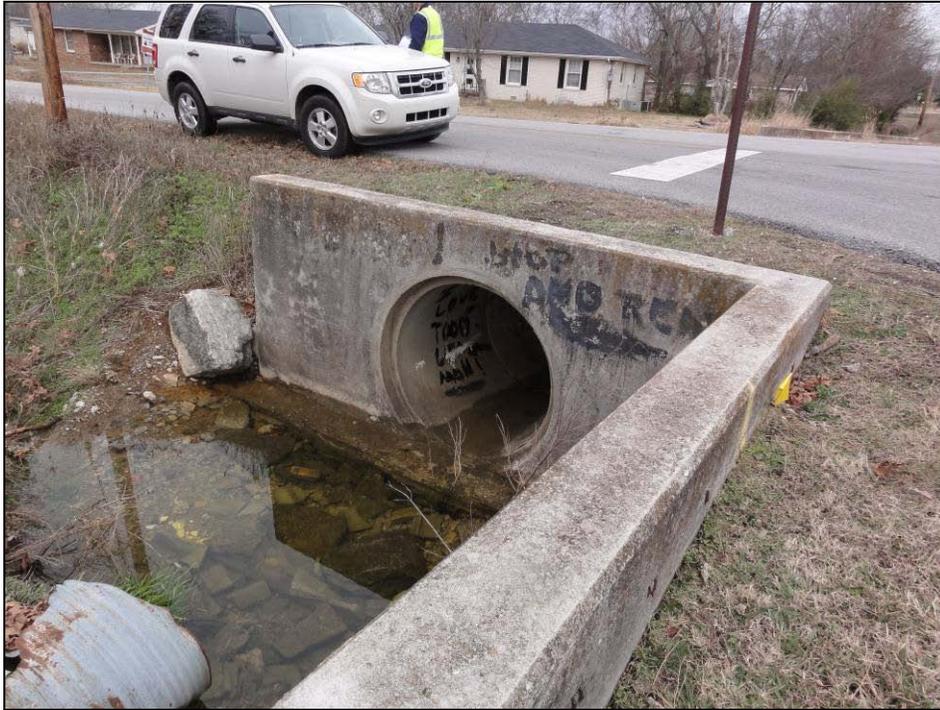
**Item 13 – Vosswood Dr. and Hartsville Pike looking north. Repair damaged end section of 36” x 21” elliptical CMP. Picture 1740.**

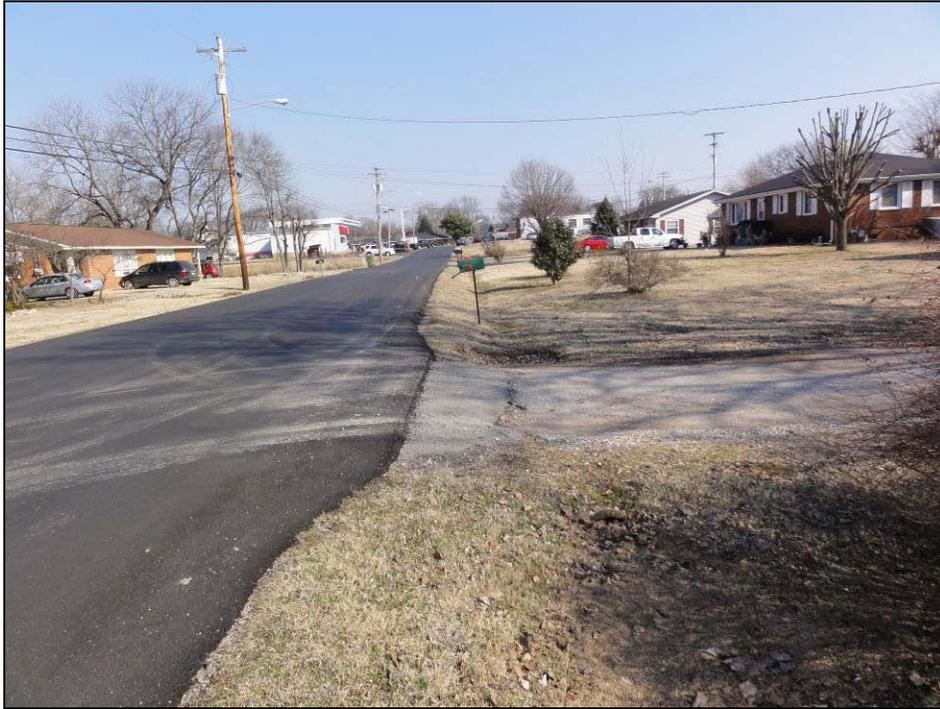
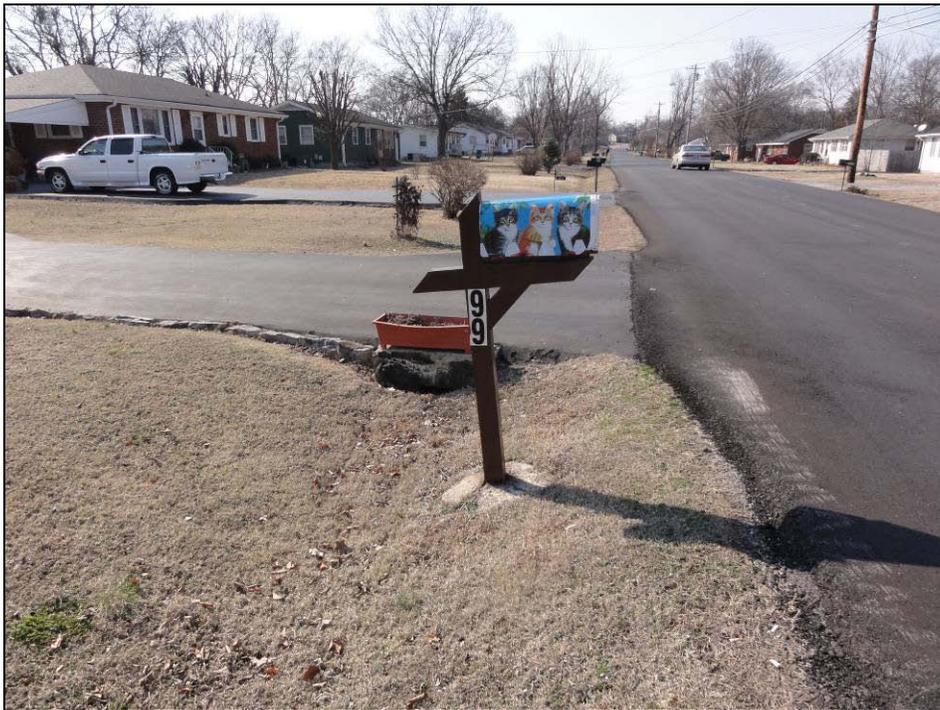
**Item 14 – Westlynn Dr. Clean out multiple driveway culverts obstructed with sediment buildup**
