ENGINEERING REPORT

Oak Hill Drive / Bartonwood Drive Area Drainage Improvements

City of Lebanon Engineering Department

Neel-Schaffer, Inc.

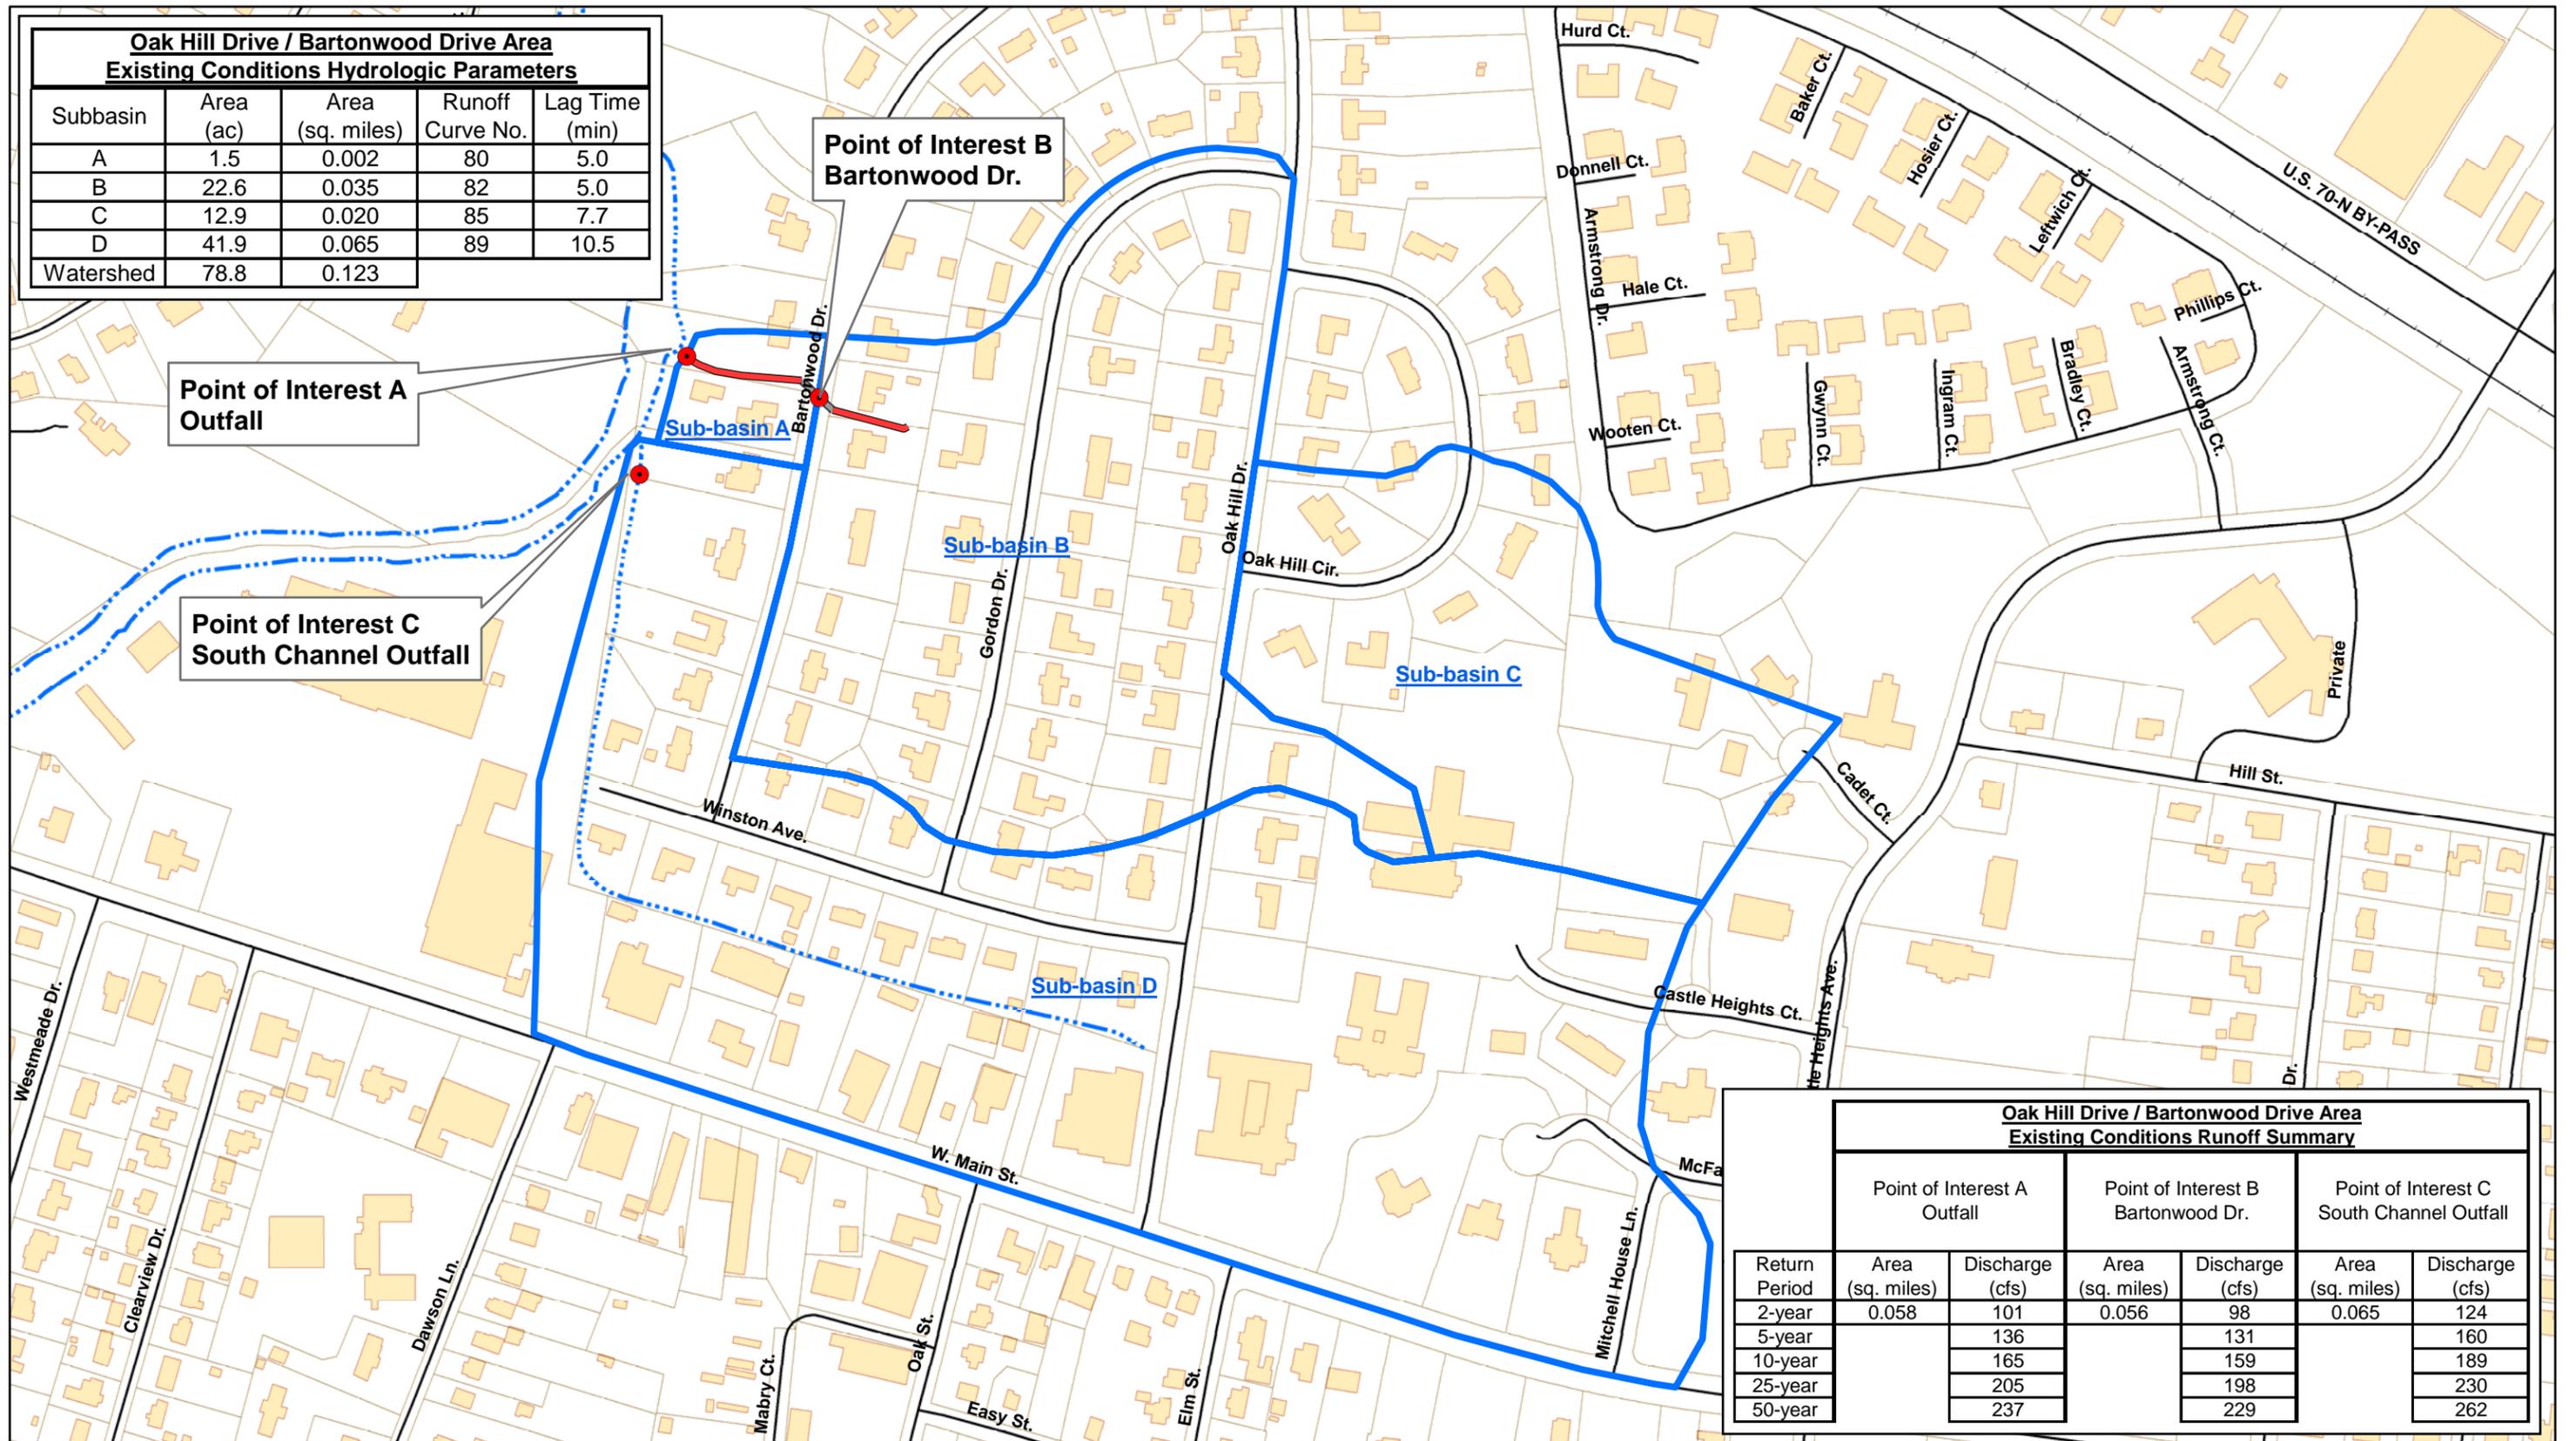
Figure 1

Oak Hill Drive / Bartonwood Drive Area Existing Conditions Hydrologic Parameters				
Subbasin	Area (ac)	Area (sq. miles)	Runoff Curve No.	Lag Time (min)
A	1.5	0.002	80	5.0
B	22.6	0.035	82	5.0
C	12.9	0.020	85	7.7
D	41.9	0.065	89	10.5
Watershed	78.8	0.123

Oak Hill Drive / Bartonwood Drive Area Existing Conditions Runoff Summary						
Return Period	Point of Interest A Outfall		Point of Interest B Bartonwood Dr.		Point of Interest C South Channel Outfall	
	Area (sq. miles)	Discharge (cfs)	Area (sq. miles)	Discharge (cfs)	Area (sq. miles)	Discharge (cfs)
2-year	0.058	101	0.056	98	0.065	124
5-year		136		131		160
10-year		165		159		189
25-year		205		198		230
50-year		237		229		262

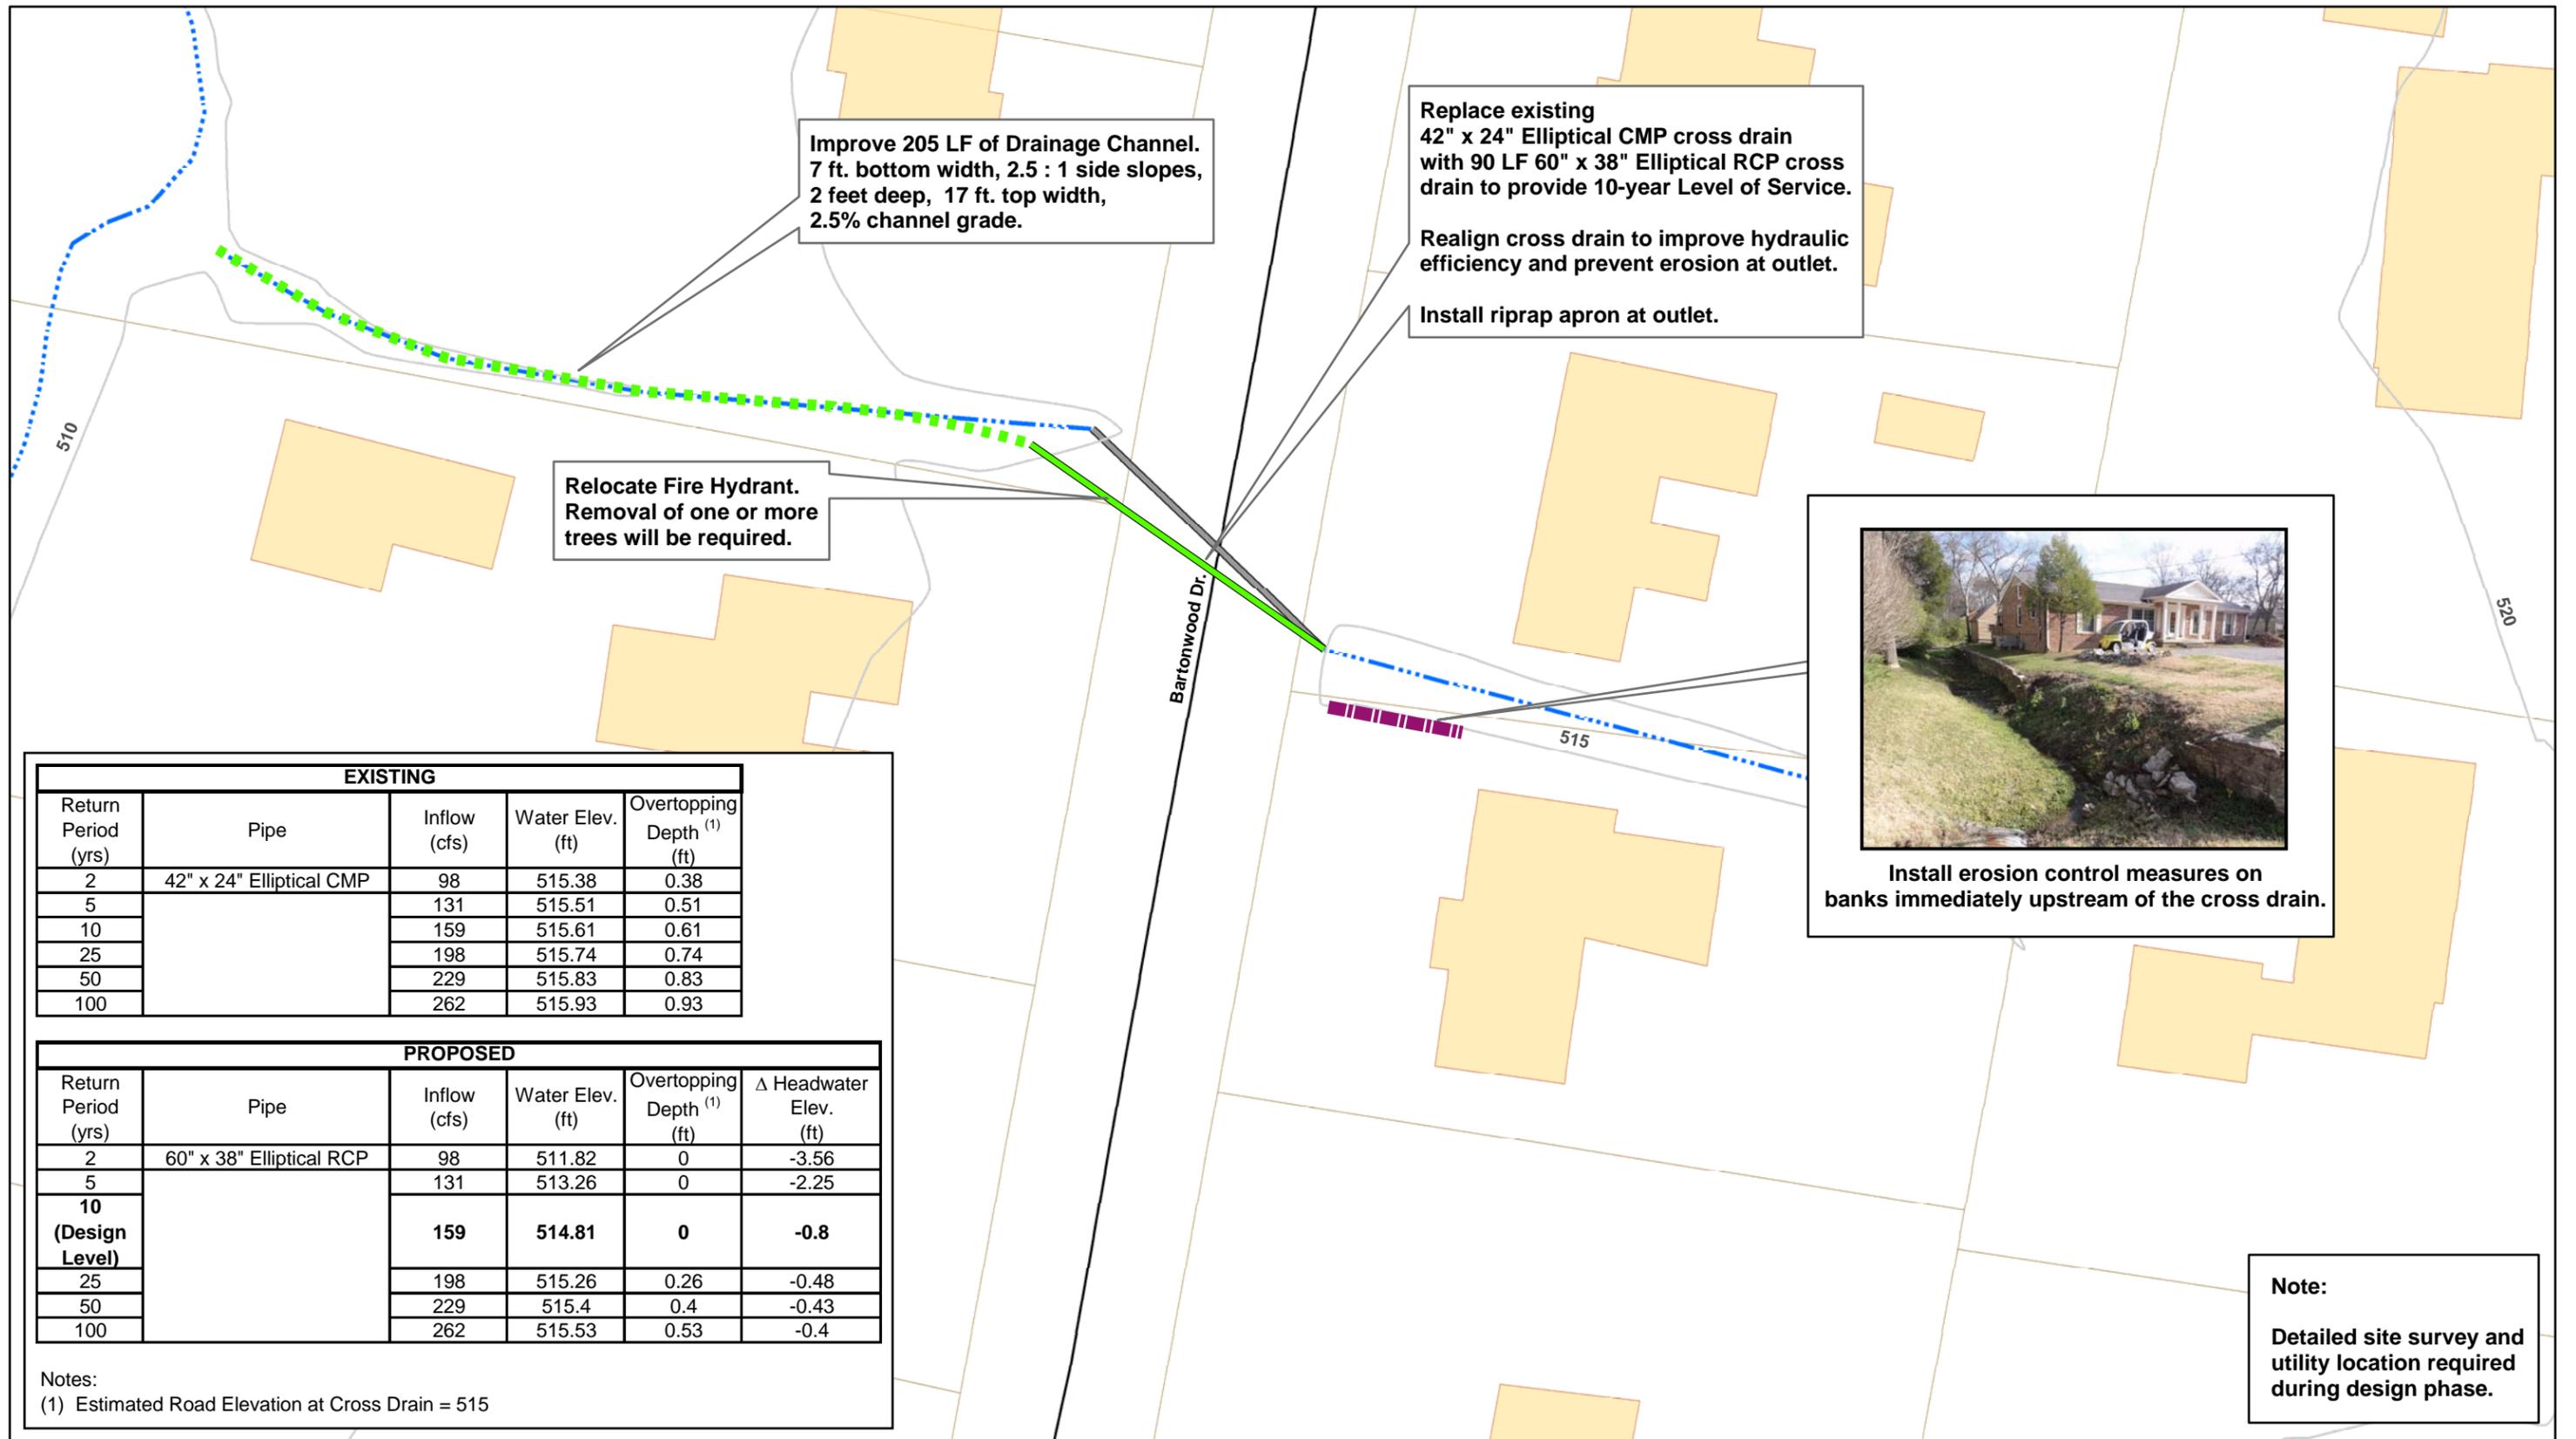
During the technical analysis, it was determined that the Bartonwood Drive cross drain, which is a 42-inch by 24-inch elliptical corrugated metal pipe (ECMP), does not have enough capacity to prevent flooding during frequent storm events. Not only is the cross drain itself undersized, but the alignment of the pipe, in relation to the flow line of the ditch, significantly decreases the efficiency of the cross drain. Storm discharge leaving the cross drain flows directly into a masonry retaining wall on the north side of the drainage ditch. Significant sediment deposits are present at the outlet of the cross drain, which indicates that excessive turbulence is created when the water hits the retaining wall. The excessive head loss at this transition causes sediment deposits to settle out. Further, the combination of an undersized pipe and poor alignment causes the storm water runoff from frequent rainfall events to back up into the adjacent properties and flow over Bartonwood Drive.

EXISTING				
Return Period (yrs)	Pipe	Inflow (cfs)	Water Elev. (ft)	Overtopping Depth ⁽¹⁾ (ft)
2	42" x 24" Elliptical CMP	98	515.38	0.38
5		131	515.51	0.51
10		159	515.61	0.61
25		198	515.74	0.74
50		229	515.83	0.83
100		262	515.93	0.93

The hydraulic operation of the cross drain was evaluated using data obtained from the City’s GIS mapping and during the field review. Based on this data, it is recommended to replace the existing culvert with a 60-inch by 38-inch elliptical reinforced concrete pipe (ERCP). It is also recommended that the cross drain alignment be shifted to more closely match the alignment of the drainage ditch. This will improve the hydraulic efficiency of the cross drain and help prevent erosion on the downstream side of Bartonwood Drive. The replacement pipe, with the new alignment, will provide a 10-year level of service for the cross drain.

PROPOSED					
Return Period (yrs)	Pipe	Inflow (cfs)	Water Elev. (ft)	Overtopping Depth ⁽¹⁾ (ft)	Δ Headwater Elev. (ft)
2	60" x 38" Elliptical RCP	98	511.82	0	-3.56
5		131	513.26	0	-2.25
10 (Design Level)		159	514.81	0	-0.8
25		198	515.26	0.26	-0.48
50		229	515.4	0.4	-0.43
100		262	515.53	0.53	-0.4

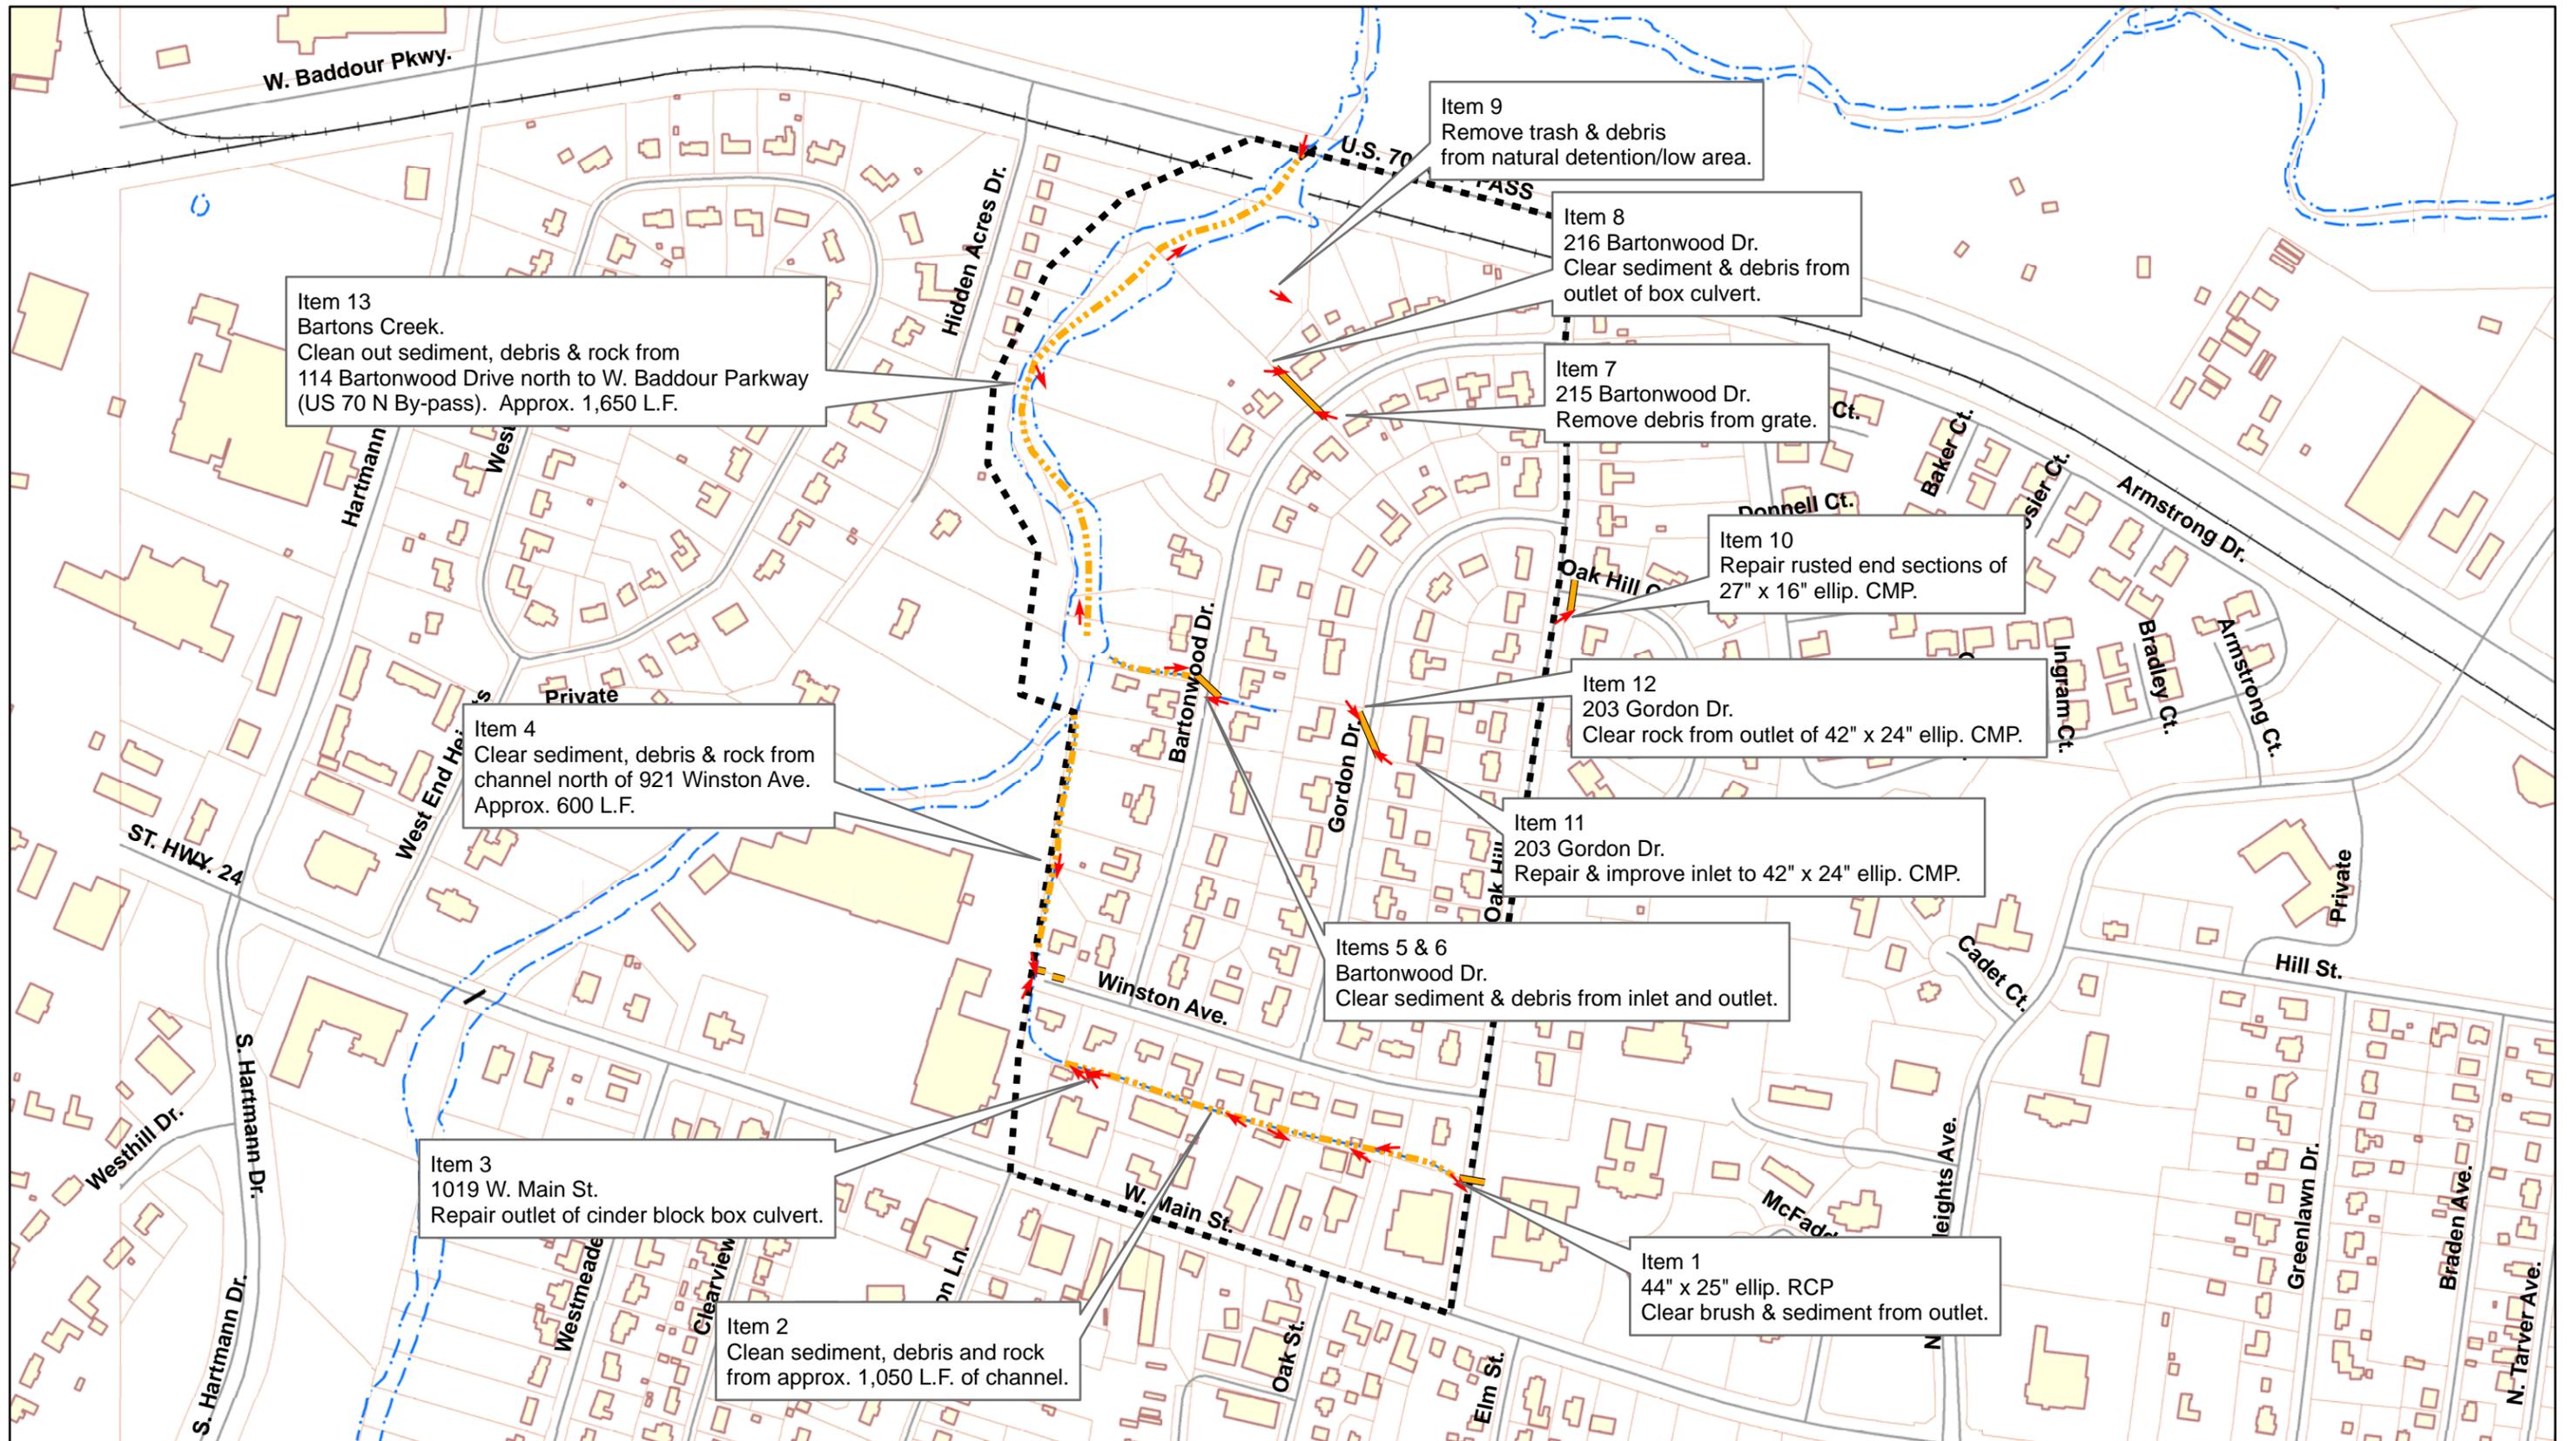
Figure 3

In addition to removing debris and obstructions described above, numerous routine maintenance issues were found throughout the study area during the field reconnaissance. Examples of required maintenance items include removing sediment buildup from culvert inlets, removing excess vegetation and debris from culvert inlets, and repairing damaged culvert end sections. While correcting these deficiencies will not solve flooding problems, it is critical to correct them

Infrastructure Maintenance Items (See Figure 3)	Preliminary Estimated Project Cost
1. Debris/sediment removal from culvert ends at five locations (Items 1, 5, 7, 8, 12)	\$ 2,500.00
2. Debris/sediment removal from channel at three locations – 3,300 L.F. (Items 2, 4, 13)	\$ 16,500.00
3. Culvert end repair at three locations (Item 3, 10, 11)	\$3,000.00
4. Remove trash/debris from natural detention/low area (Item 9)	\$ 4,500.00
Total Maintenance Cost	\$ 23,000.00

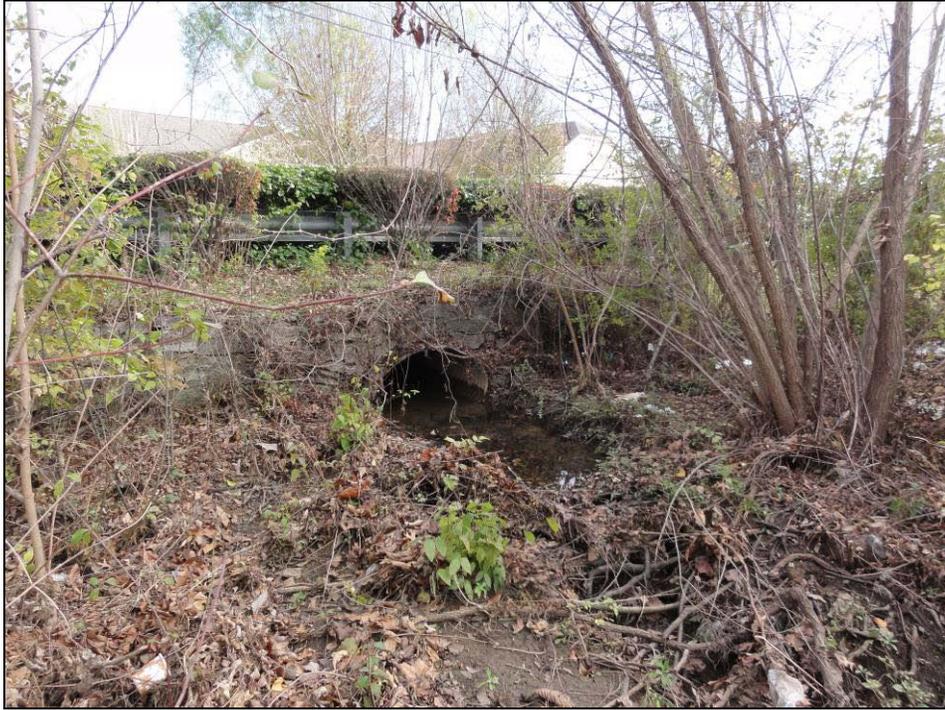
Item 1 - Oak Hill Dr. north of W. Main St. Clear brush and sediment from outlet of 44" x 25" Ellip. RCP. Picture 2061.

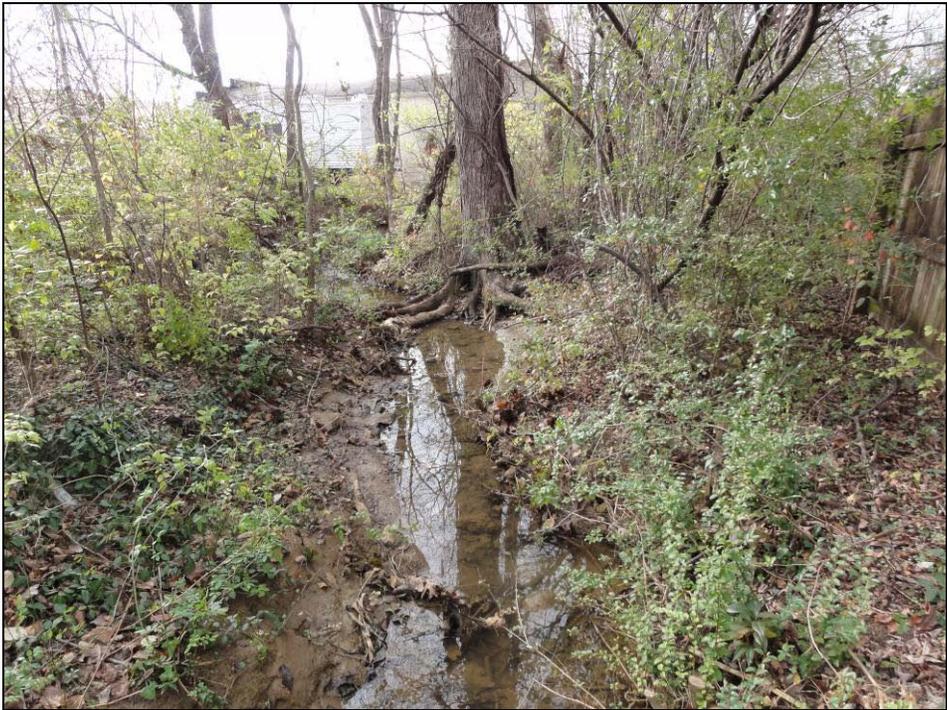
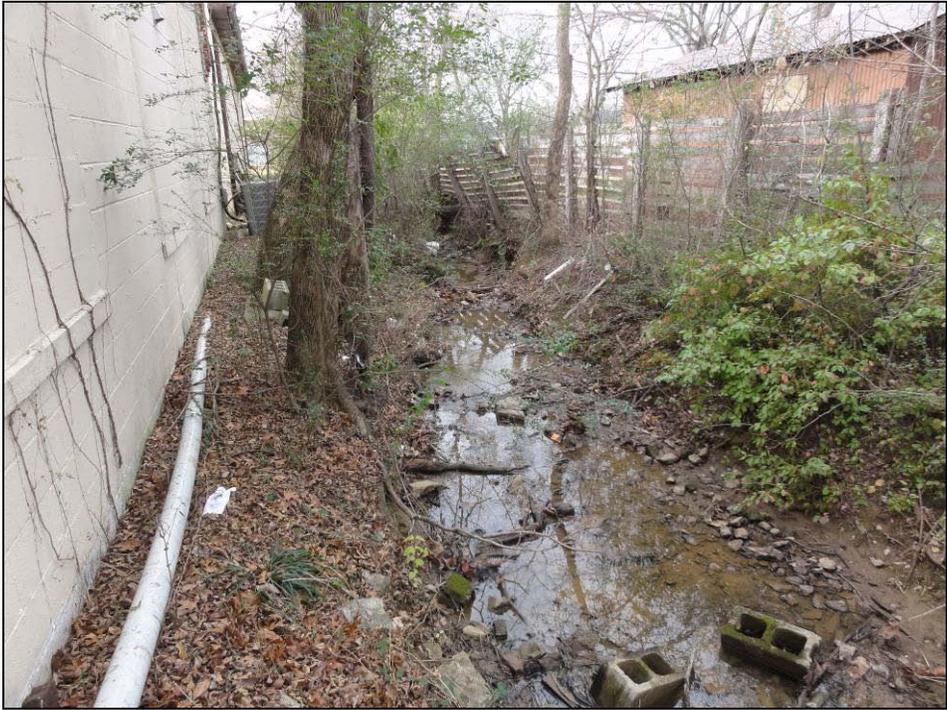
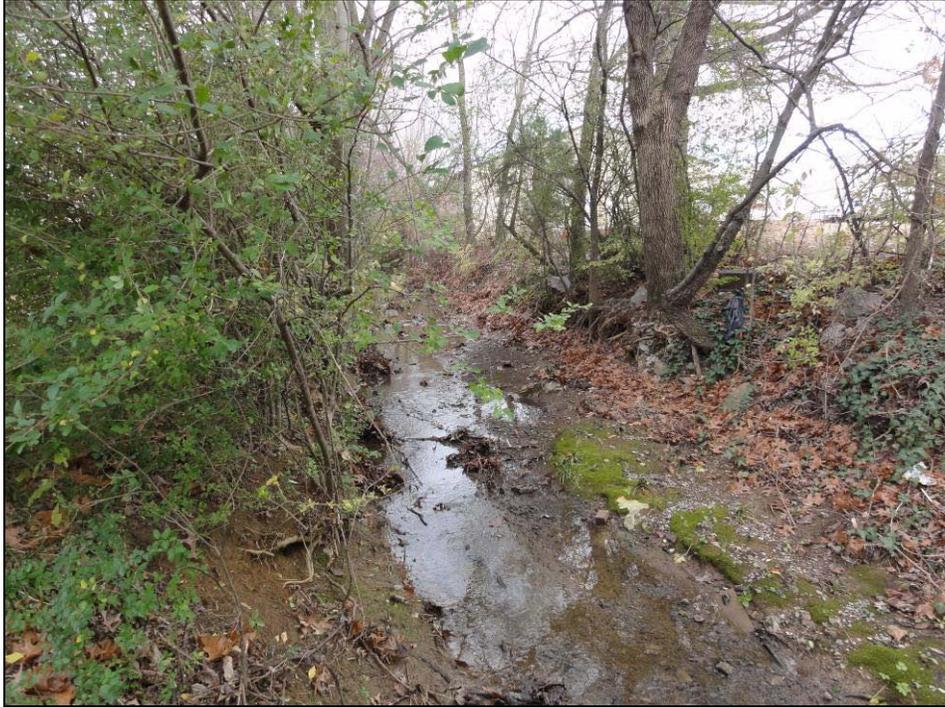
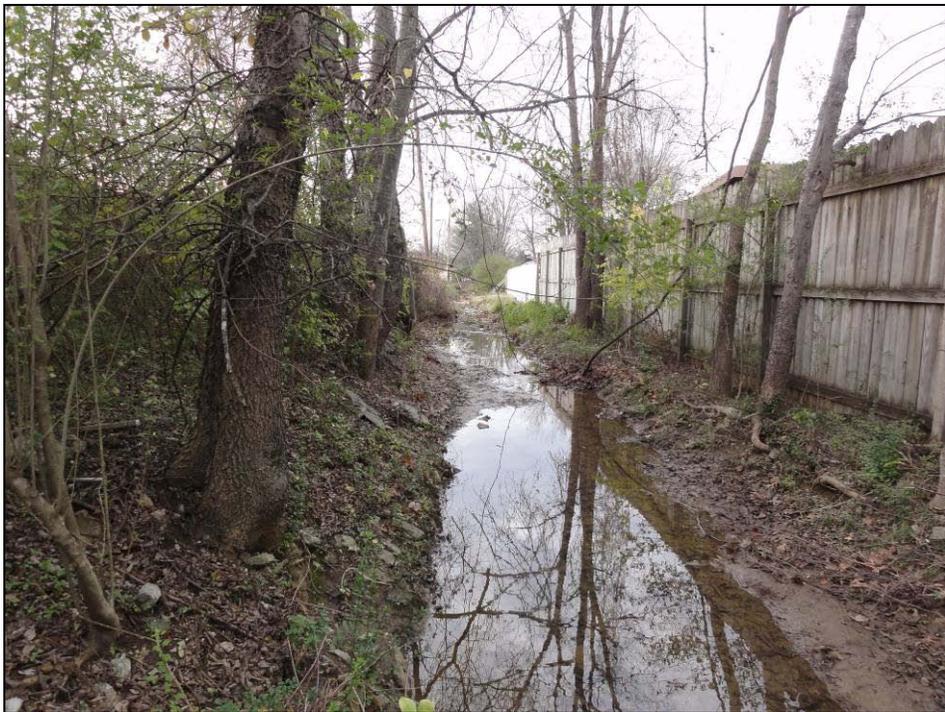
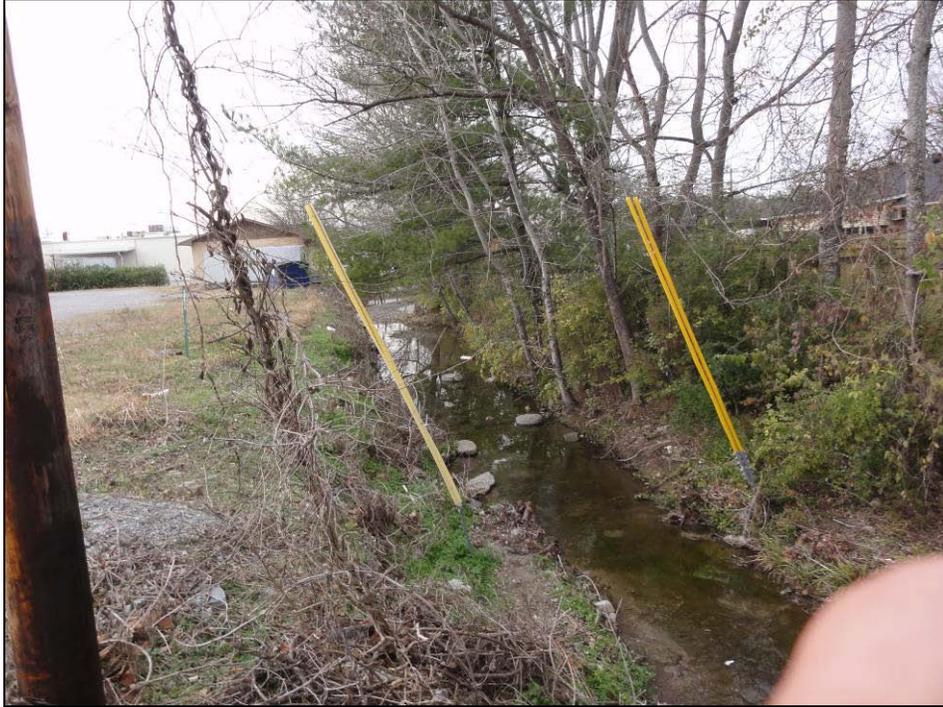
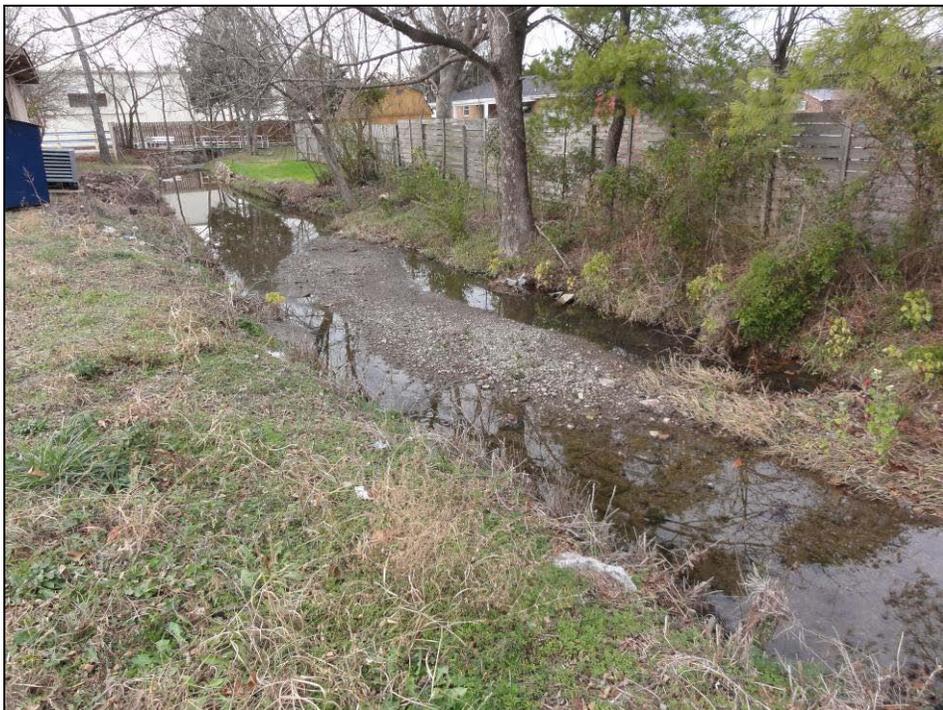
Item 2 – Clean out sediment, debris and rock from channel running westward Oak Hill Drive to 922 Winston Av. Approx. 1,050 l.f.

Looking west from 908 Winston Ave. Picture 2063

Looking west from 1003 W. Main St. Picture 2065

Looking west from 1007 W. Main St. Picture 2071

Looking west from 1011 W. Main St. Picture 2075

Looking west from 1019 W. Main St. Picture 2080

Looking west from 1019 W. Main St. Picture 2082

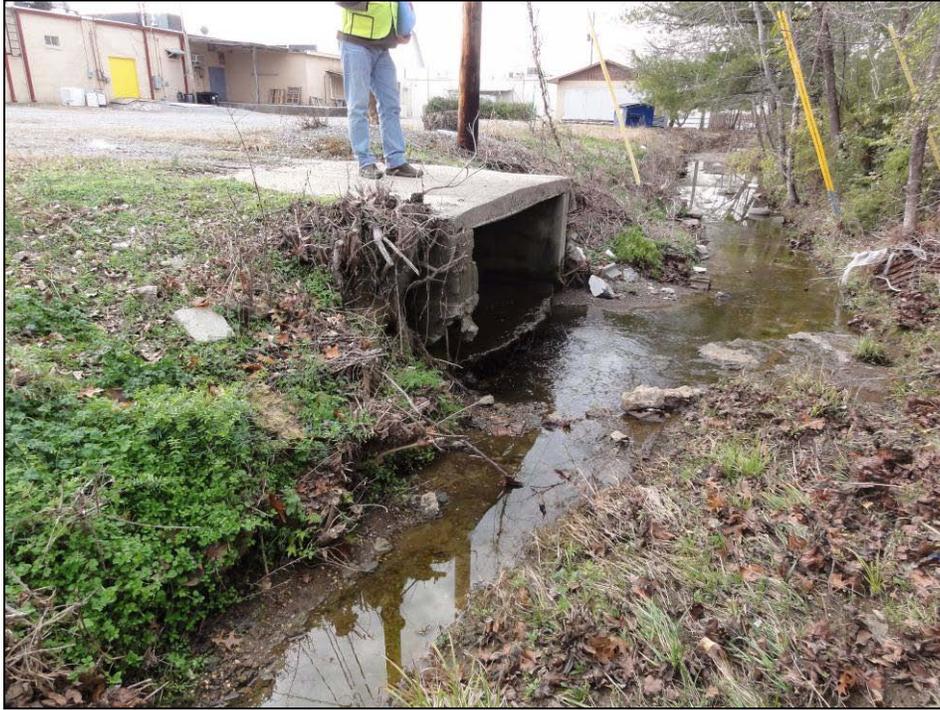
Item 3 – 1019 W. Main St. Repair outlet of 7'-3" x 32" cinder block box culvert. Picture 2081.

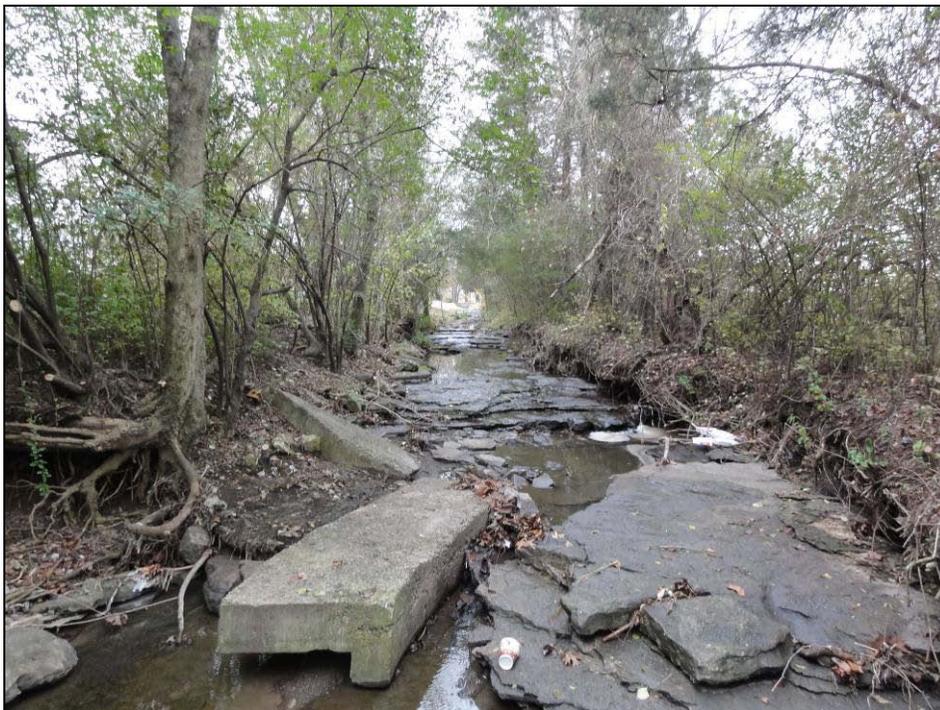
Item 4 – Channel running north from 921 Winston Ave. to 112 Bartonwood Dr. Approx. 600 l.f. Clean out sediment, debris and rock. Picture 2110.

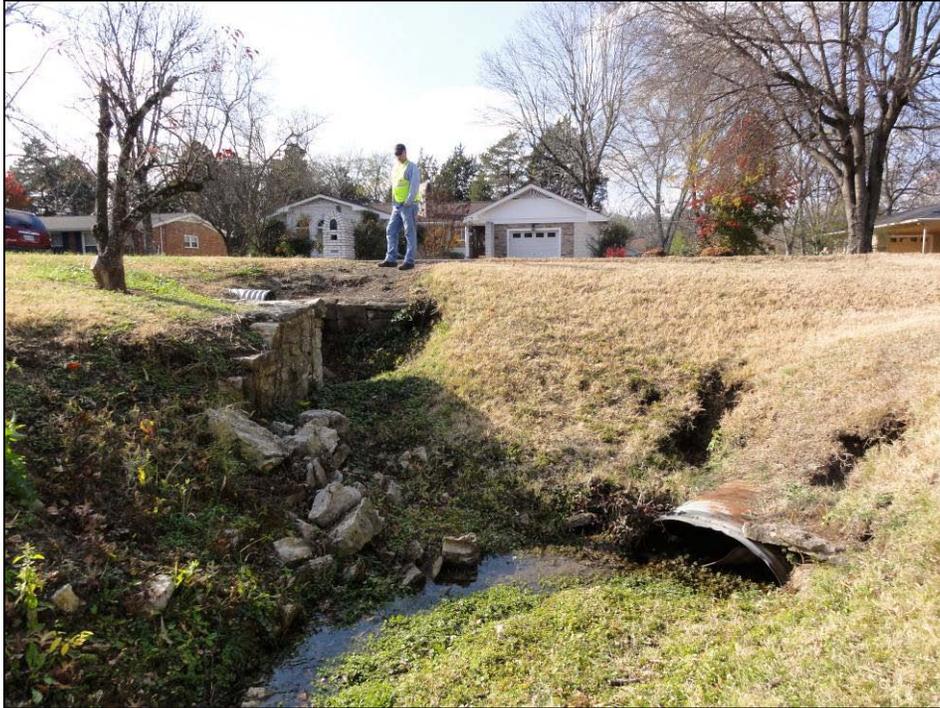
Item 5 –East side of Bartonwood Dr. Inlet of 42” x 24” CMP is clogged with sediment /debris. Also note active erosion above inlet. Picture 1341.

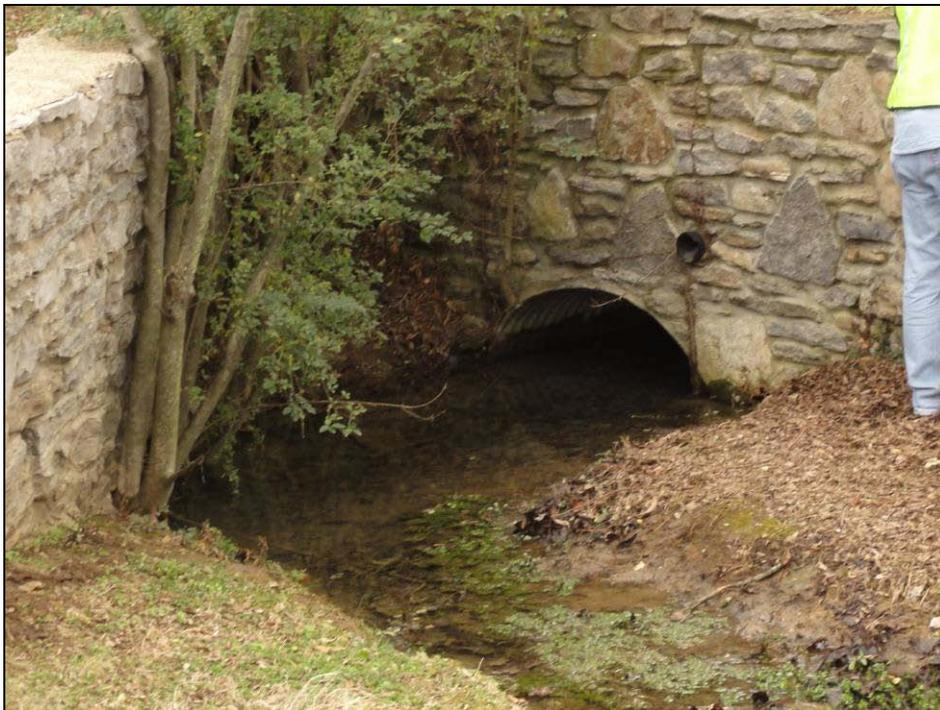
Item 6 – West side of Bartonwood Dr. Clean sediment and debris from outlet of 42” x 24” CMP. Picture 2105.

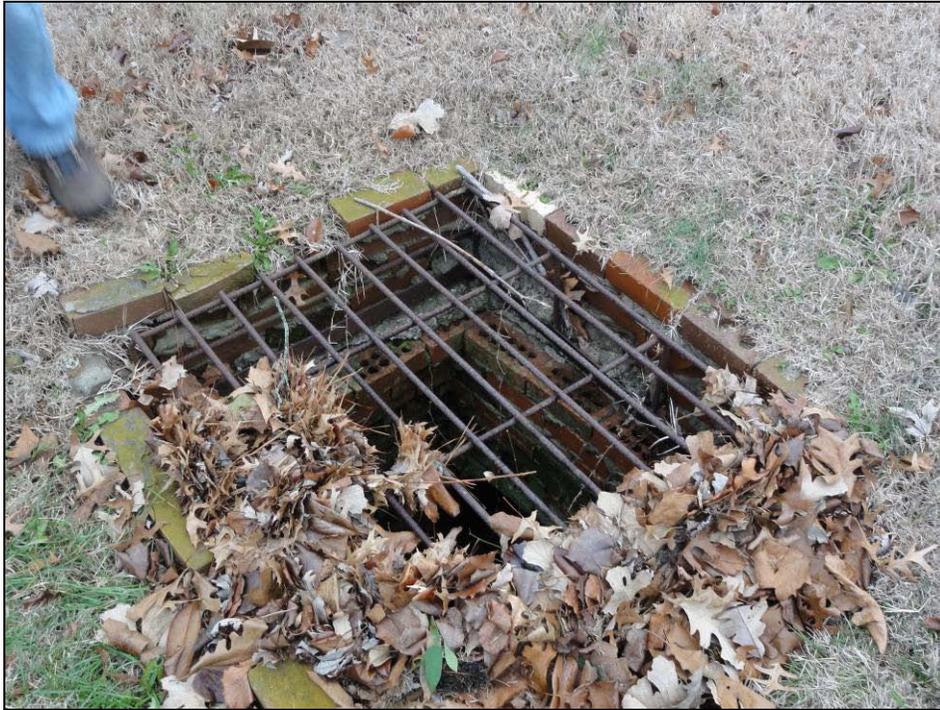
Item 7 – 215 Bartonwood Dr. Remove debris from grate. Picture 2113.

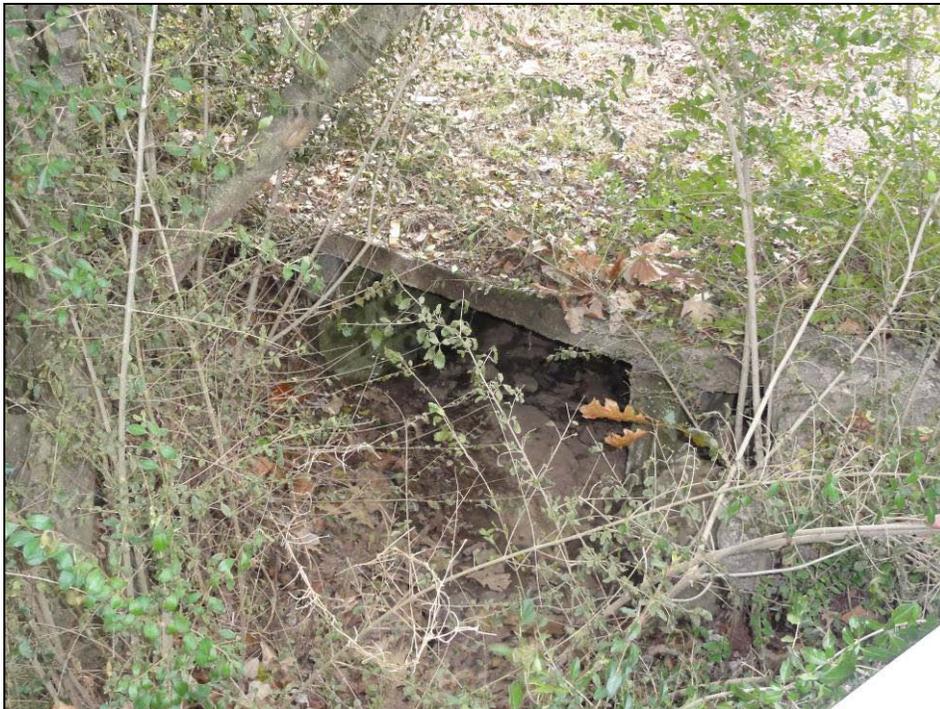
Item 8 – 216 Bartonwood Dr. Clean debris and sediment from outlet of 4' x 2' box culvert. Picture 2120.

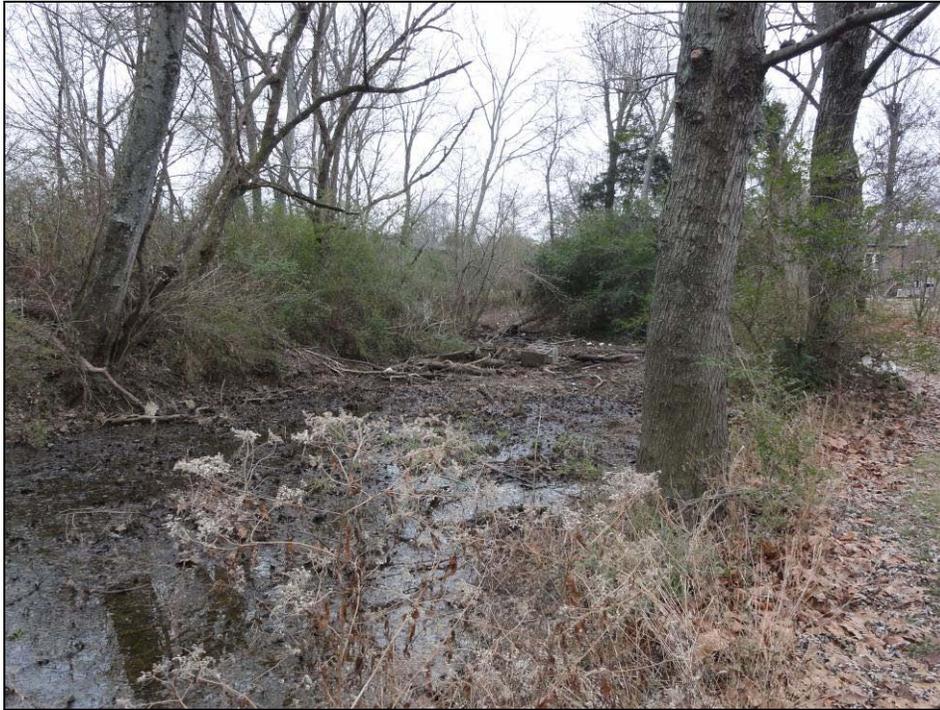
Item 9 – Natural detention/low area adjacent to Bartons Creek south of W. Baddour Pkwy. Clean out trash and debris. Picture 2126.

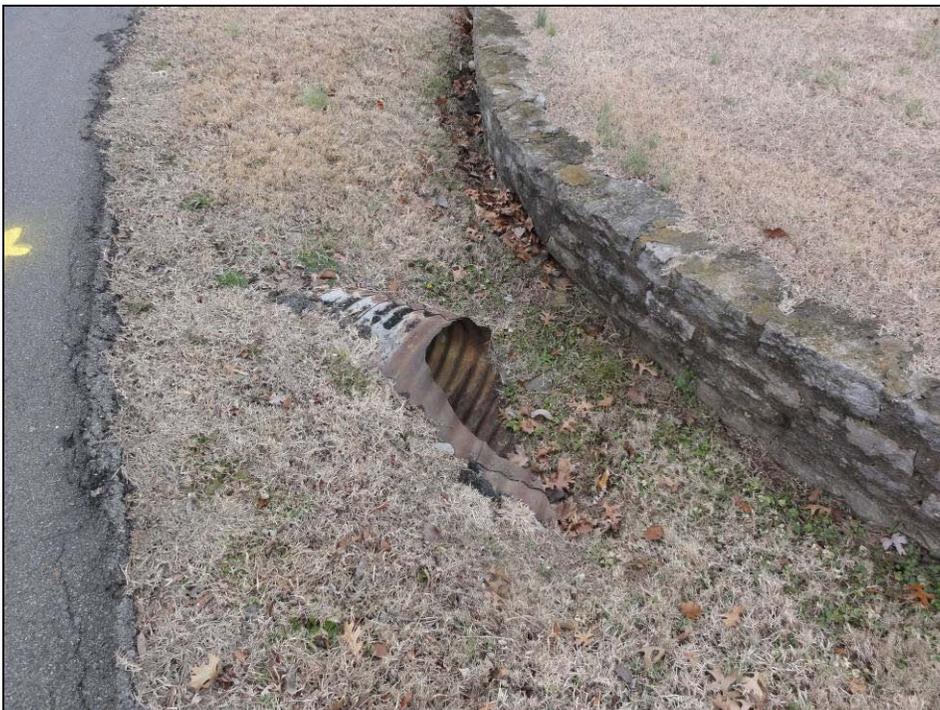
Item 10 – Oak Hill Dr. and Oak Hill Cir. Repair rusted end sections of 27” x 16” ellip. CMP. Picture 2140.
