ENGINEERING REPORT

Oak Hill Drive / Bartonwood Drive Area Drainage Improvements

City of Lebanon Engineering Department

Neel-Schaffer, Inc.

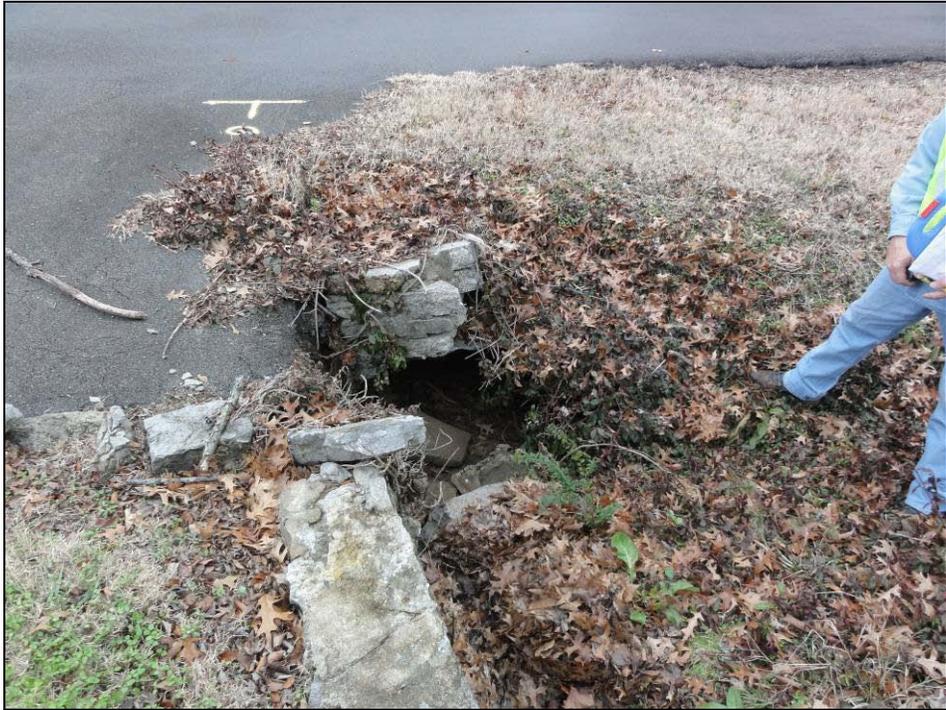
Item 11 – 203 Gordon Dr. Repair and improve inlet to 42” x 24” ellip. CMP. Picture 2152.

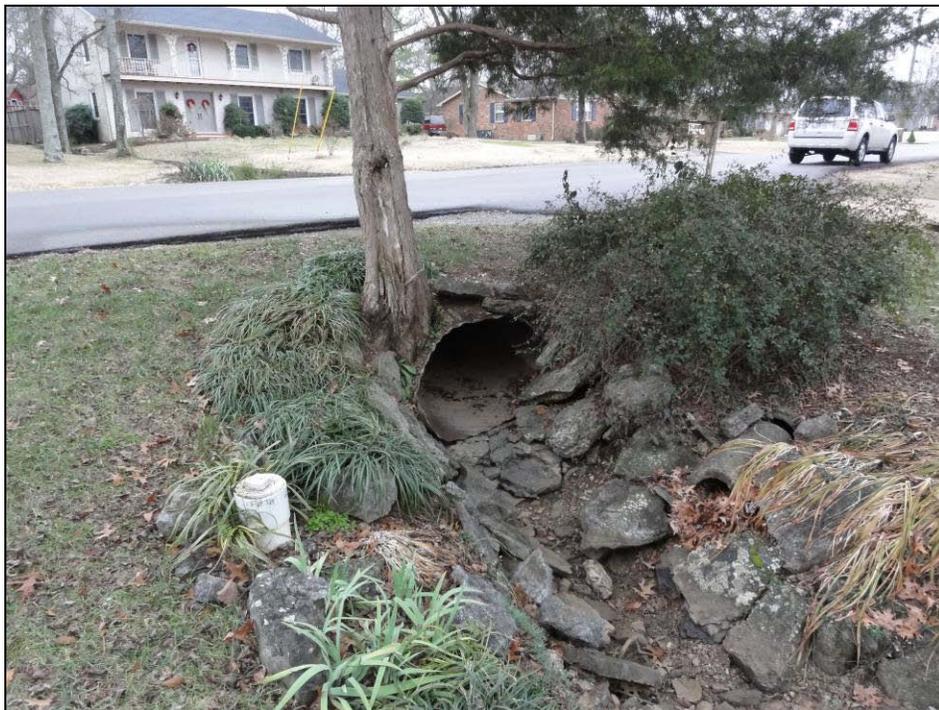
Item 12 – 203 Gordon Dr. Clear rock from outlet of 42” x 24” ellip. CMP. Picture 2155.

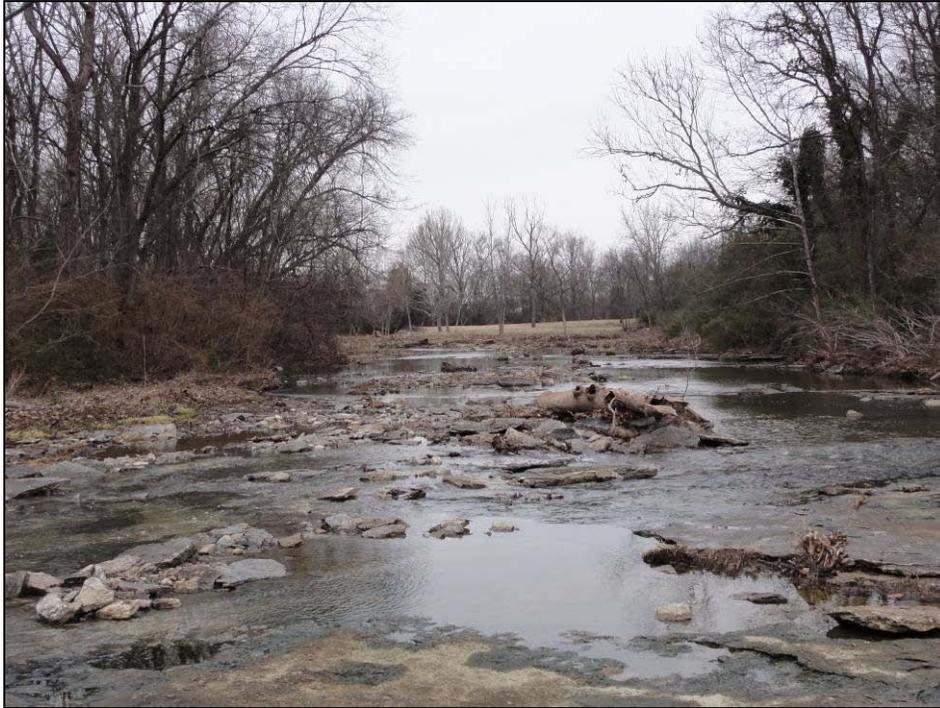
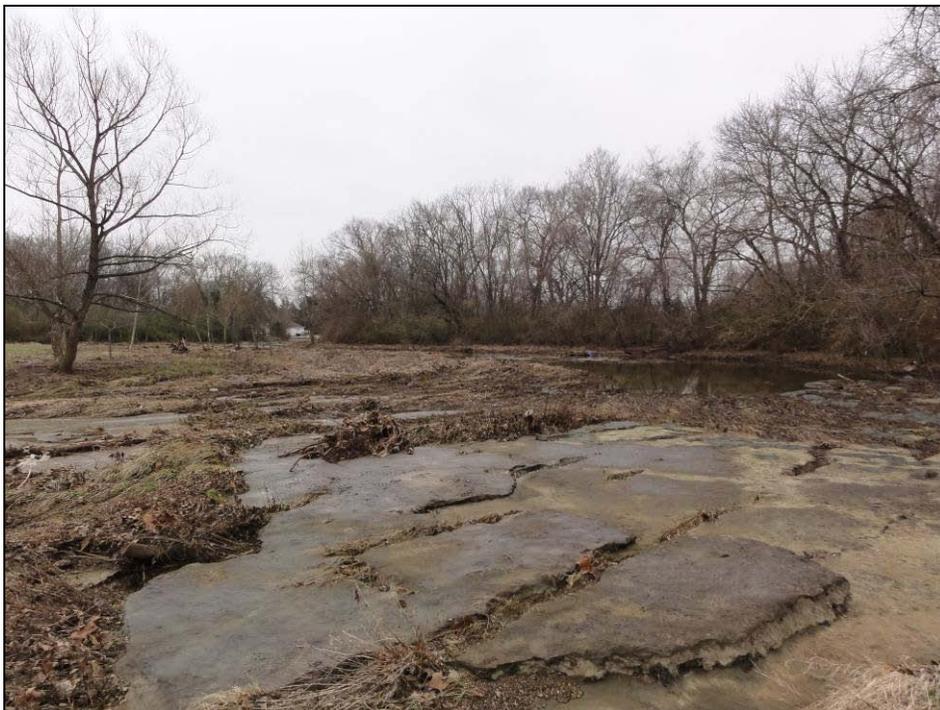
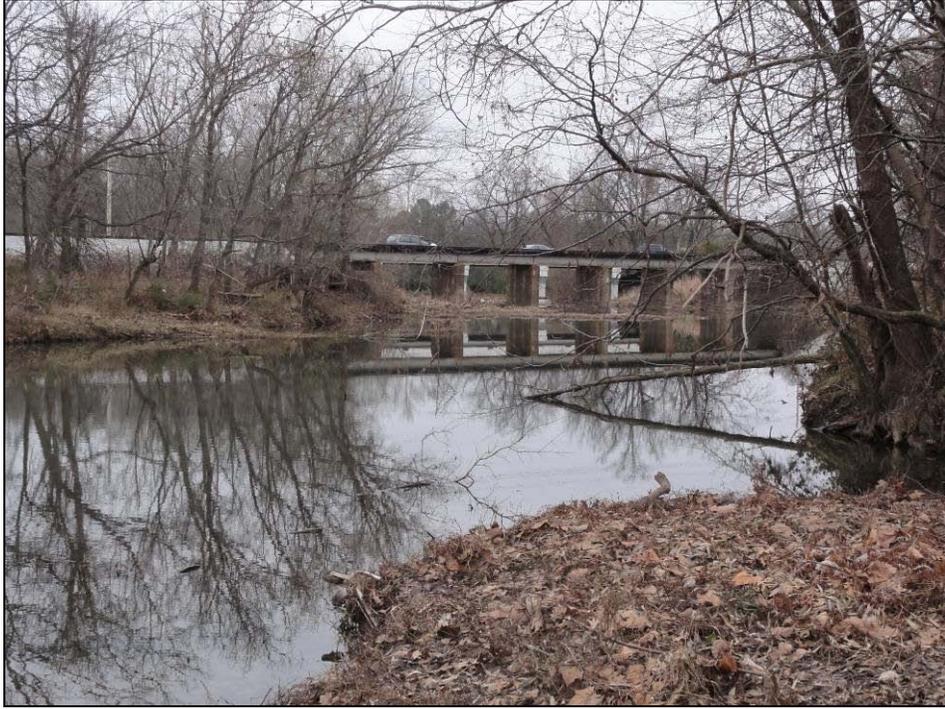
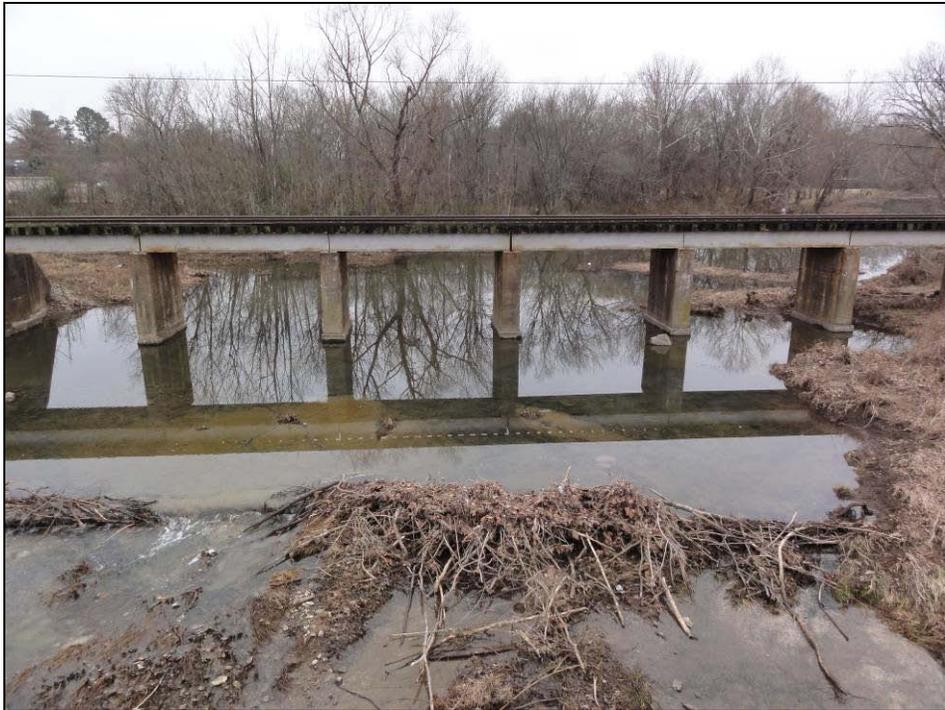
Item 13 – Bartons Creek. Clean out sediment, debris and rock from 114 Bartonwood Drive north to W. Baddour Parkway (US 70 N By-pass). Approx. 1,650 l.f.

Looking north from 204 Baronwood Dr. Picture 2109.

Looking south. From approx. midway point of clean out reach. Picture 2131.

Looking north at railroad bridge. Picture 2128.

Looking north from W. Baddour Parkway bridge. Picture 2128.
