## ENGINEERING REPORT

### Richmond Hills Subdivision at Barnes Drive Drainage Improvements

**City of Lebanon Engineering Department**

**August 31, 2011**

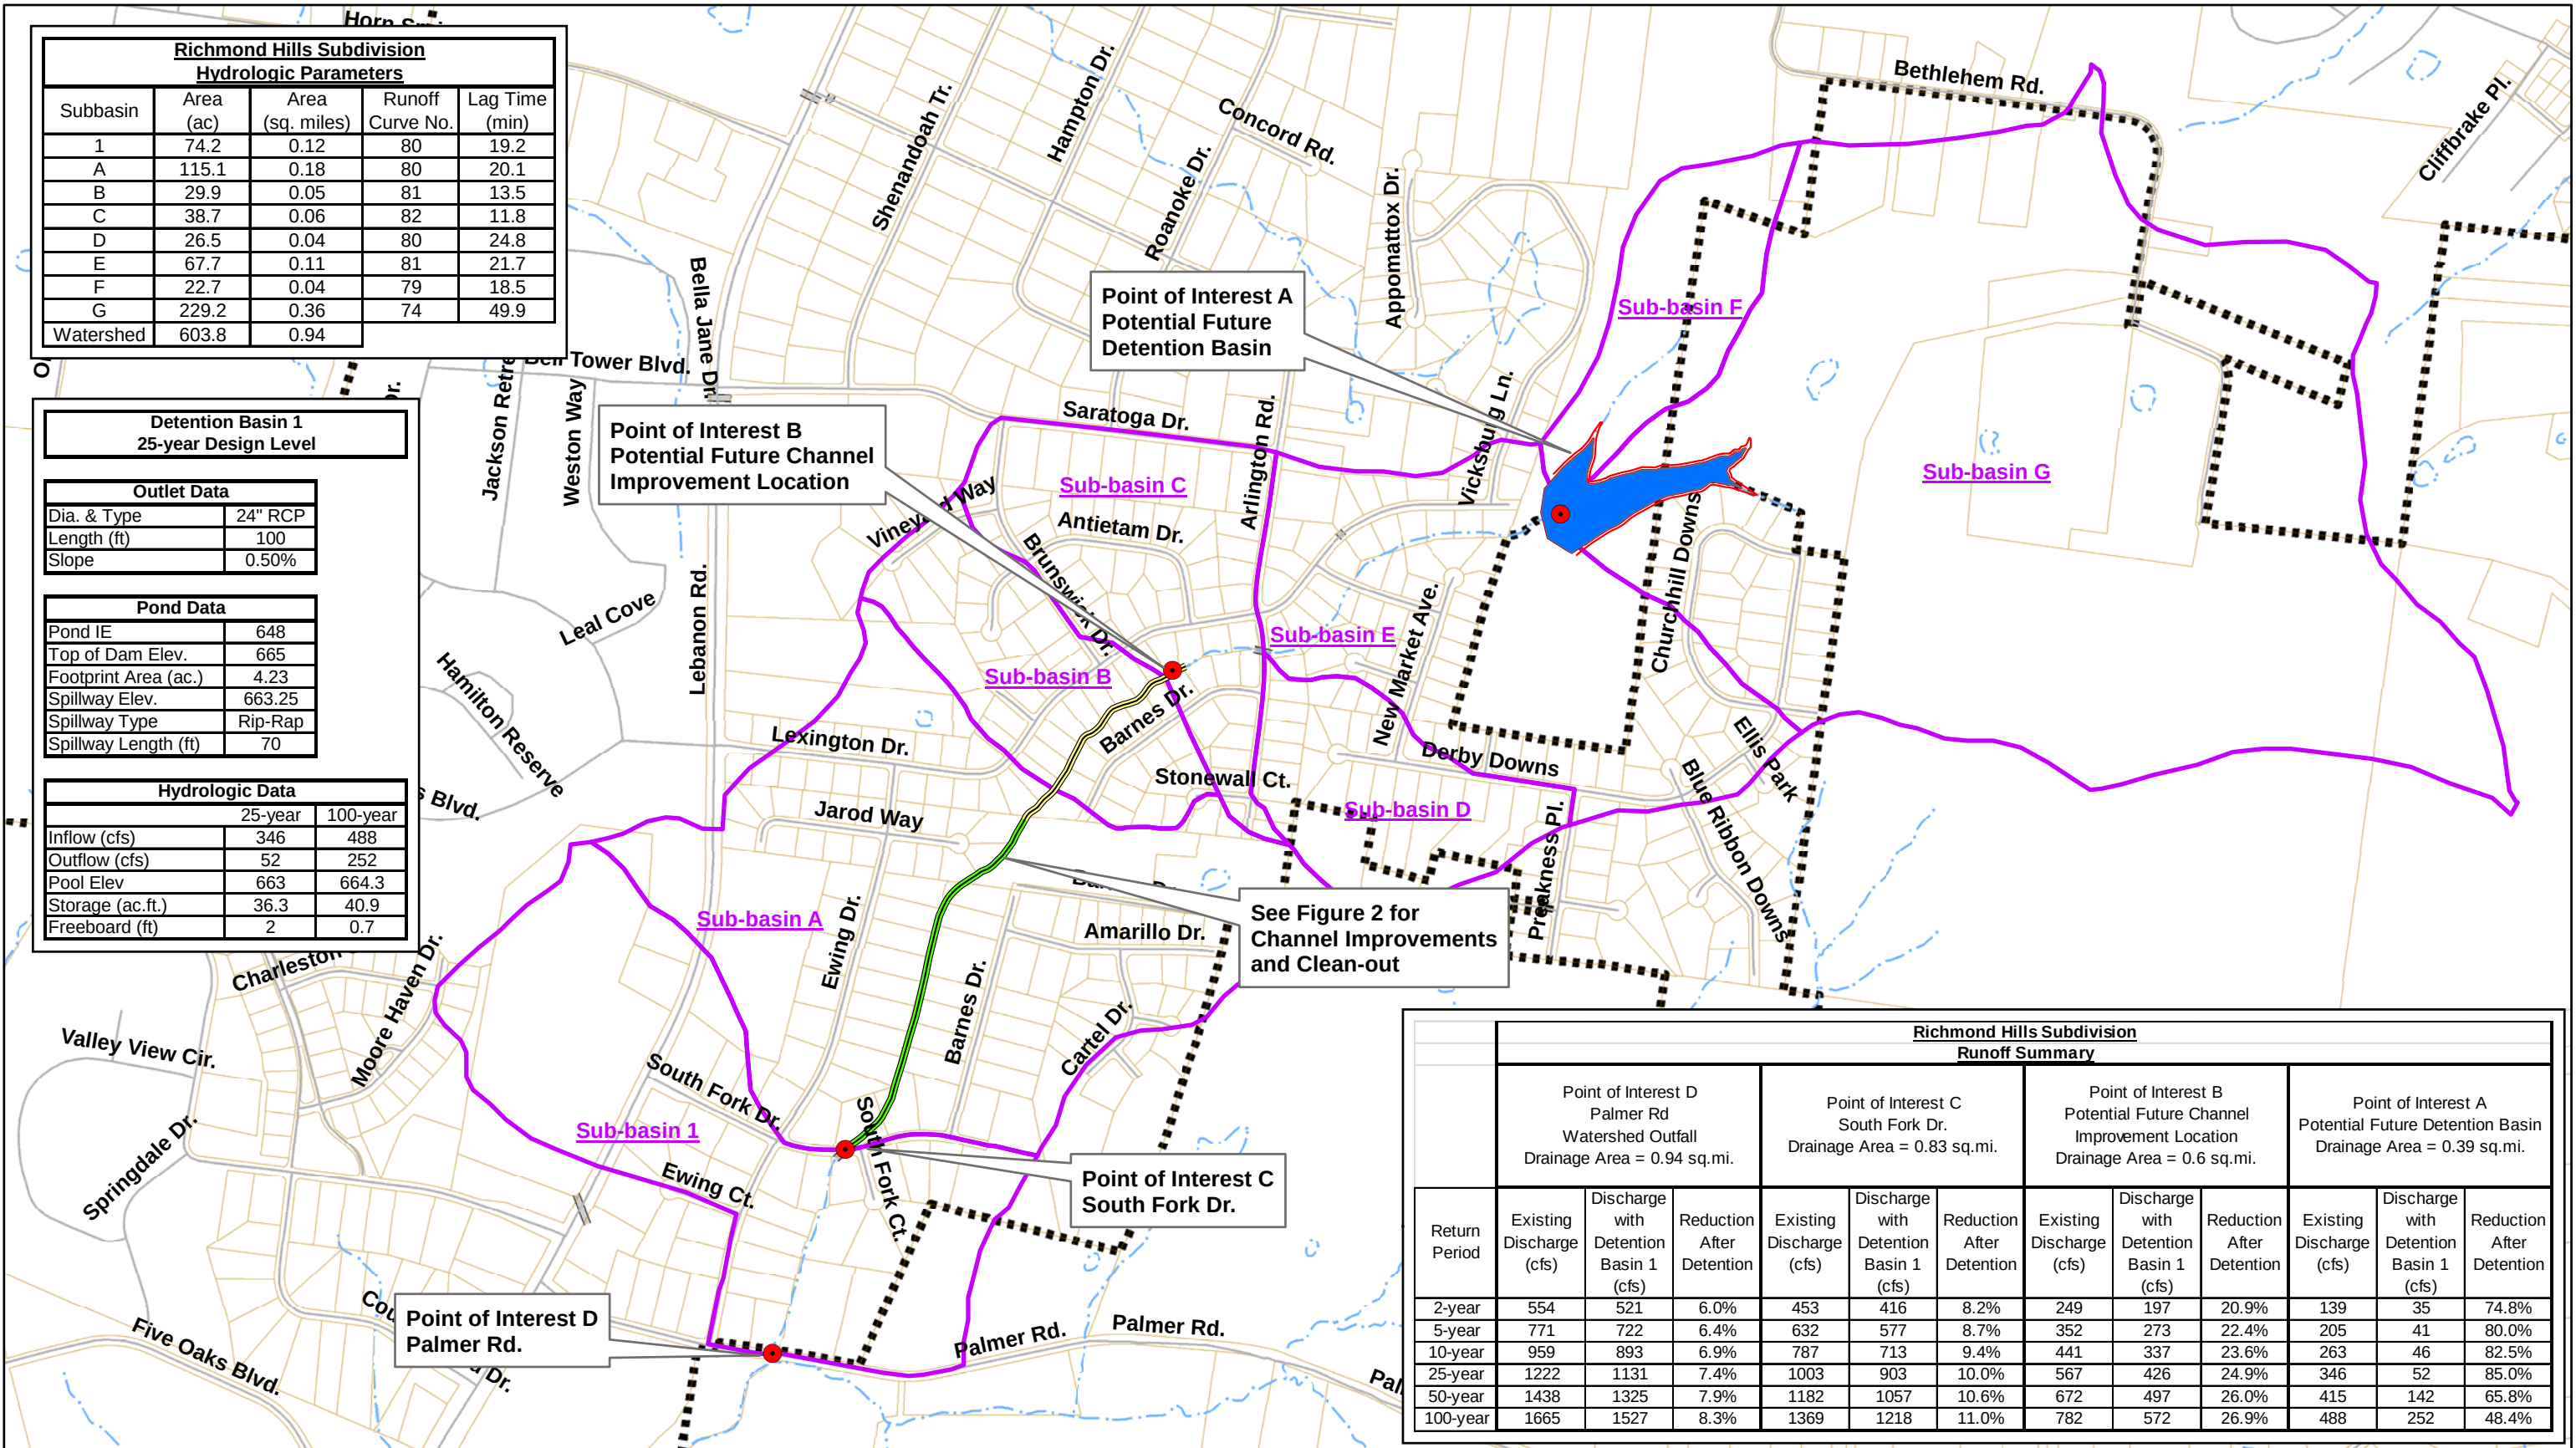
Figure 1

During the initial phases of the project, a location for a potential detention area was identified between the end of Lexington Drive and Churchhill Downs (See Figure 1). A 4.2-acre detention basin, with a depth of 17 feet, was modeled to intercept flow from the upper reaches of the watershed. Such a detention basin would provide a reduction of almost 27% in the existing discharges at Barnes Drive. However, the detention basin alone would not be sufficient enough to solve all flooding issues at Barnes Drive.

| <b>Major (Future) Drainage Improvement Alternatives<br/>(See Figures 1 and 2)</b> | <b>Preliminary Estimated<br/>Project Cost</b> |
|---|---|
| Construct 4.2-acre detention pond as shown on Figure 1. | \$ 200,000.00 |

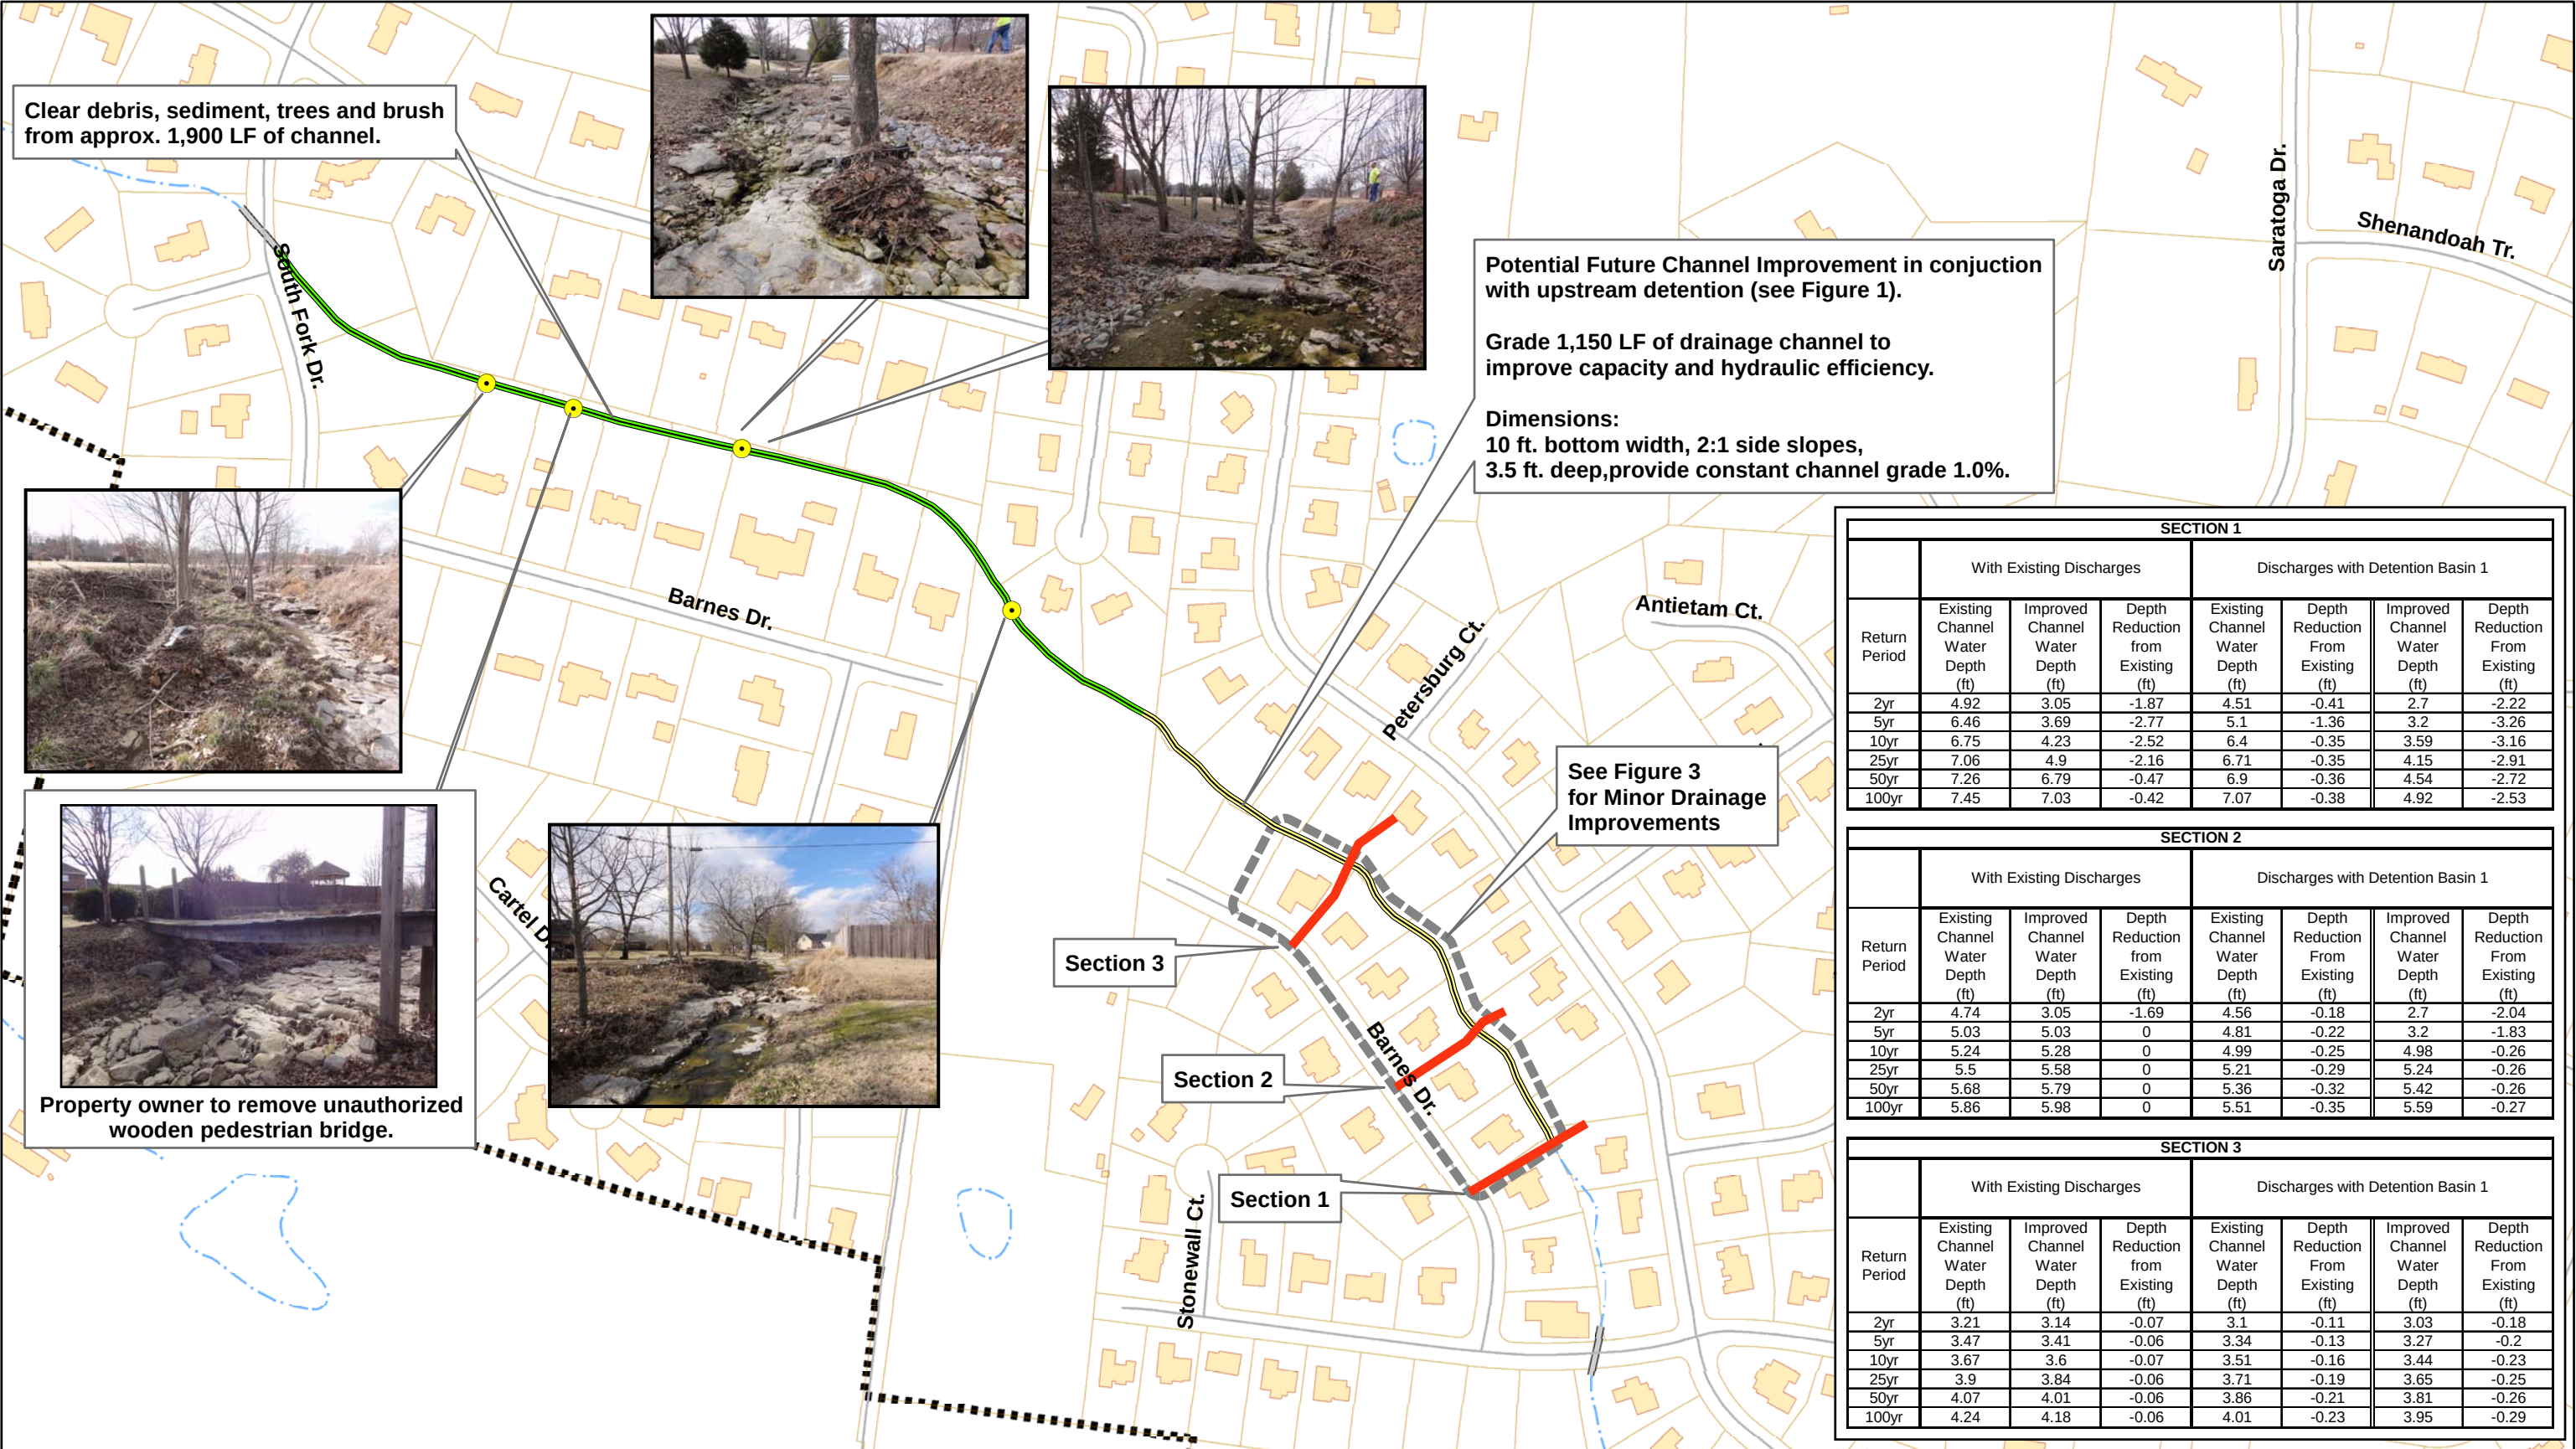
The analysis shows that the existing 2-year flood elevation exceeds the elevation of the southern stream bank, and therefore flooding occurs along the properties on the south side of the creek (between 405 and 415 Barnes Drive) in less than a 2-year storm. To evaluate the benefits of channel improvements, it was assumed that the improved channel would have a 10-foot bottom width, sides slopes of 2:1 (two feet horizontal for every one foot vertical), and a minimum depth of 3.5 feet. It was determined that the existing 2-year discharges would be contained within the improved channel (i.e. no flooding) by constructing this trapezoidal section for a length of 1,150 feet along the creek. However, due to the low level of benefit versus the high cost of channel improvements, it is **not recommended** to perform the channel improvements unless the

During the field reconnaissance, it was noted that the channel from approximately the cul-de-sac of Barnes Drive northwestward to South Fork Drive was in need of maintenance. As shown on Figure 2, the channel contains numerous debris piles, sediment and rock deposits, and large diameter trees that are obstructing both normal and flood flows. As stated previously, backwater effects are not the sole cause of flooding along Barnes Drive. However, removing obstructions and cleaning sediment and debris from this reach of channel may yield a small improvement to the flooding depths upstream. In addition, many reaches of the channel banks are severely eroded between the end of Barnes Drive and South Fork Drive (see photographs on Figure 2). This is due in part to the large volumes of storm water runoff, but is also due to these obstructions causing turbulent conditions, which leads to stream bank erosion and scour.

In addition, an unauthorized wooden pedestrian bridge was found that causes a minor constriction during high flood flows (see photograph on Figure 2). This bridge should be removed at the expense of the property owner who installed it. While it is not a major contributor to flooding upstream, removing this manmade obstruction along with the other natural obstructions mentioned above may have small positive impacts to the upstream flooding situation along Barnes Drive.

| <b>Major (Future) Drainage Improvement Alternatives<br/>(See Figures 1 and 2)</b> | <b>Preliminary Estimated<br/>Project Cost</b> |
|---|---|
| Grade 1,150 L.F. of main drainage channel to dimensions shown on Figure 2. | \$ 28,000.00 |

| <b>Minor Drainage Improvement Alternatives (See Figures 2 and 3)</b> | <b>Preliminary Estimated Project Cost</b> |
|---|---|
| Clear debris, sediment, trees and brush from approximately 1,900 L.F. of main drainage channel as shown on Figure 2. | \$ 12,700.00 |

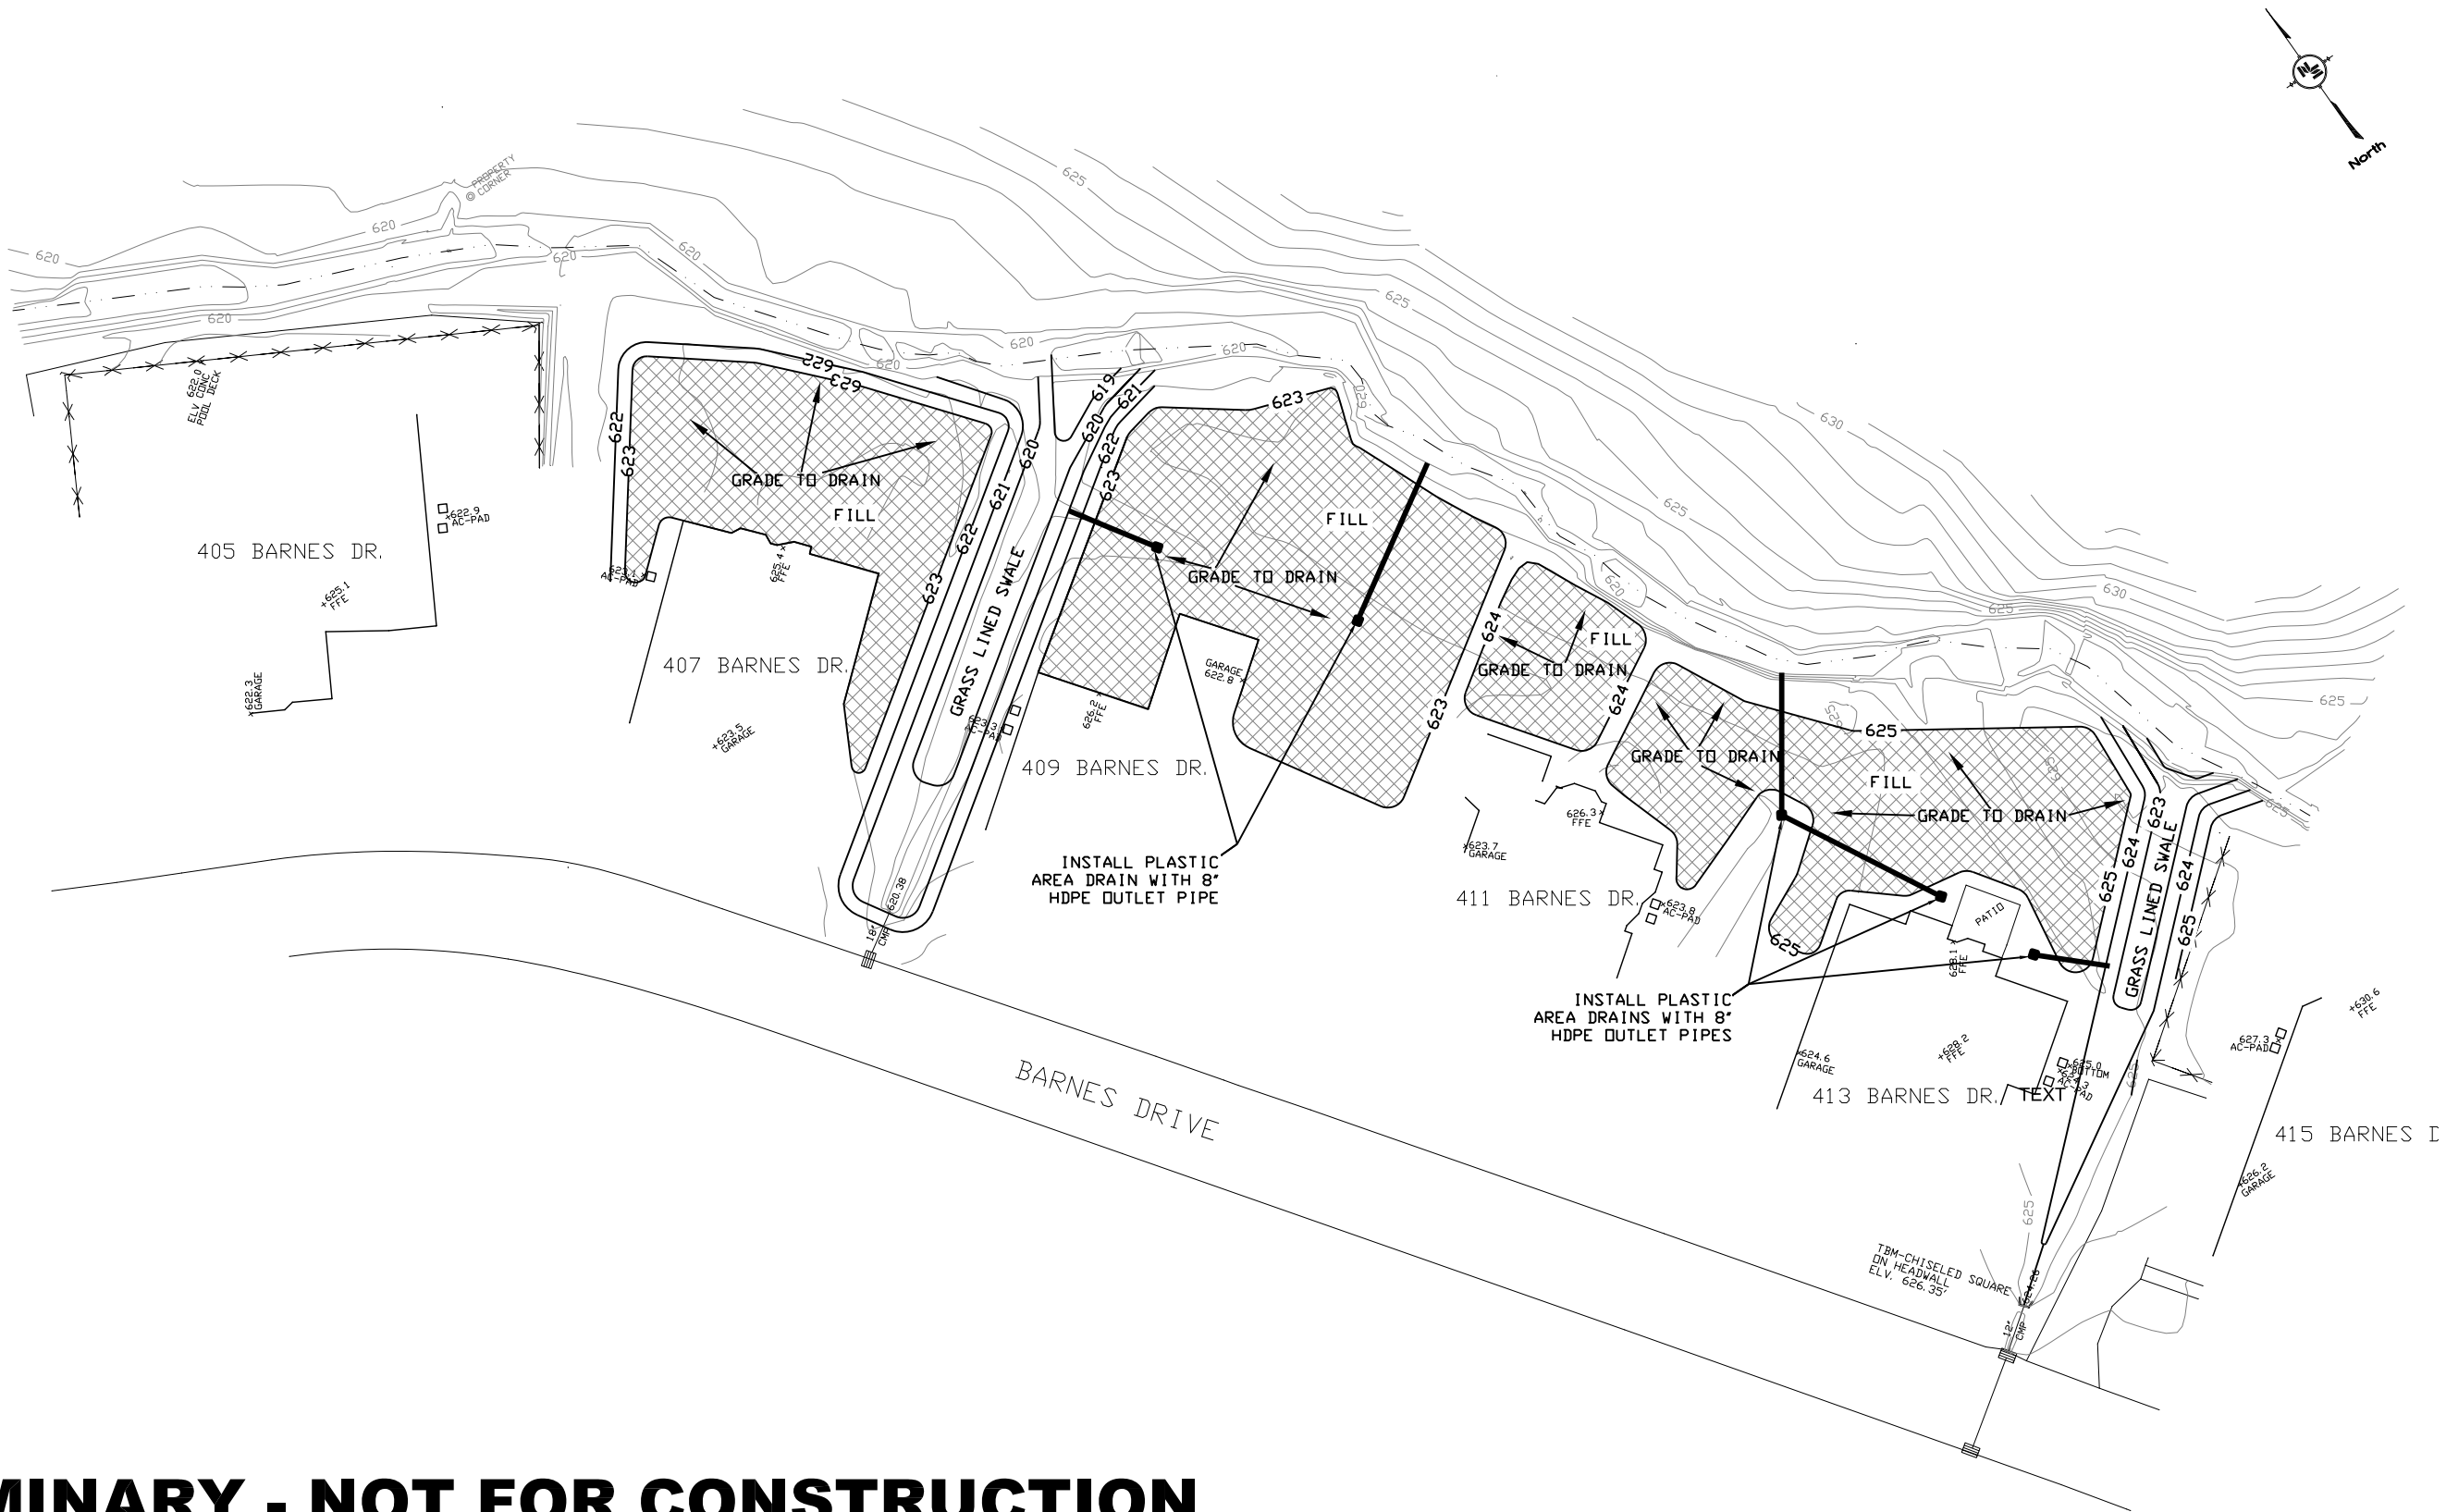
FIGURE 3

Several of the properties along Barnes Drive have yards that are lower than the bank elevations of the main creek. This causes local runoff received from Barnes Drive to the west to pond around the houses and in the yards. The low areas and the lack of positive drainage also cause damage to HVAC units and garages during larger storm events.

Runoff from Barnes Drive discharges to a 12" corrugated metal pipe, which discharges into a shallow swale that runs between 413 and 415 Barnes Drive. The berm on the southern creek bank, which is approximately 2 feet higher than the back yard, forces the runoff to flow to the northeast after passing between the two houses. The topographic survey of the property shows that the patio and area around the southeast corner of the house at 413 Barnes Drive are low points, and the HVAC pad is only 3 inches higher. In other words, during minor rainfall events the patio is flooded and the HVAC pad is flooded if the water is more than 3 inches deep. As shown on Figure 3, the placement of fill material at least one foot deep in the back yards of 411 and 413 Barnes Drive, and deepening/widening of the current grass swale between 413 and 415 Barnes Drive will help mitigate the minor flooding issues.

Plastic area drains connected to plastic pipes (8" diameter HDPE) should be installed in several locations as shown on Figure 3 to drain areas that cannot be filled. It should be noted that full topographic survey of the area will be needed before finalize the grading plan. The complete topographic survey may expose other areas between/adjacent to certain homes that may not be able to be filled. Area drains and/or trench drains may need to be used in other areas not shown on Figure 3.

| <b>Minor Drainage Improvement Alternatives (See Figures 2 and 3)</b> | <b>Preliminary Estimated Project Cost</b> |
|---|---|
| Grade (fill) yards between 405 and 415 Barnes Drive as shown on Figure 3. | \$ 36,000.00 |

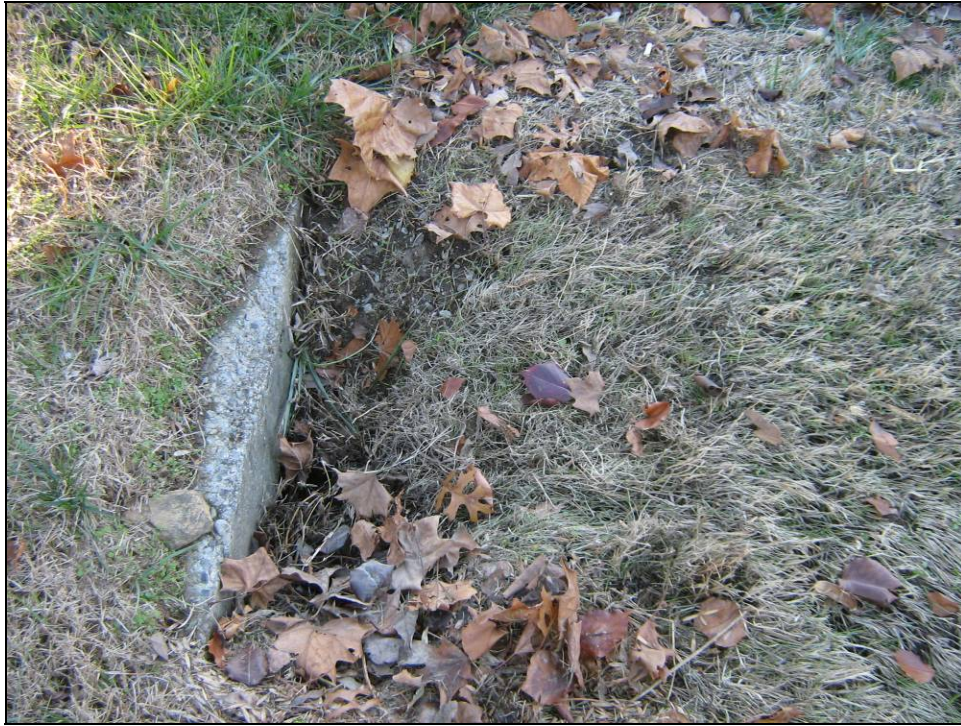
**Item 1 - 18" RCP on Lexington Dr. north of Vicksburg Ln. Clear debris and sediment from 18" RCP culvert. Picture 2312.**

| <b>Infrastructure Maintenance Items (See Figure 4)</b> | <b>Preliminary Estimated Project Cost</b> |
|---|---|
| 2. Debris/sediment removal from culvert ends at five locations (Items 1, 2, 3, 6, and 7) | \$ 2,500.00 |

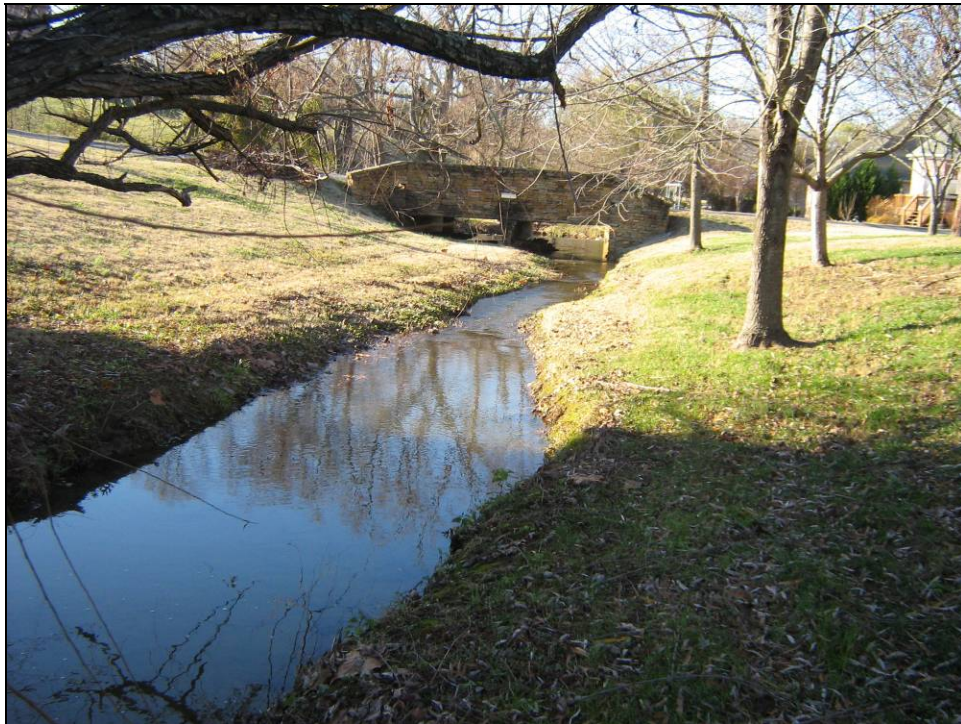
**Item 2 – Looking north at Letcher Ave. Clear sediment from west span of double 8' x 3' RCB. Picture 2318.**

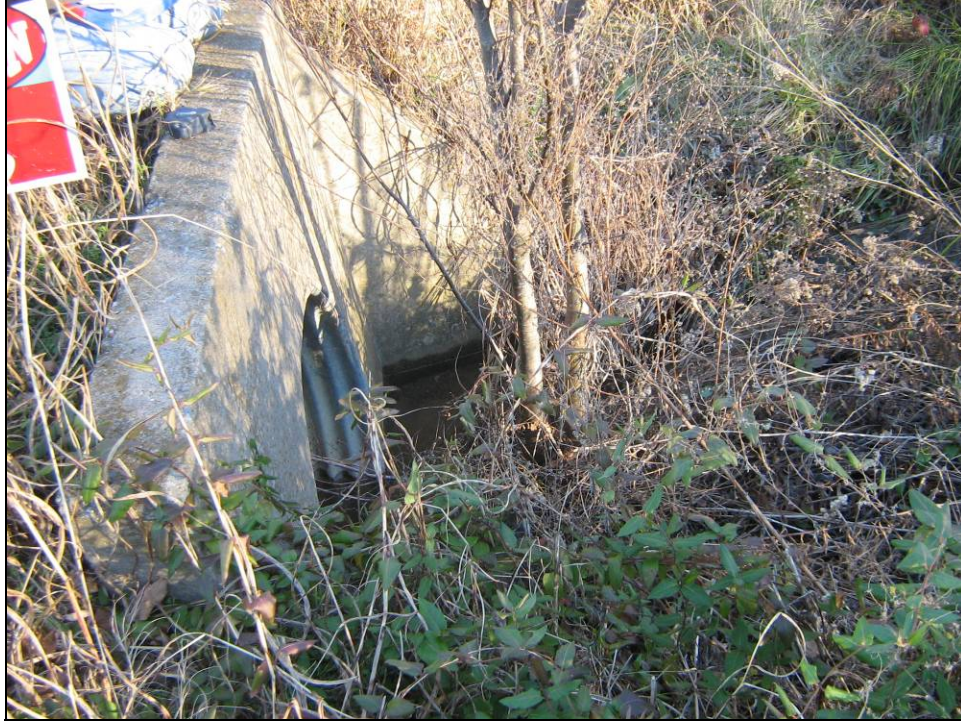
**Item 3 - Arlington Rd. and Barnes Dr. Remove brush from inlet of 36" CMP. Picture 2333.**

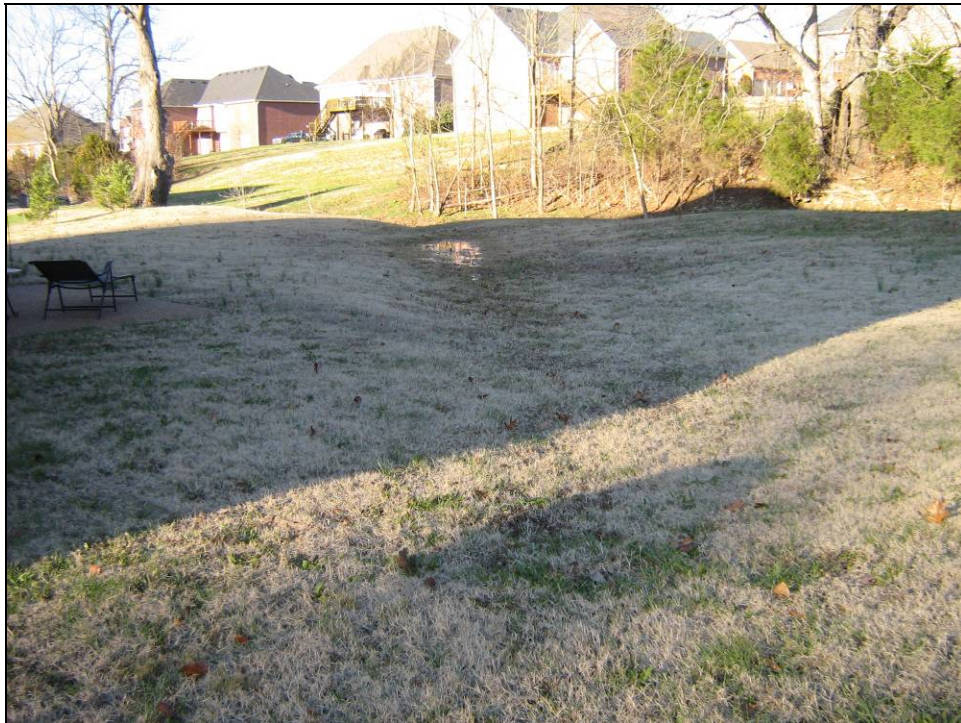
**Item 4 - 413 Barnes Drive. Grade ditch to drain into creek. Note standing water. Looking downstream (east) from Barnes Dr. Picture 2350.**

| <b>Infrastructure Maintenance Items (See Figure 4)</b> | <b>Preliminary Estimated Project Cost</b> |
|---|---|
| 1. Ditch grading at four locations (Items 4, 5, 8, and 9) – 750 L.F. | \$ 3,750.00 |

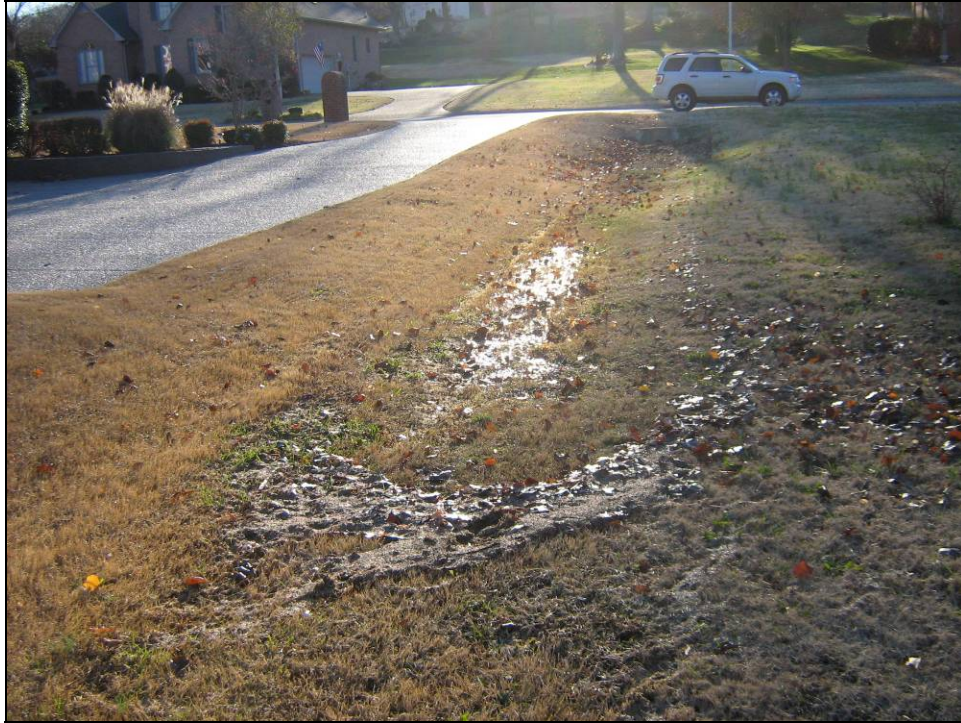
**Item 5 – 409 Barnes Drive. Grade ditch to drain into creek. Looking upstream (west) toward Barnes Drive. Note standing water and debris. Picture 2352.**

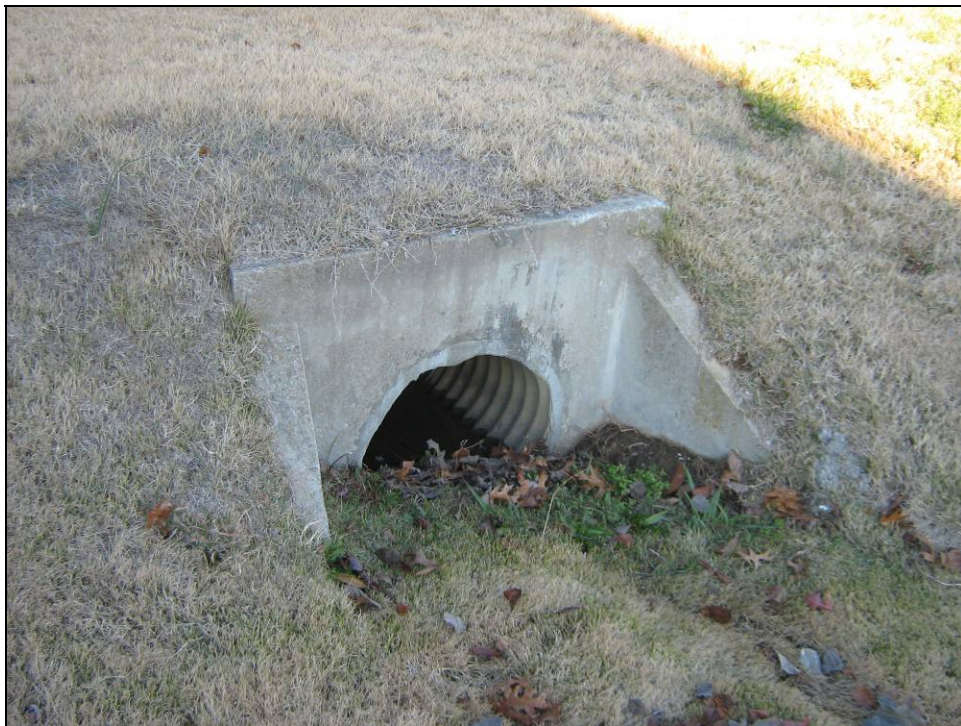
**Item 6 - Lexington Dr. north of Antietam Dr. Clean silt from 36" CMP outlet. Picture 2368.**

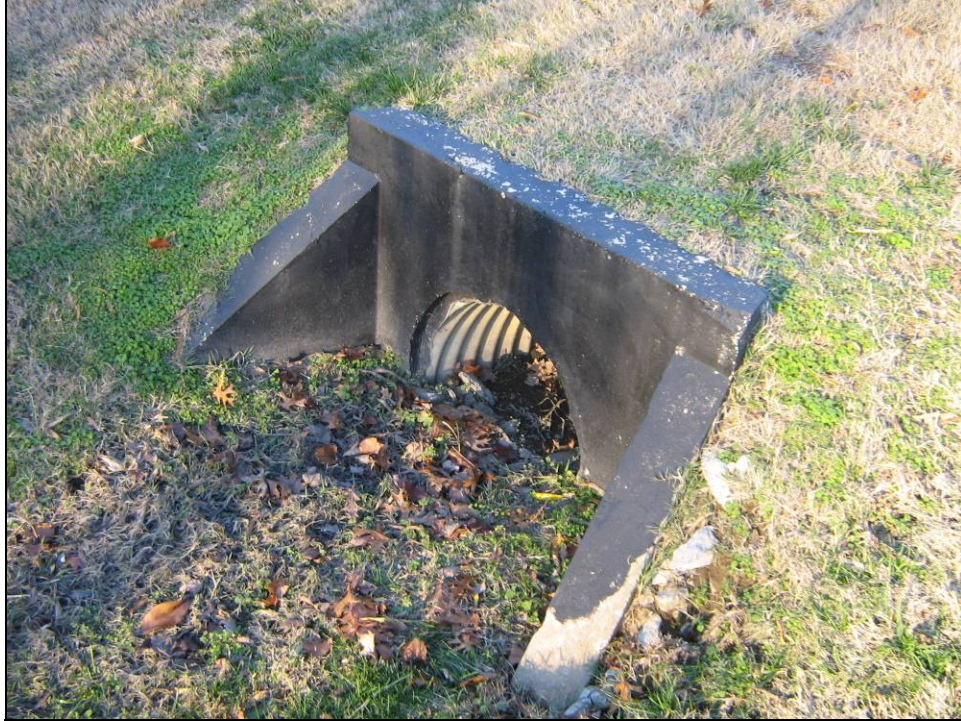
**Item 7 - Lexington Dr. at Brunswick Dr. Clean out silt at outlet of 18" CMP. Picture 2370.**

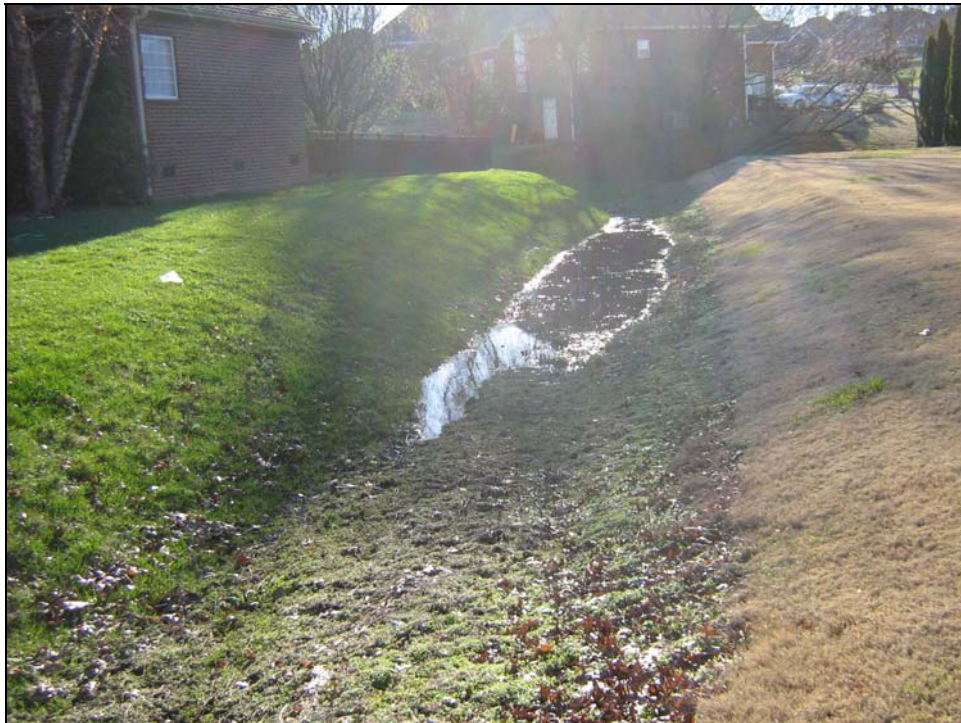
**Item 8 – Looking west from Lexington Dr. cross drain (south of Letcher Ave). Grade ditch to drain into creek. Note standing water. Picture 2315.**

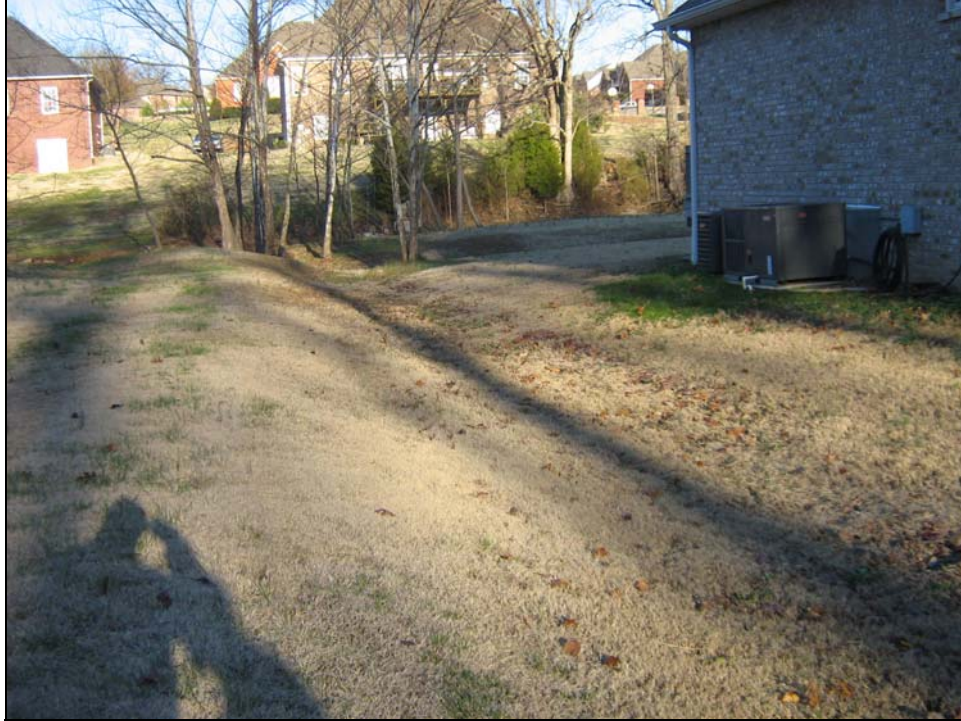
Another grass swale is located between 407 and 409 Barnes Drive, where runoff from Barnes Drive discharges to an 18" corrugated metal pipe, which outlets between these two houses. This swale is recommended to be deepened/widened, and fill material about one foot deep should be placed in the back yards of these two houses.

**Item 9 – 407/409 Barnes Dr.. Grade ditch to drain into creek. Picture 2356.**
