## ENGINEERING REPORT

### Cumberland University Drainage Improvements

**City of Lebanon Engineering Department**

**Neel-Schaffer, Inc.**

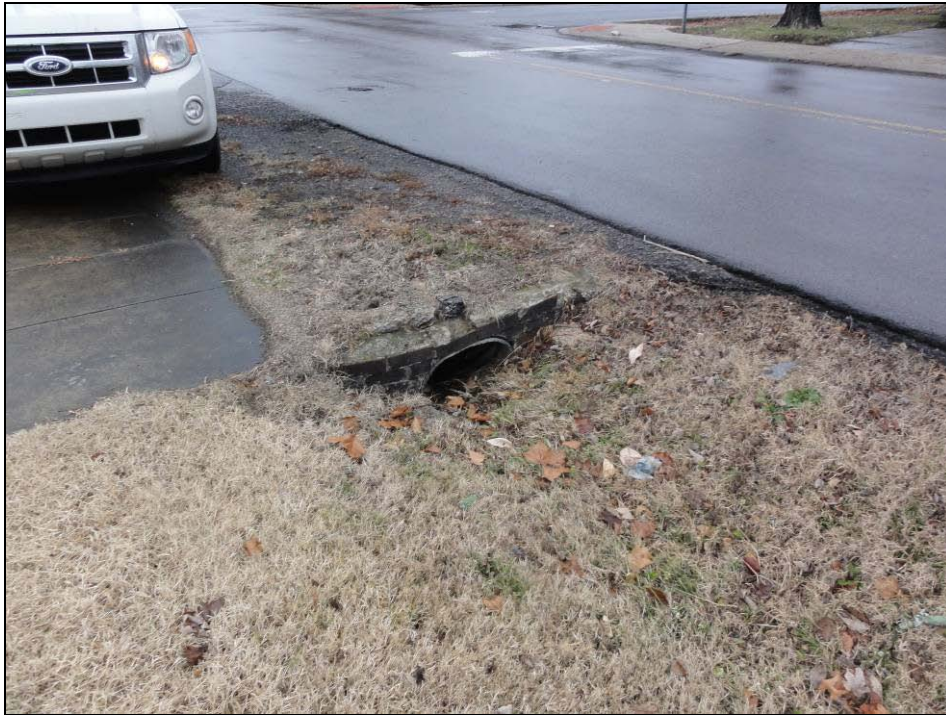
**Item 1 W. Spring St. and S. Greenwood St. Clear sediment from 16" x 10" ellip. CMP. Picture 2167.**

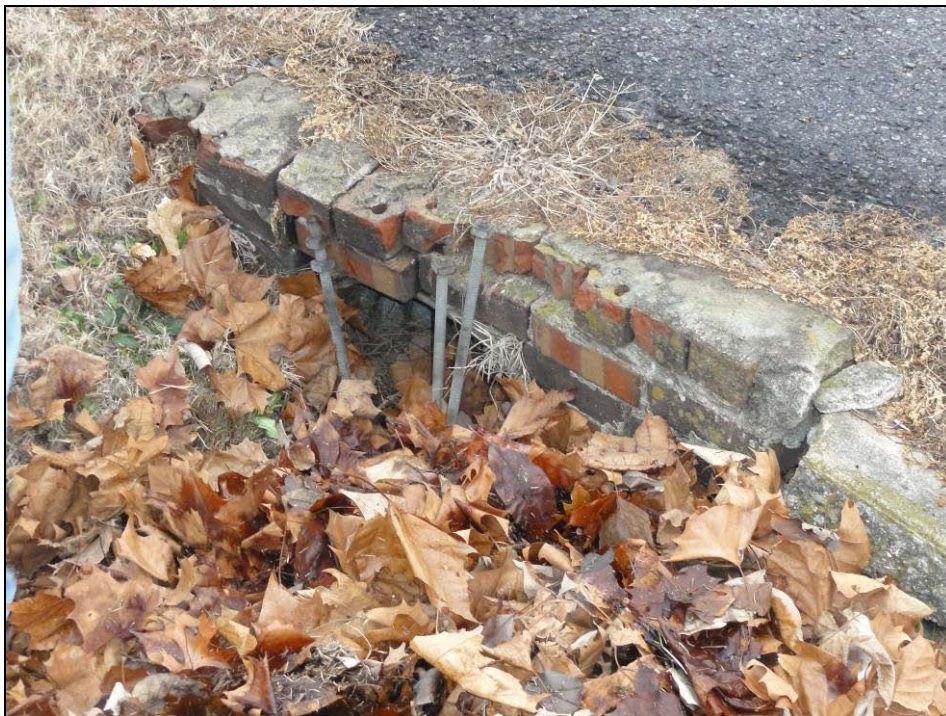
**Item 2 - W. Spring St. and S. Greenwood St. Clear sediment and debris from 18" CMP. Picture 2169.**

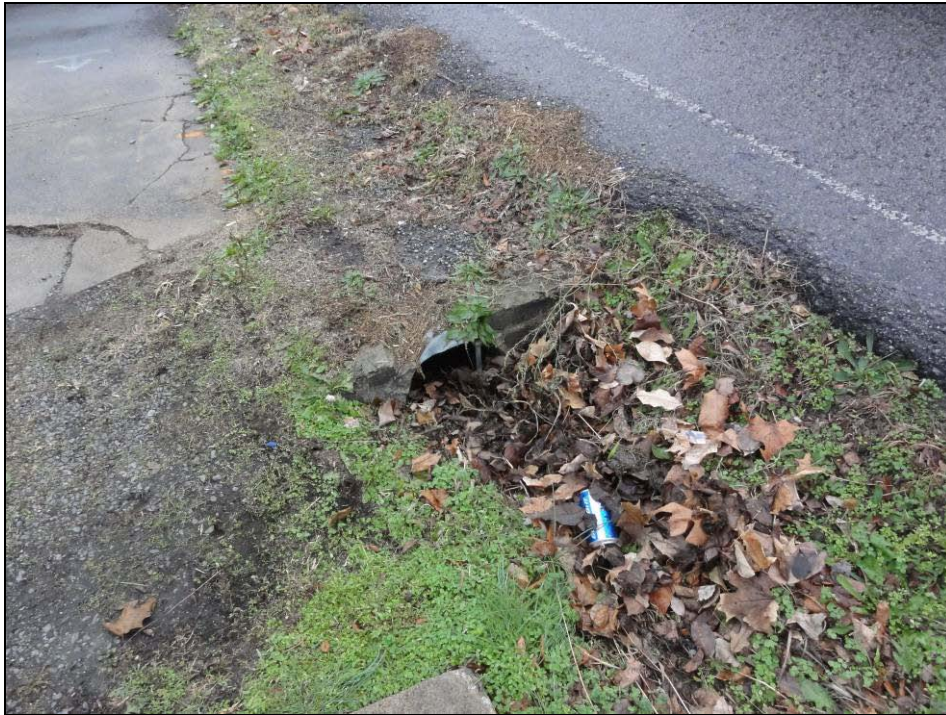
**Item 3 – W. Spring St. and S. Greenwood St. Remove debris from 12” CMP. Picture 2171.**

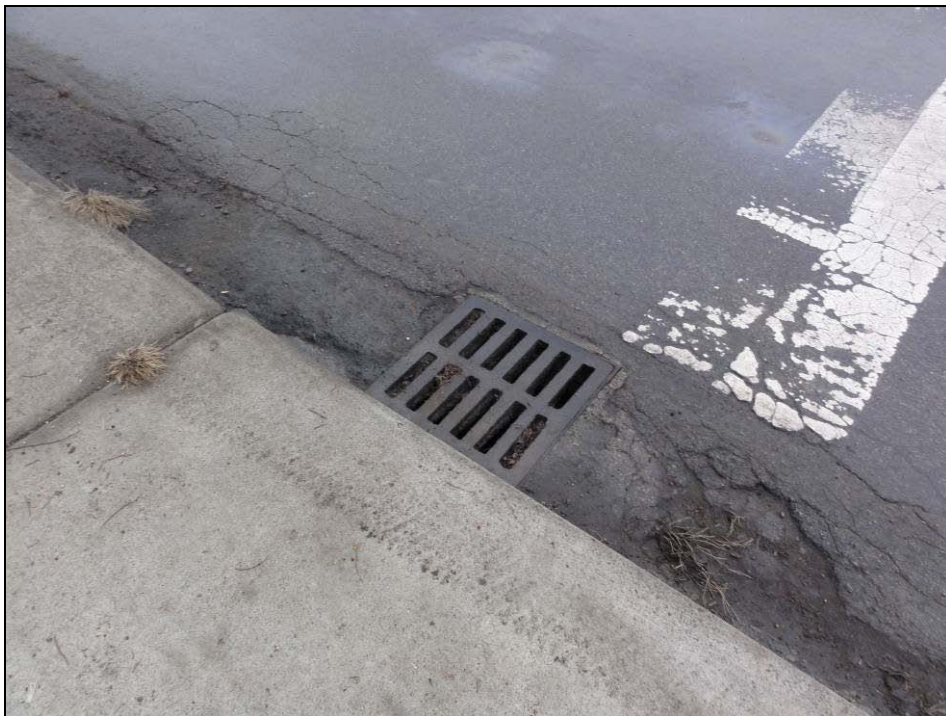
**Item 4 – S Greenwood St. at W. Spring St. Clean catch basin grate. Picture 2173.**

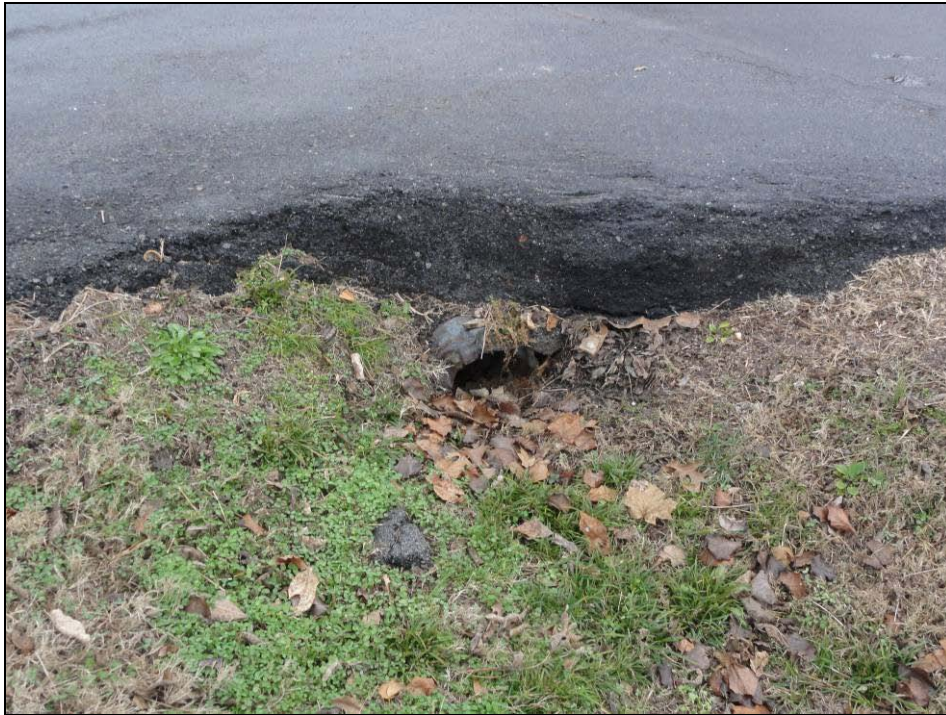
**Item 5 – West side of S. Greenwood St. just north of University Ave. Clear sediment and debris from 12" CMP under parking lot access drive. Picture 2176.**

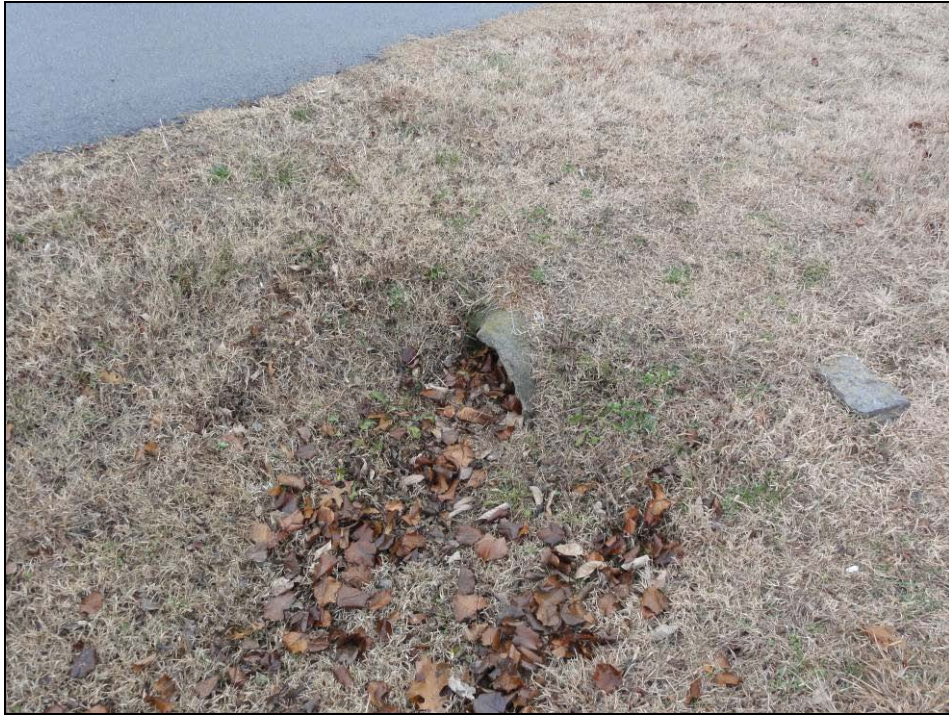
**Item 7 – West side of S. Greenwood St. south of University Ave. Clear sediment and debris from RCP. Picture 2178.**

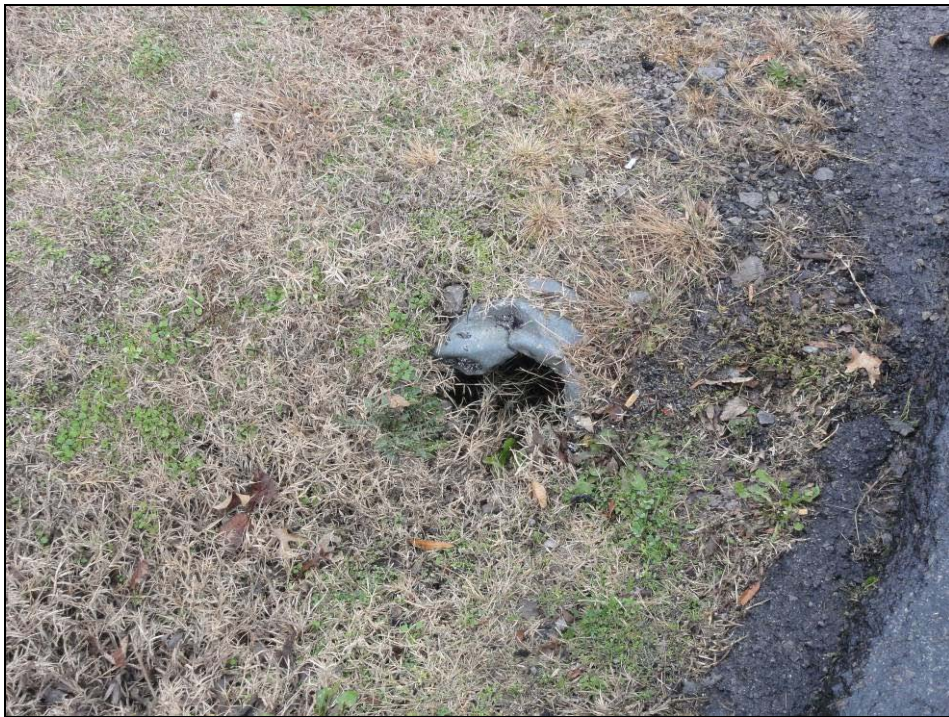
**Item 8 – West side of S. Greenwood St. north of McClain Ave. Repair pipe end section, clear sediment and debris from CMP. Picture 2182.**

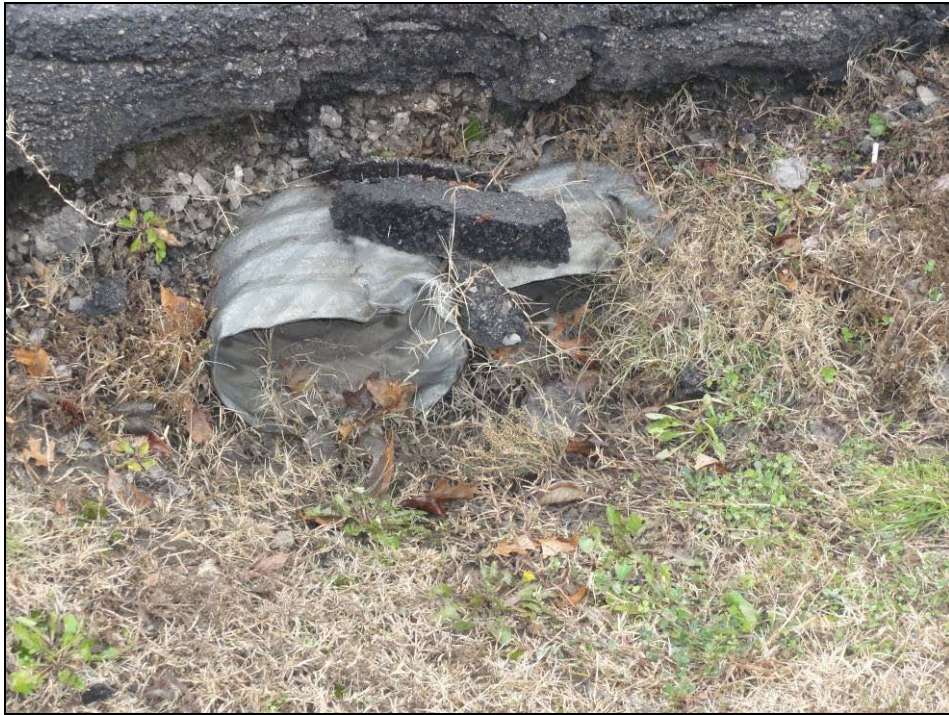
**Item 9 –S. Greenwood St. and McClain Ave. 2 – 14” x 10” elliptical CMP’s under S. Greenwood St.  
Repair damaged inlets. Clean out sediment and debris from inlets and outlets.**

**Inlets of 2 – 14” x 10” ellip. CMP’s. Picture 2184.**

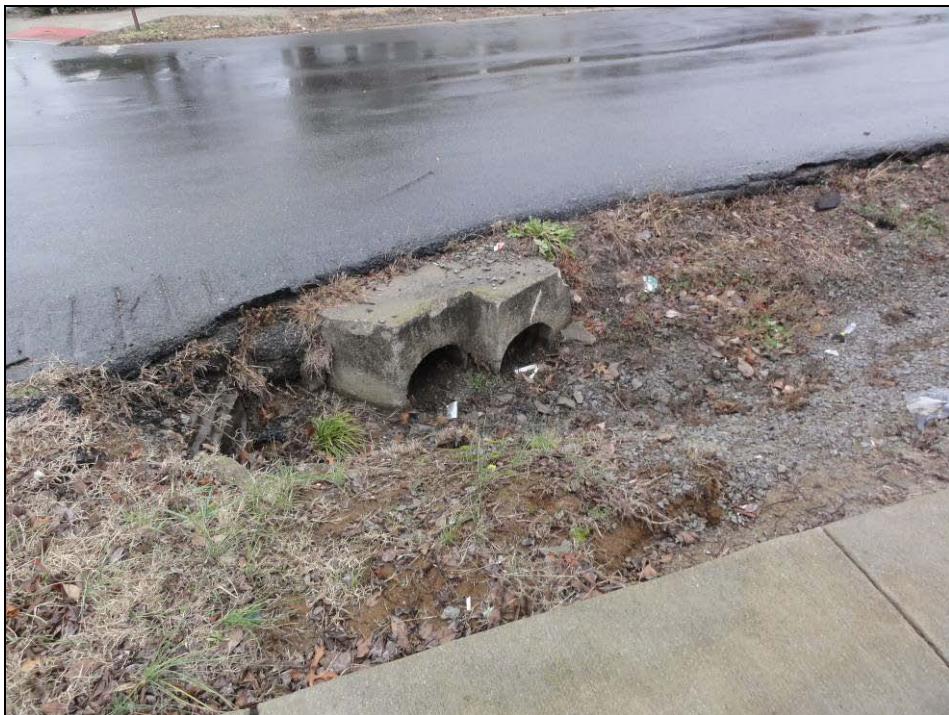
**Outlets of 2 – 14” x 10” ellip. CMP’s. Picture 2189.**

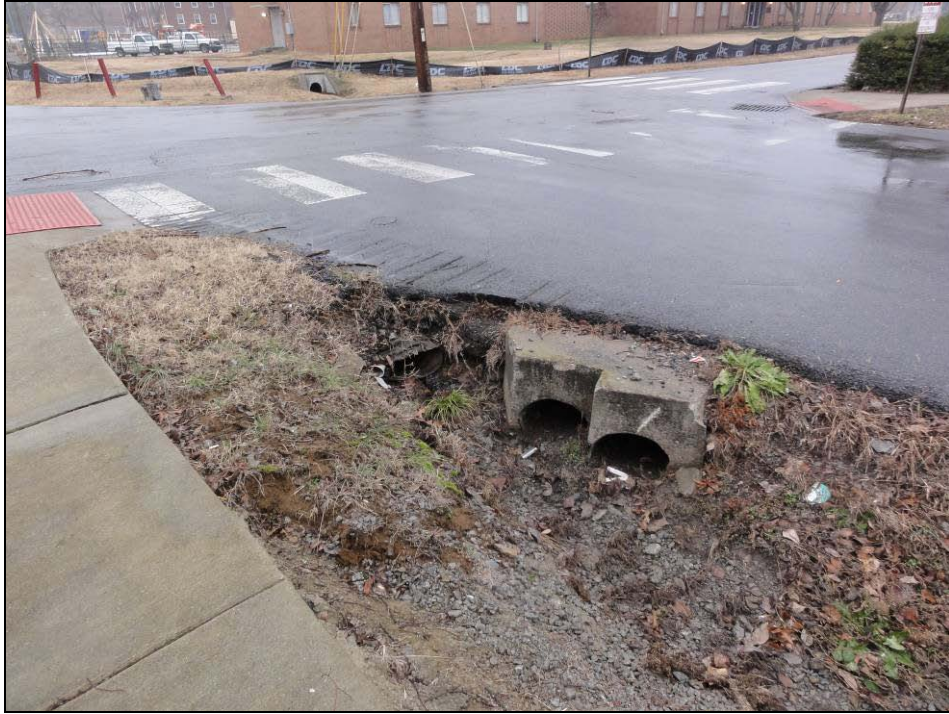
**Item 10 – S. Greenwood St. and McClain Ave. Repair damaged end section of 12” CMP. Picture 2191.**

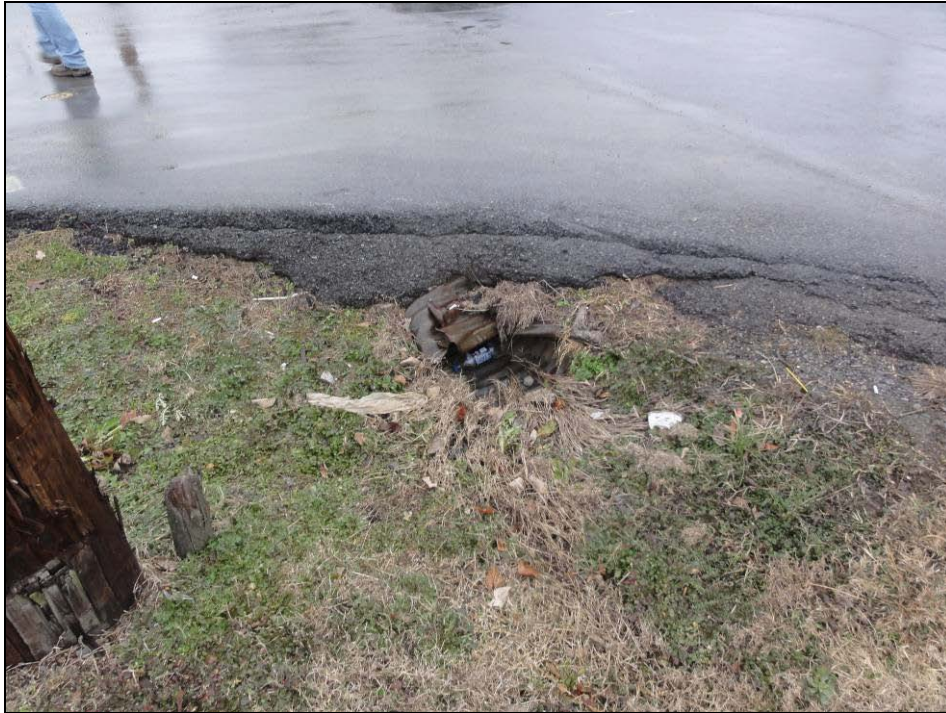
**Outlet. Picture 2192.**

**Item 11 – S. Greenwood St. and Martin Ave.. 20" x 10" elliptical CMP. Repair damaged end sections. Clear sediment and debris from inlet and outlet.**

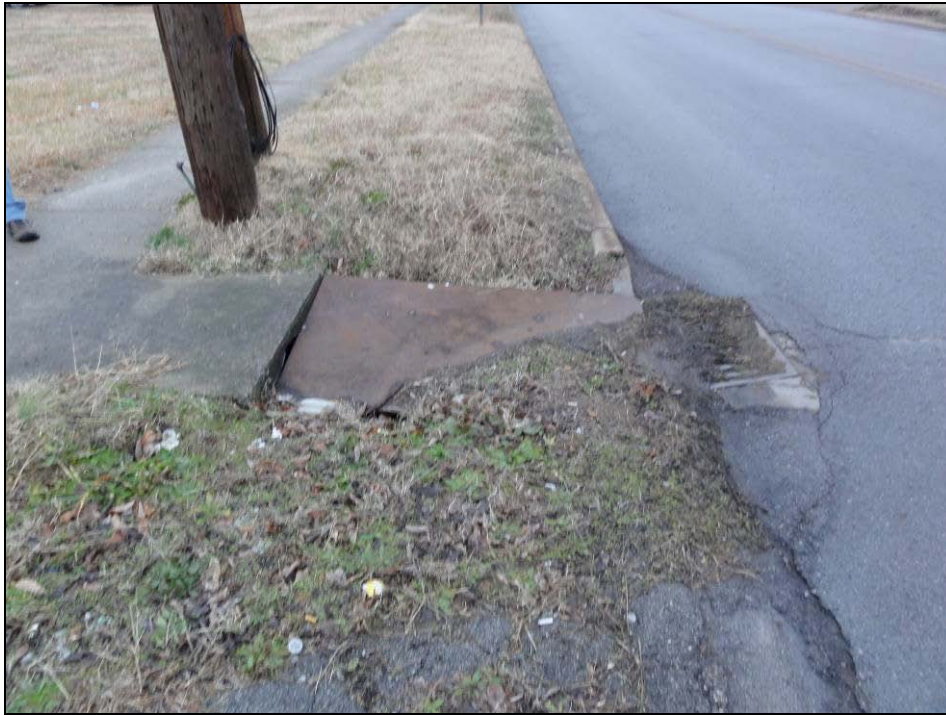
**Item 12 – 334 S. Maple St. Repair catch basin cover, clean out catch basin grate, and clear sediment and debris from HDPE inlet.**

**Catch basin cover and grate. Picture 2256.**

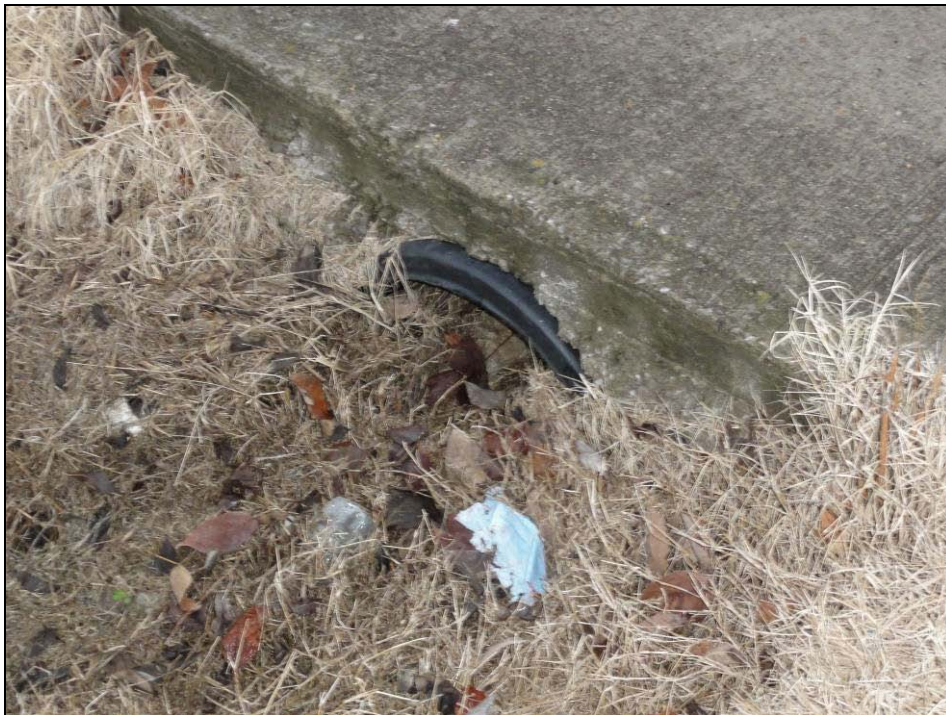
**HDPE Inlet. Picture 2255.**

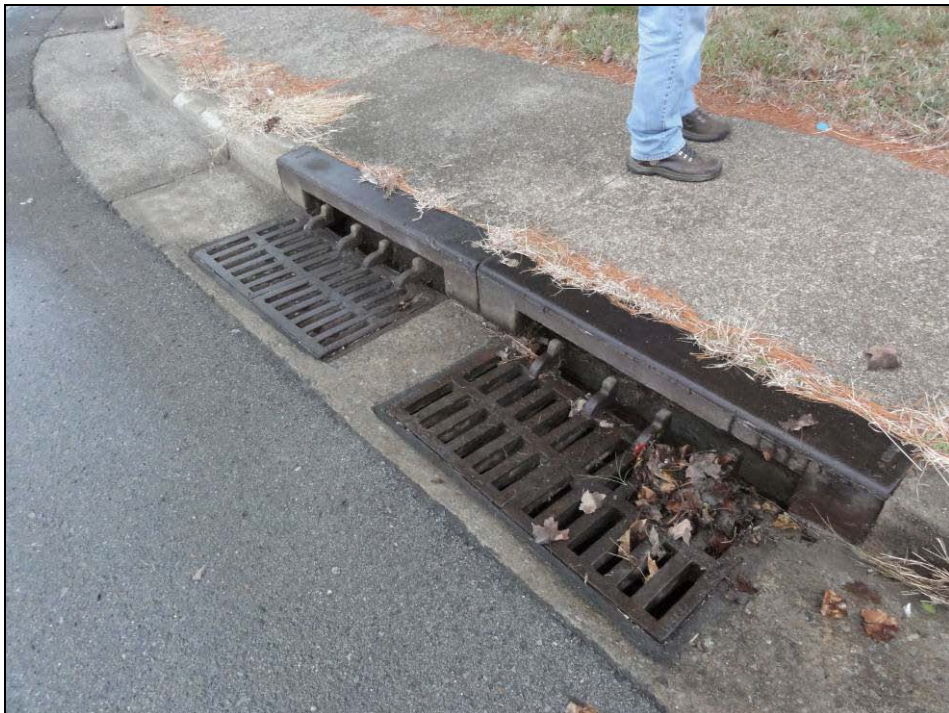
**Item 16 – W. Main St. and S. Hatton Ave. Clean debris from catch basin grate. Picture 2217.**

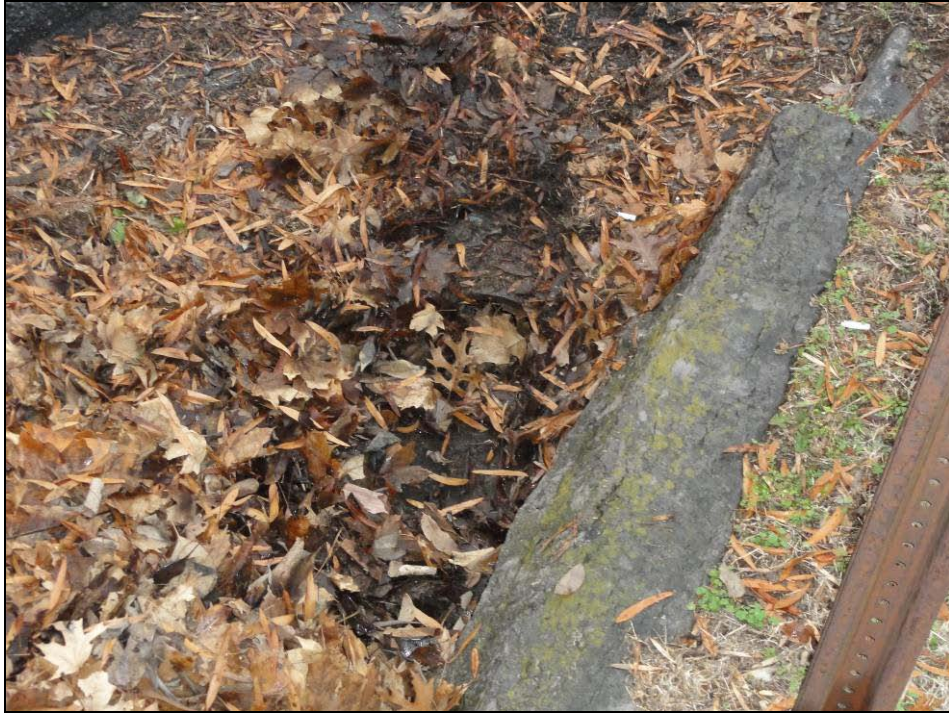
**Item 17 – W. Spring St. and S. Tarver Ave. Clean debris from culvert inlet. Picture 2223.**

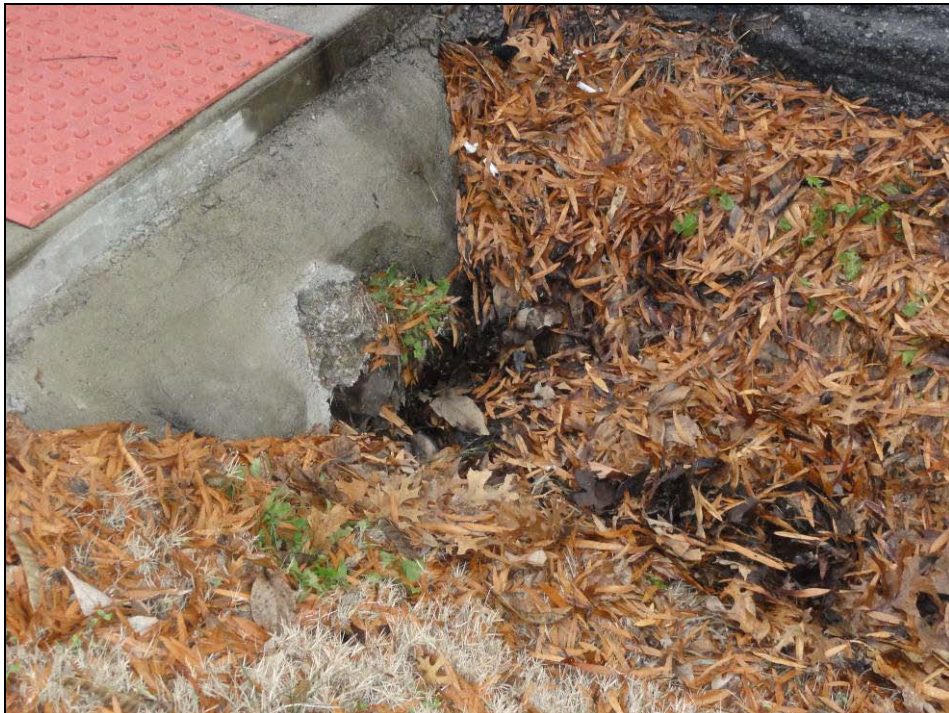
**Item 18 – W. Spring St. and S. Tarver Ave. Clean debris from culvert inlet. Picture 2224.**

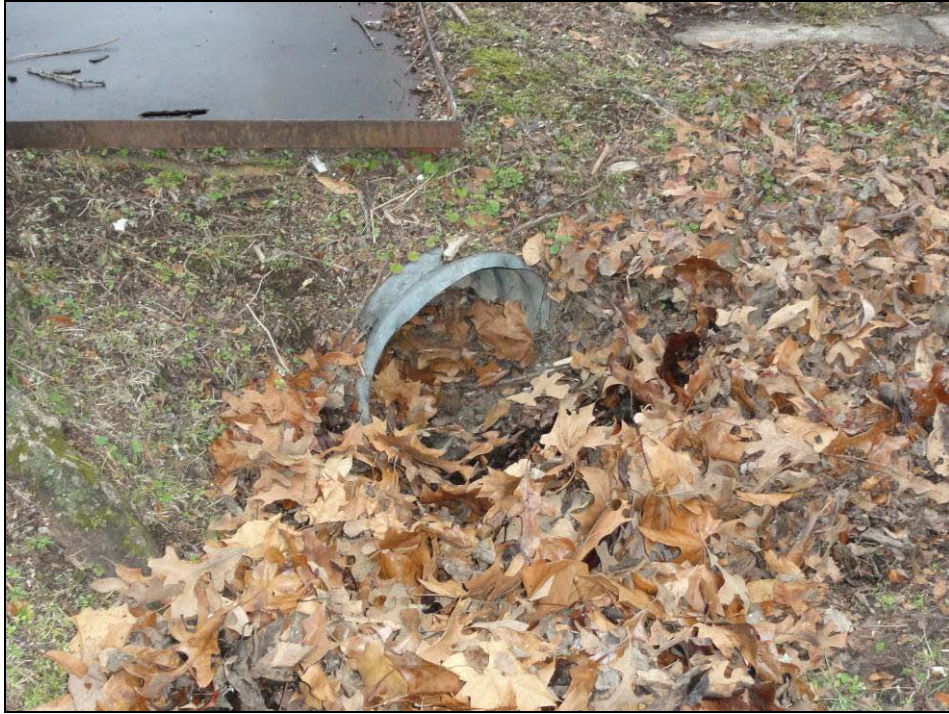
**Item 19 – 514 W. Spring St. Clean debris and sediment from culvert inlet. Picture 2225.**

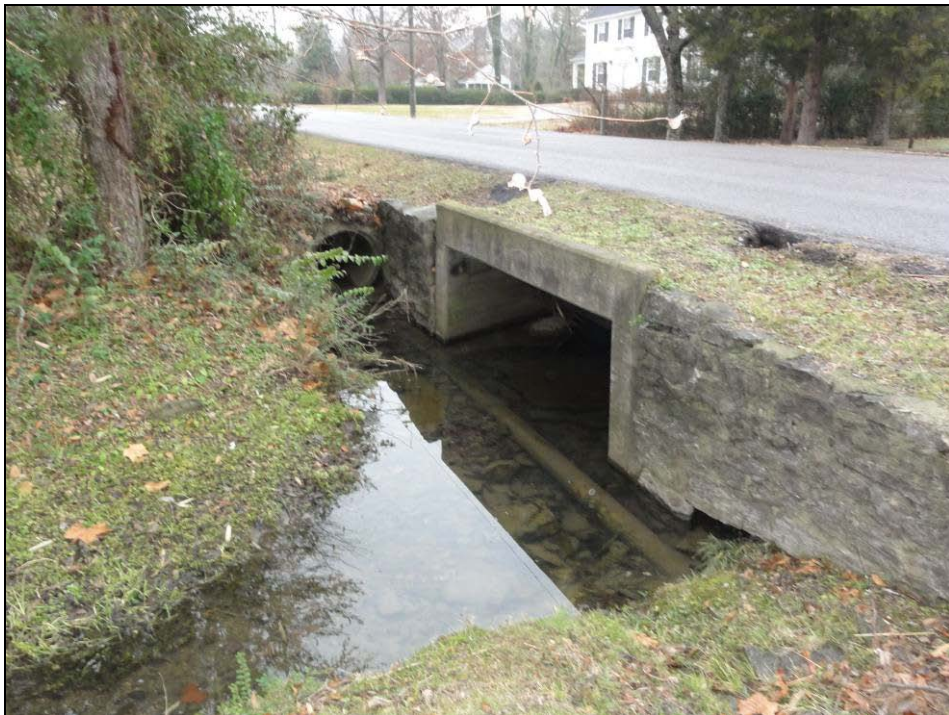
**Item 20 – 514 W. Spring St. Improve channel section immediately upstream of 10' x 4' RCB. Picture 2230.**

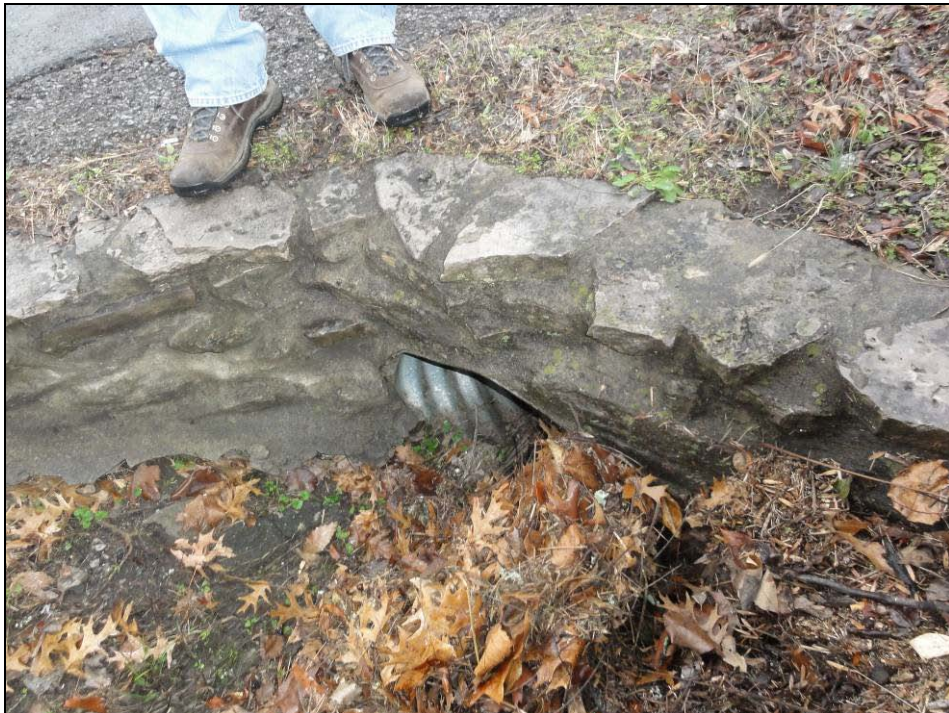
**Item 22 – W. Spring St. and Pennsylvania Ave. Clear debris from west end of 15” CMP. Picture 2239.**

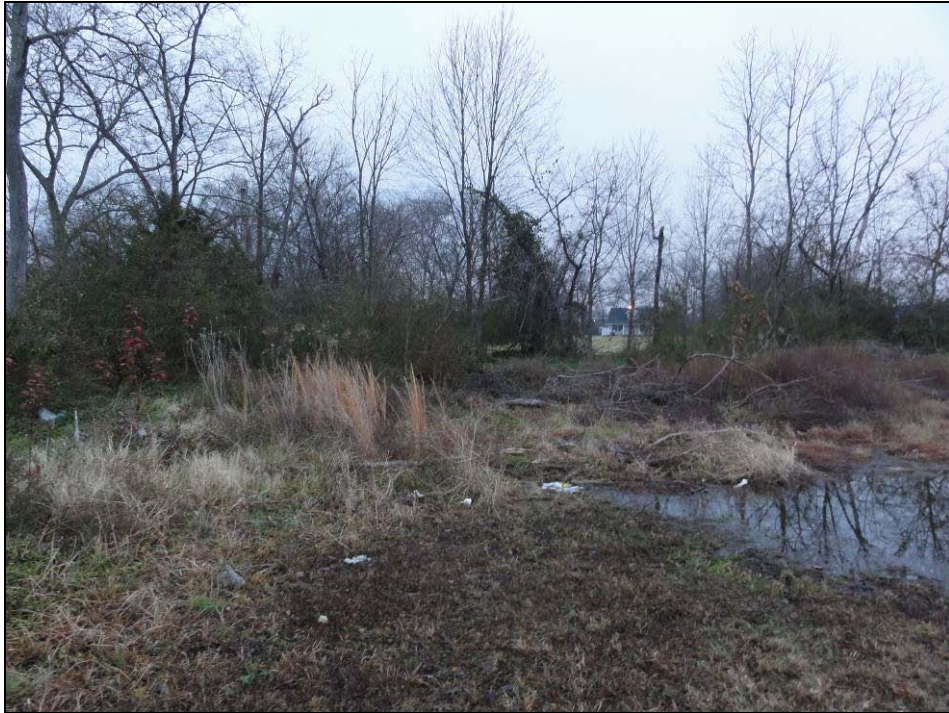
**Picture 2251.**

**Item 24 – 338 S. Maple St. to 220 Cumberland Dr. Clear debris and brush from approx. 265 LF of channel.**

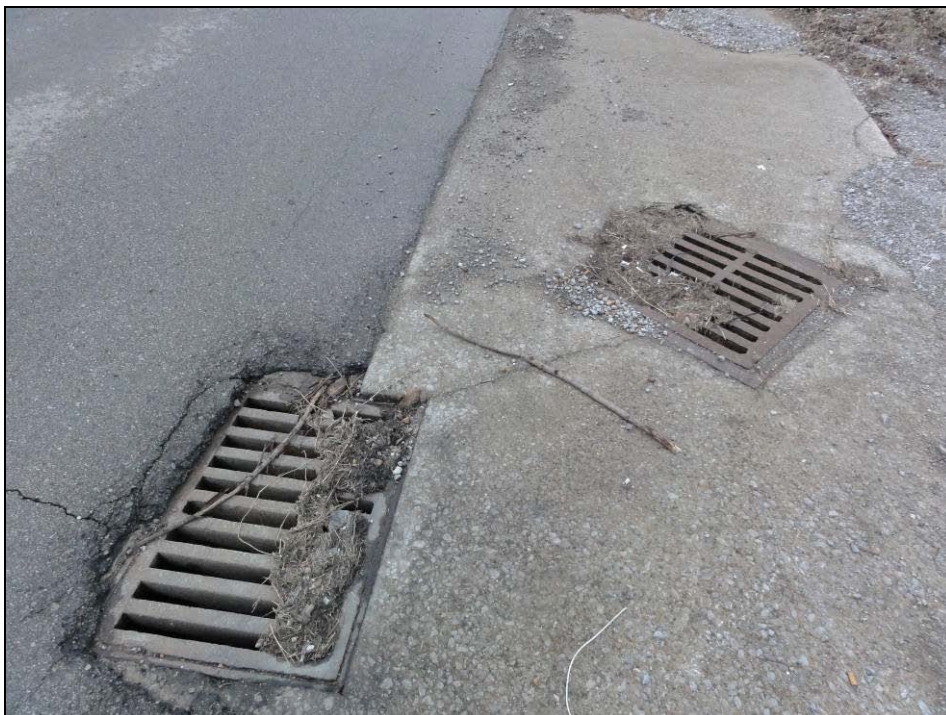
**Item 26 – 319 S. Maple St. Clear debris from catch basin grates. Picture 2271.**

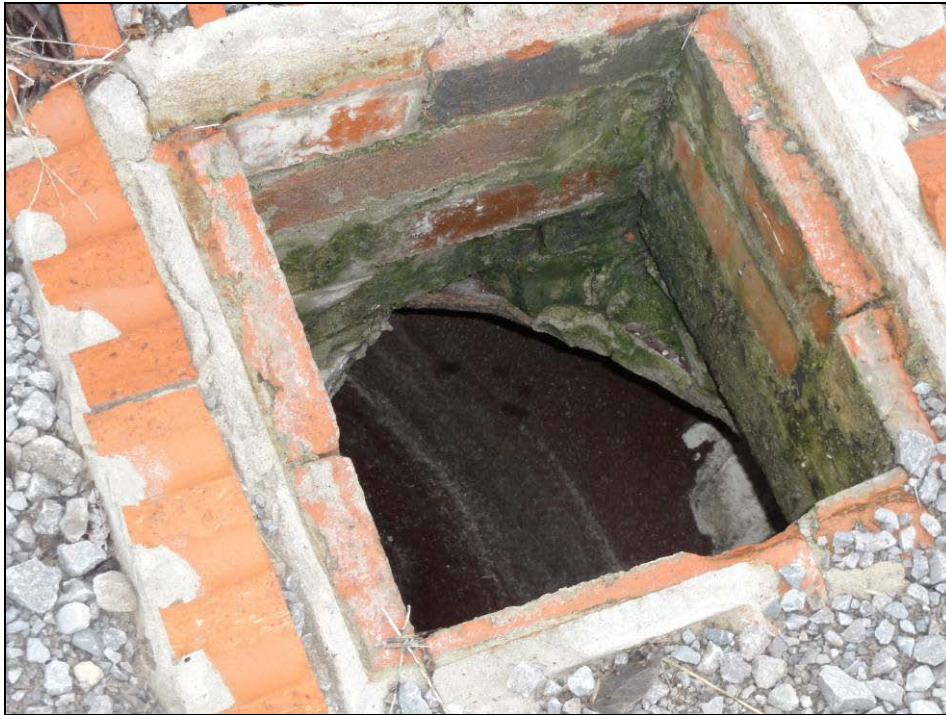
**Item 27 – 319 S. Maple St. Install grate on catch basin. Picture 2272.**

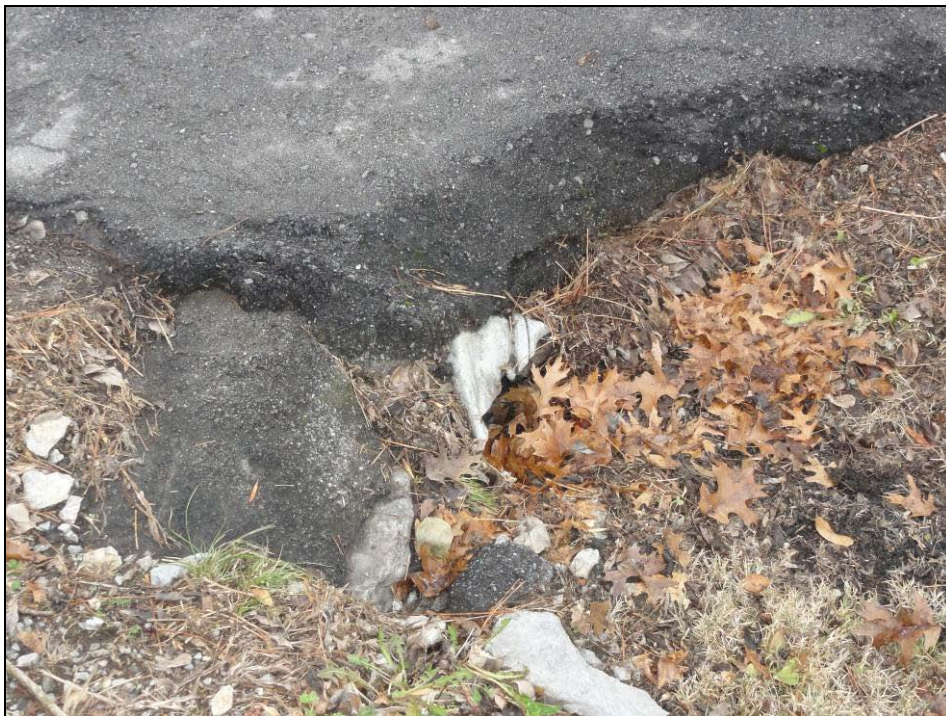
**Item 28 – East side of S. Tarver Ave. Clear debris and repair end section of 12" CMP. Picture 2299.**

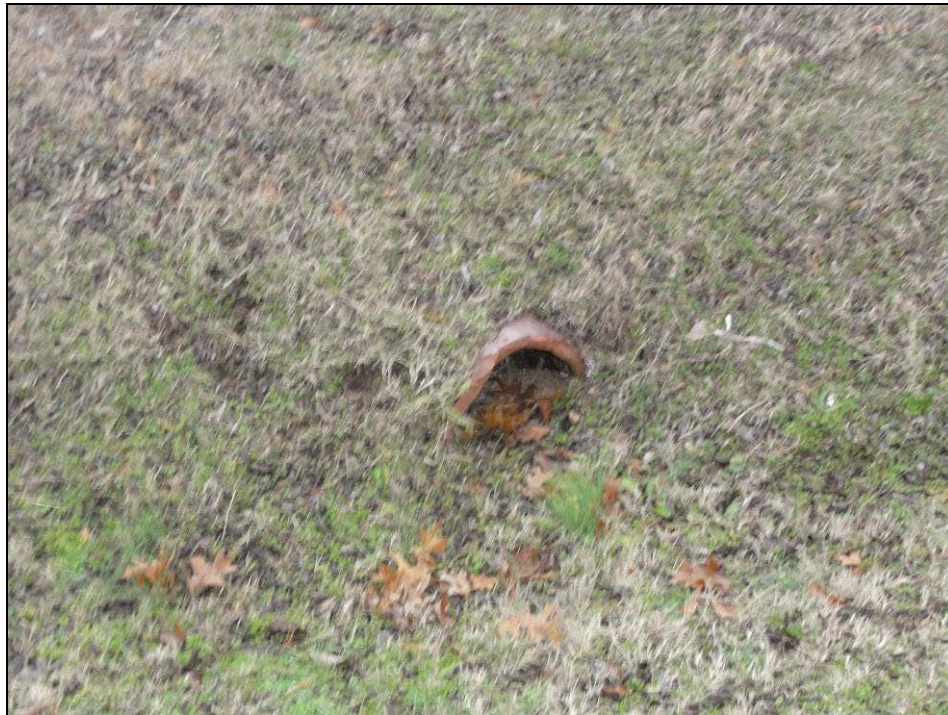
**Item 29 – 224 S. Tarver Ave. Flush sediment and debris from 12” clay pipe. Picture 2304.**

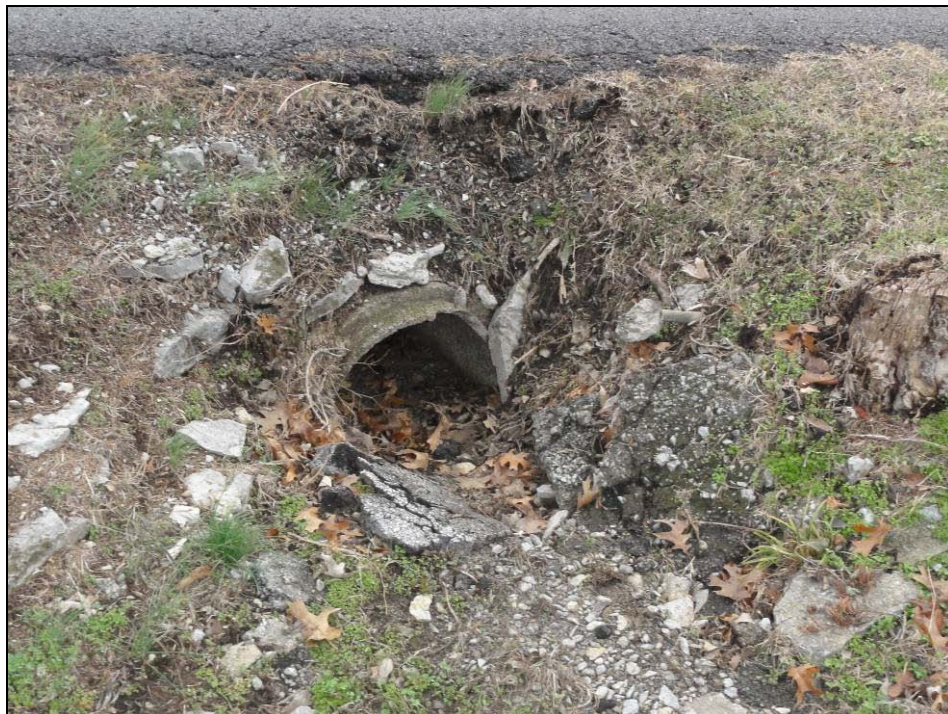
**Item 30 – 224 S. Tarver Ave. Clear debris and sediment from both ends of 18” RCP cross drain. Picture 2305.**

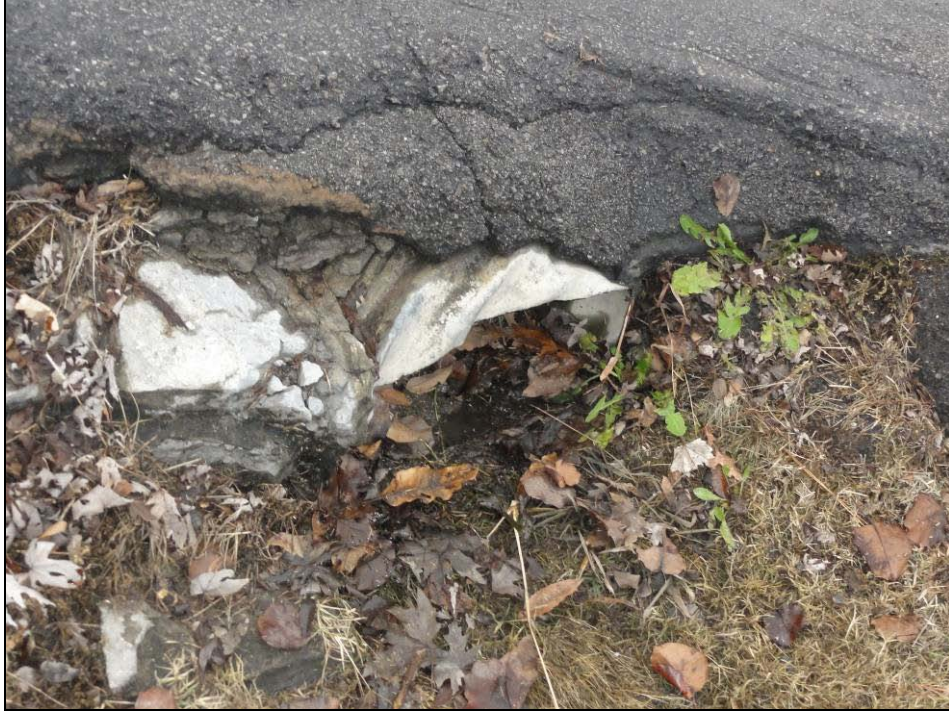
**Item 33 – S. Tarver Ave. and McClain Ave. Clear sediment and debris from both ends 20” x 10” ellip. CMP cross drain. Repair end section. Picture 2315.**

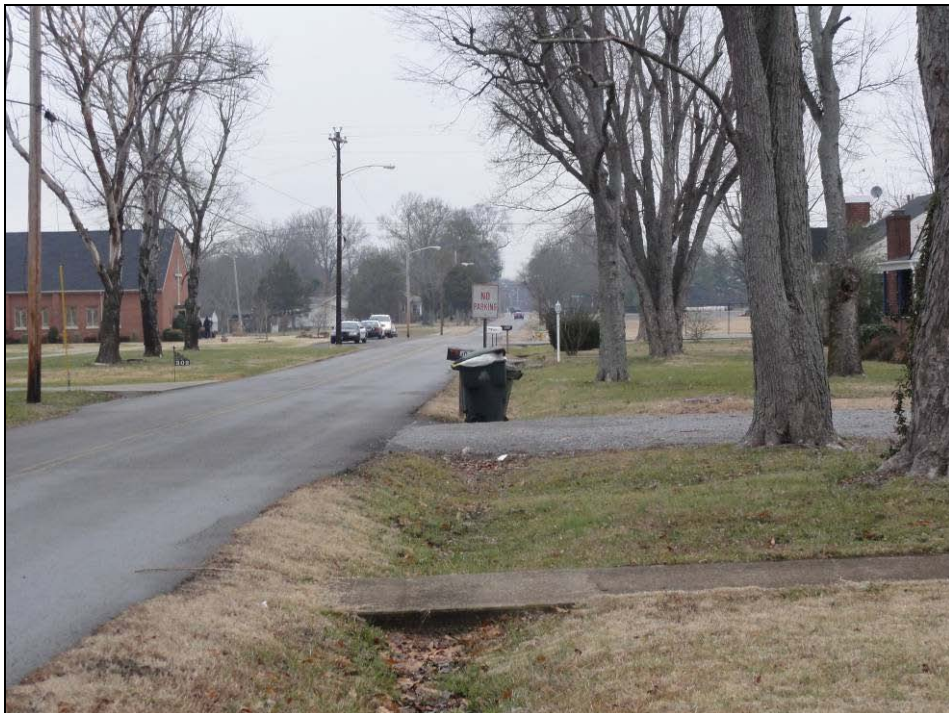
**Item 34 – S. Tarver Ave. from Martin Ave. to McClain Ave. View is looking north towards McClain Ave. No culverts under sidewalks and driveways on east side of S. Tarver Ave. Provide positive drainage in ditch. Approx. 310 LF. Picture 2324.**

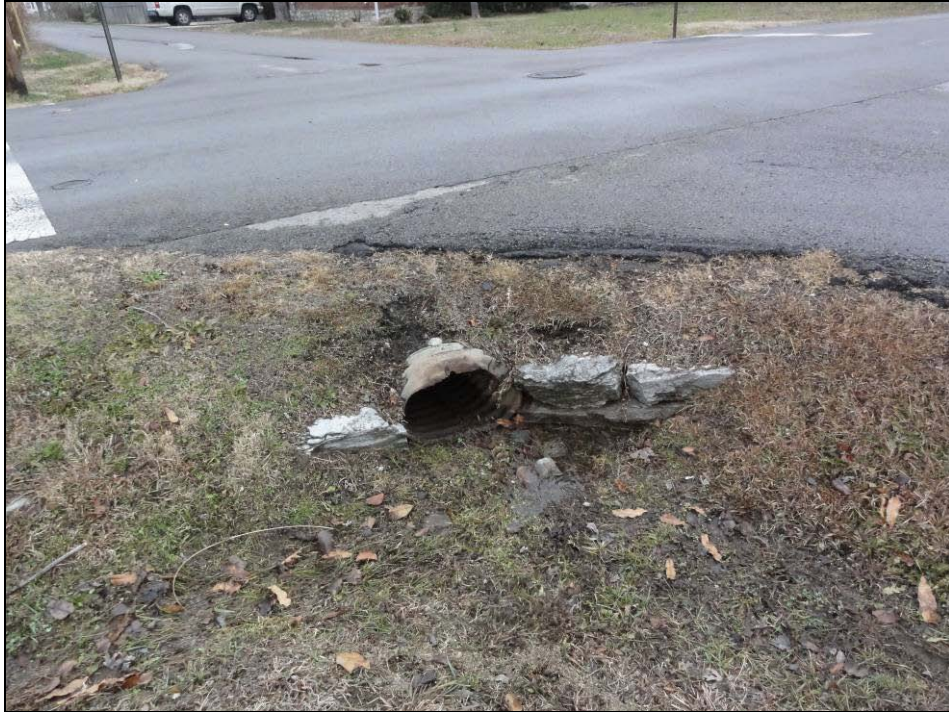
**Item 35 – S. Tarver Ave. and McClain Ave. Repair end of 22” x 12” CMP. Picture 2326.**

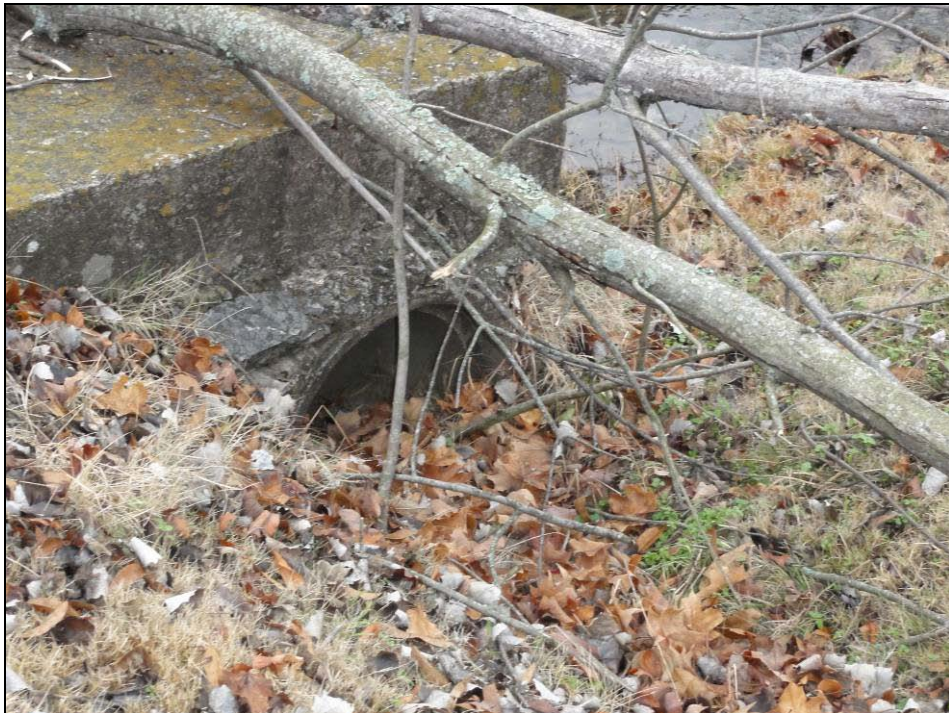
**Item 36 – 431 Martin Ave. Clear debris from 15” RCP. Picture 2331.**

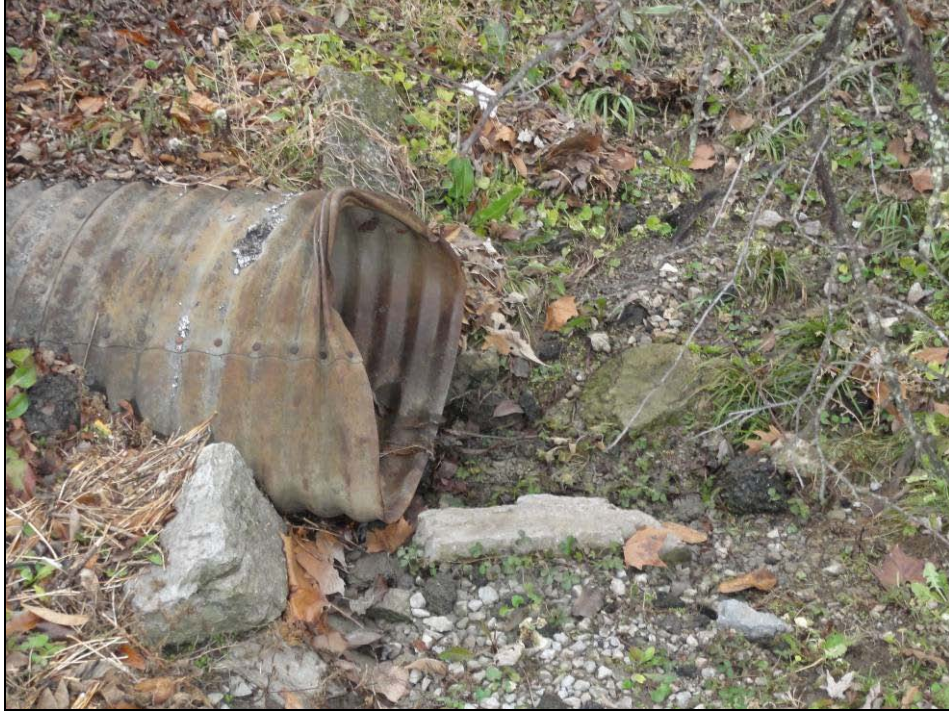
**Item 37 – Martin Ave. and Cleveland Ave. Repair end of 26” x 20” ellip. CMP. Picture 2340.**

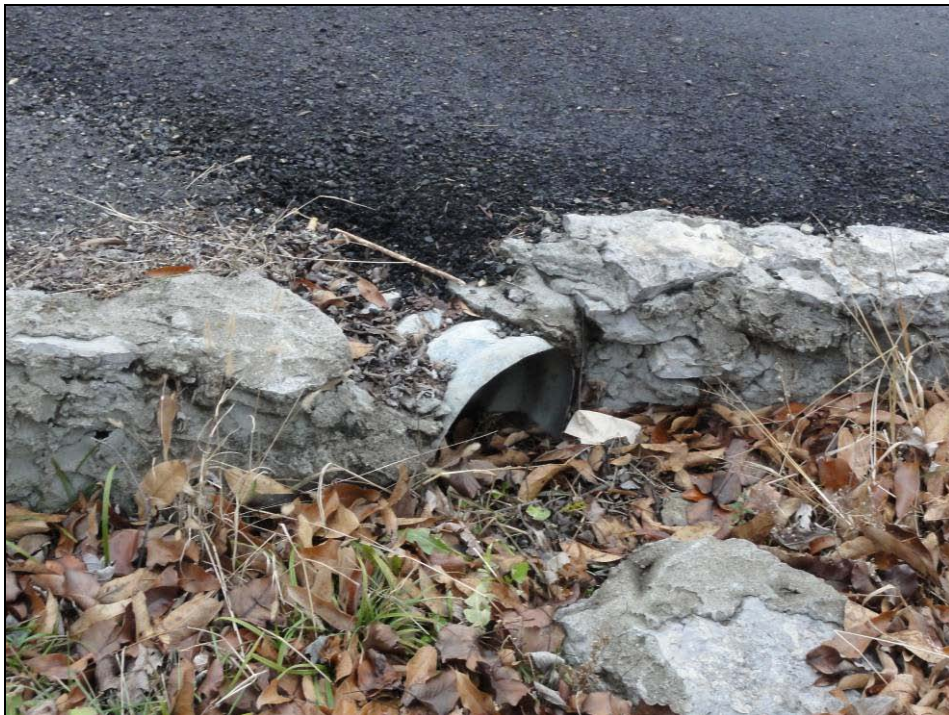
**Item 38 - Martin Ave. and Cleveland Ave. Clear debris from ends of 10” CMP. Picture 2342.**

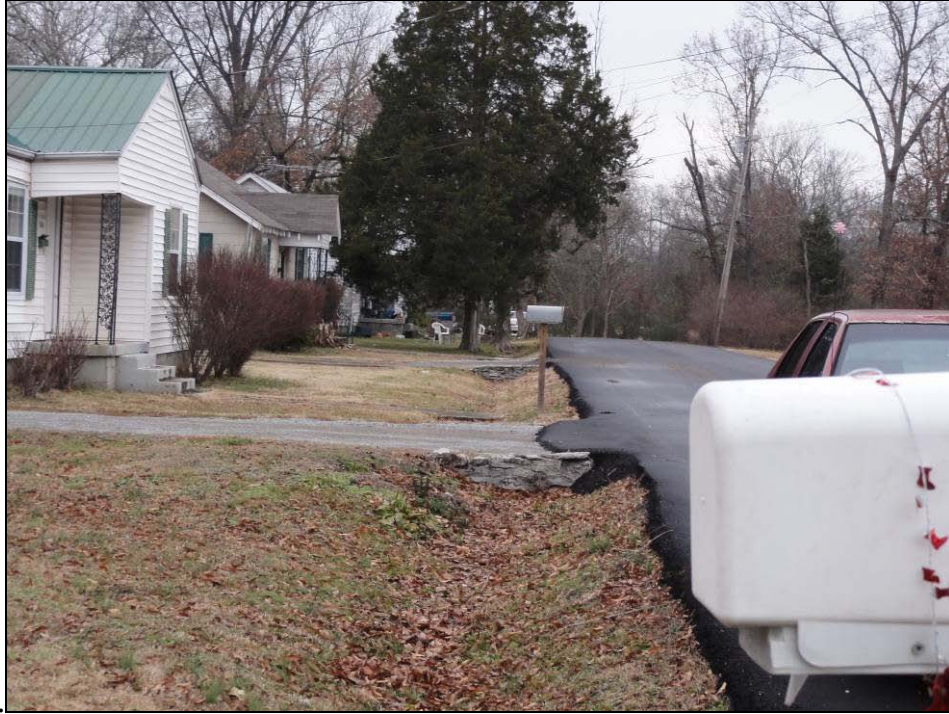
**Item 39 – Cleveland Ave north of McClain Ave, looking north. Clear debris and sediment from driveway culverts and ditch. Approx. 400 LF Picture 2344.**
