## ENGINEERING REPORT

### Cumberland University Drainage Improvements

**City of Lebanon Engineering Department**

**Neel-Schaffer, Inc.**

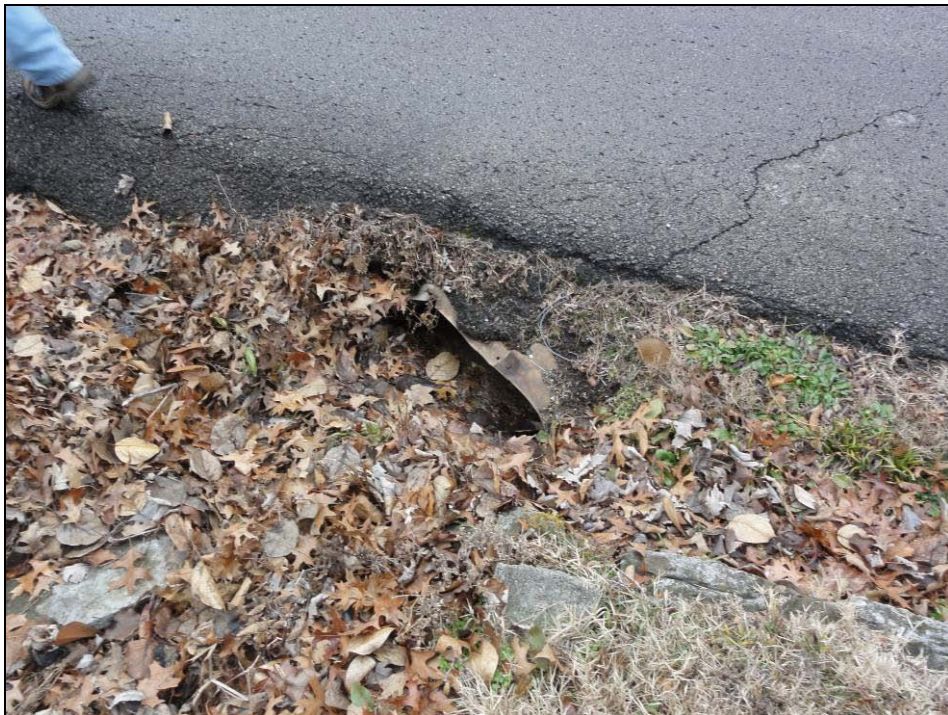
**Item 40 – Cleveland Ave. and McClain Ave. Clear debris and sediment from 14" x 9" ellip. CMP cross drain and repair damaged end section. Note crack in pavement. Picture 2346.**

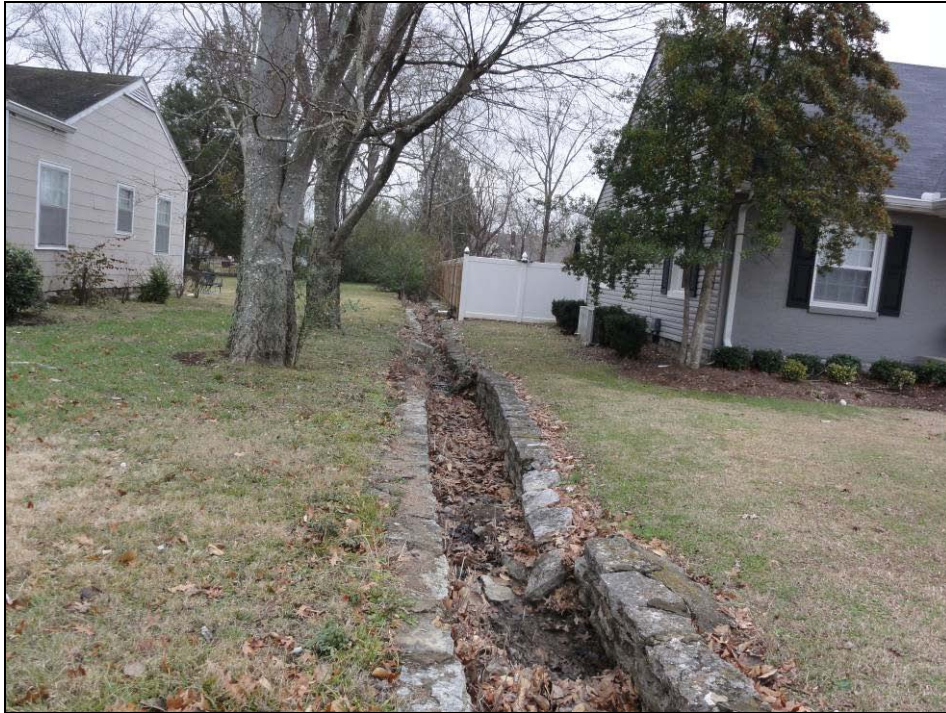
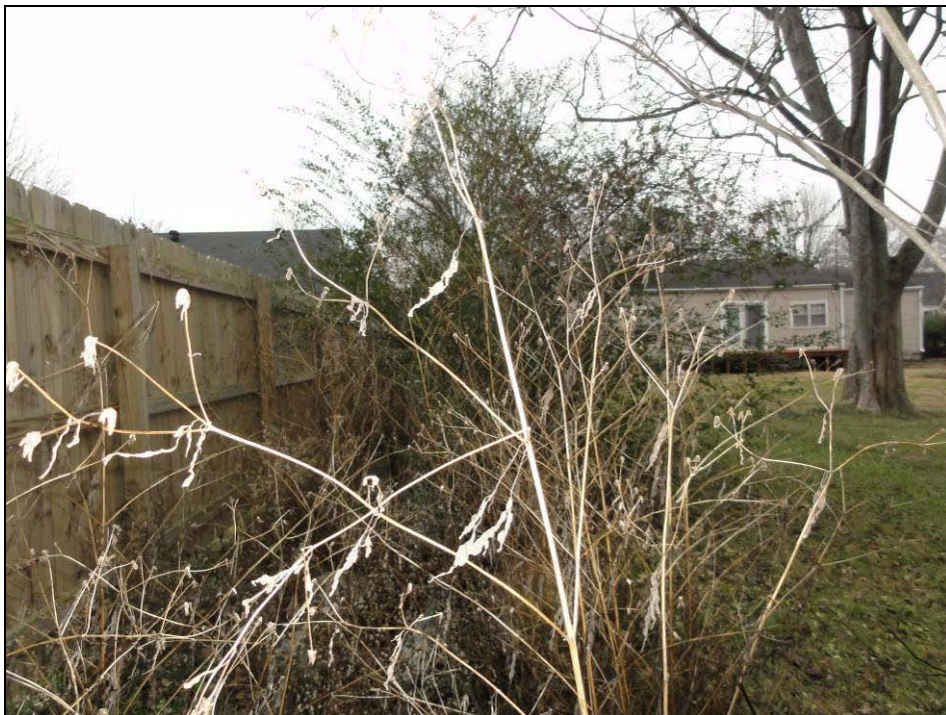
**Item 41 – Drainage channel running east from Pennsylvania Ave at 227 Pennsylvania Ave. Clear debris, sediment and brush from approx 200 LF of manmade channel.**

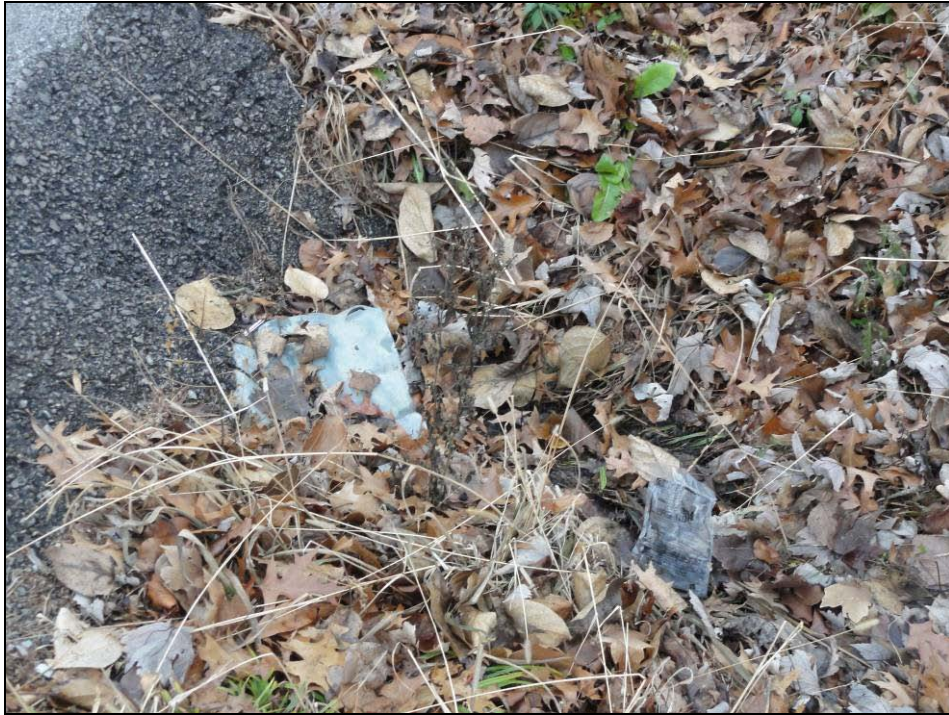
**Item 42 – Wagoner St. and Pennsylvania Ave. Clear debris from 15" x 10" ellip. CMP. Picture 2352.**

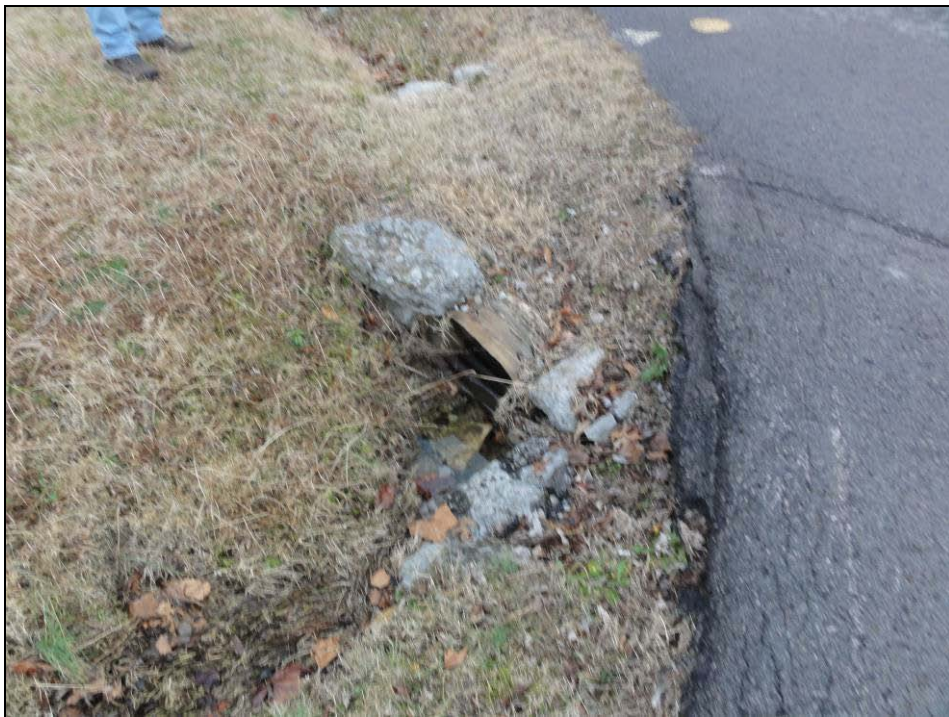
**Item 43 – Martin Ave. and Pennsylvania Ave. Clear debris and sediment from 23" x 12" CMP. Picture 2356.**

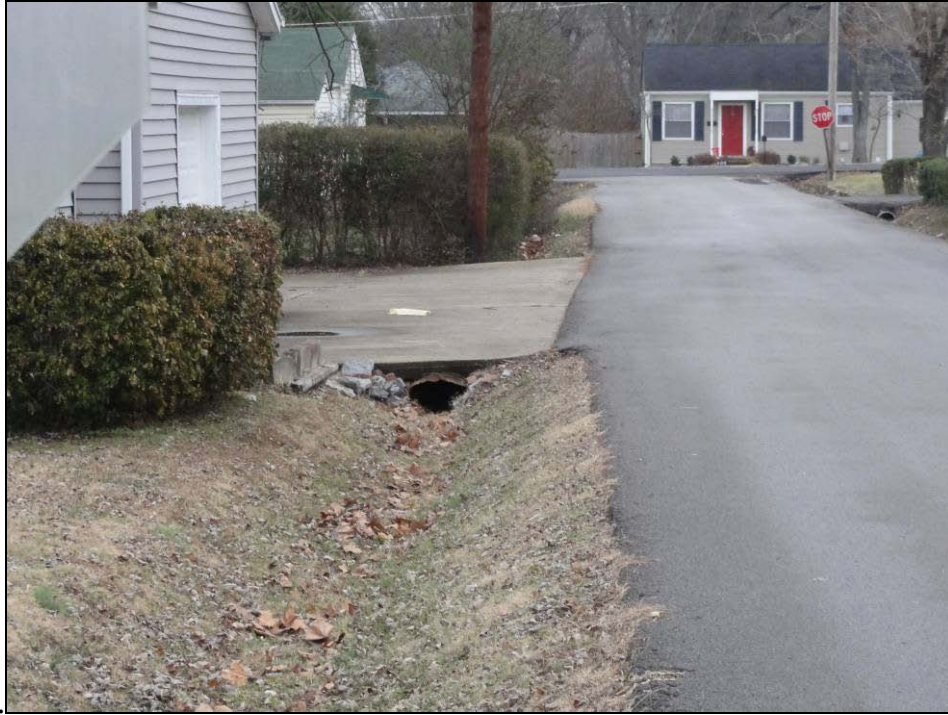
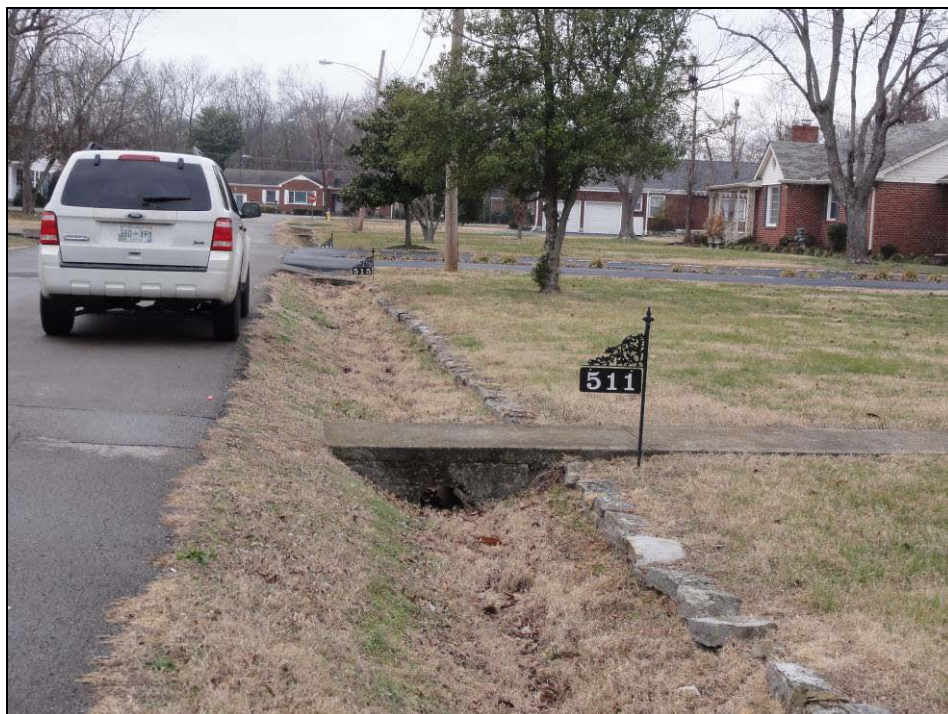
**Item 44 – Martin Ave. from Pennsylvania Ave. to Cleveland Ave. Clear debris and sediment from roadside ditches and all driveway culverts. Approx. 340 LF each side of road.**

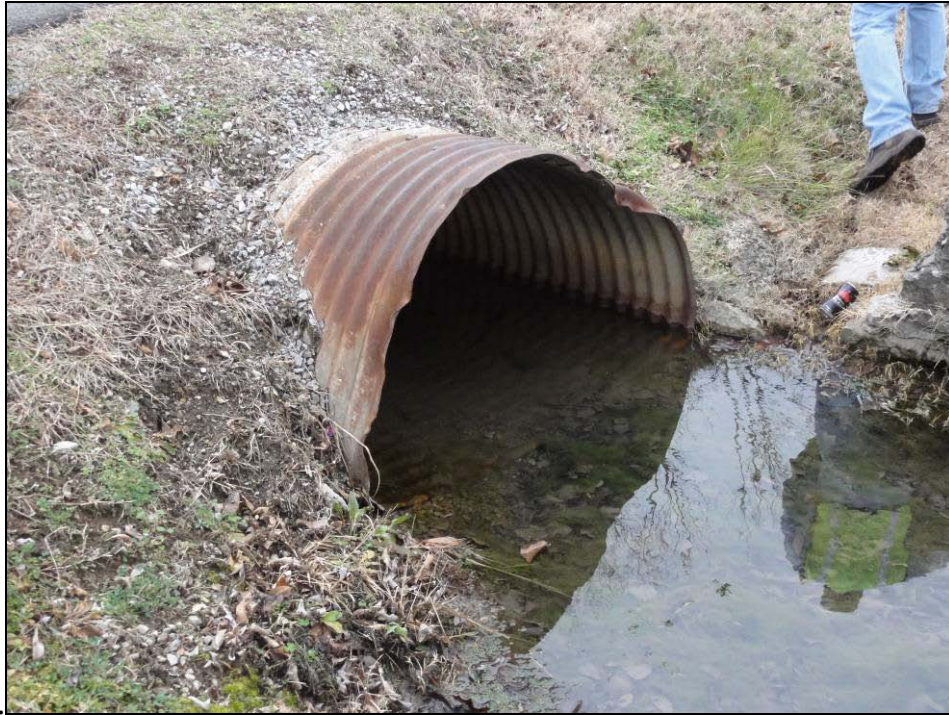
**Item 46 - 511 W. Sunset Dr. Clear debris and sediment from 57" x 36" ellip. CMP. Picture 2380.**

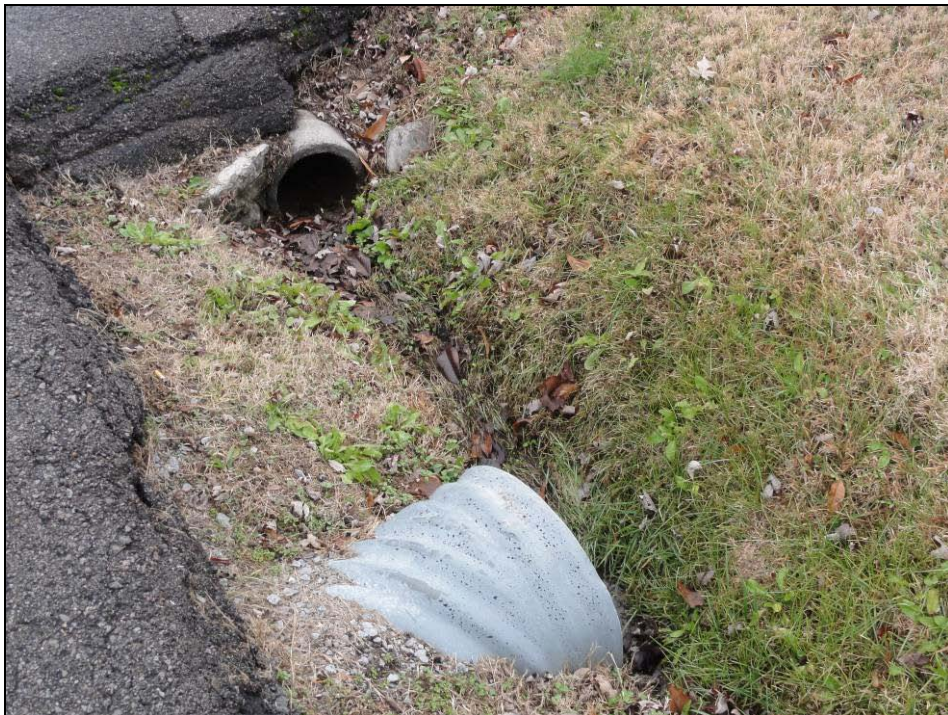
**Item 47 – Pennsylvania and W. Sunset Dr. Improve ditch section at end of 18" CMP. Picture 2389.**

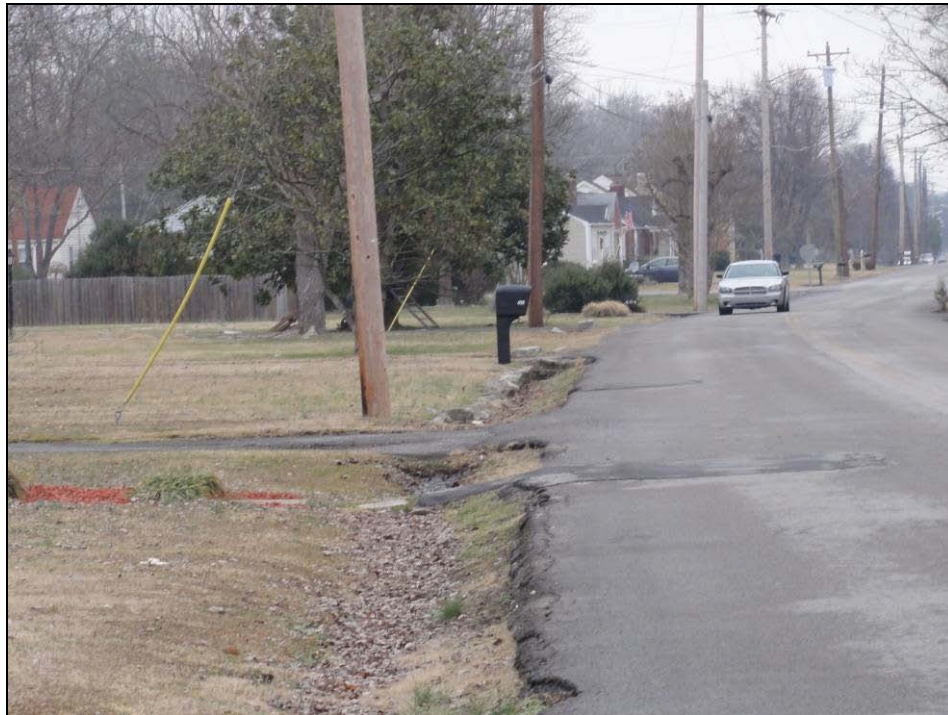
**Item 48 – Pennsylvania Ave from Leeville Pk. to Martin Ave. View is looking north from 410 Pennsylvania Ave. Clear debris and sediment from road side ditch and culverts on the west side of Pennsylvania Ave. Approx. 900 LF. Picture 2390.**

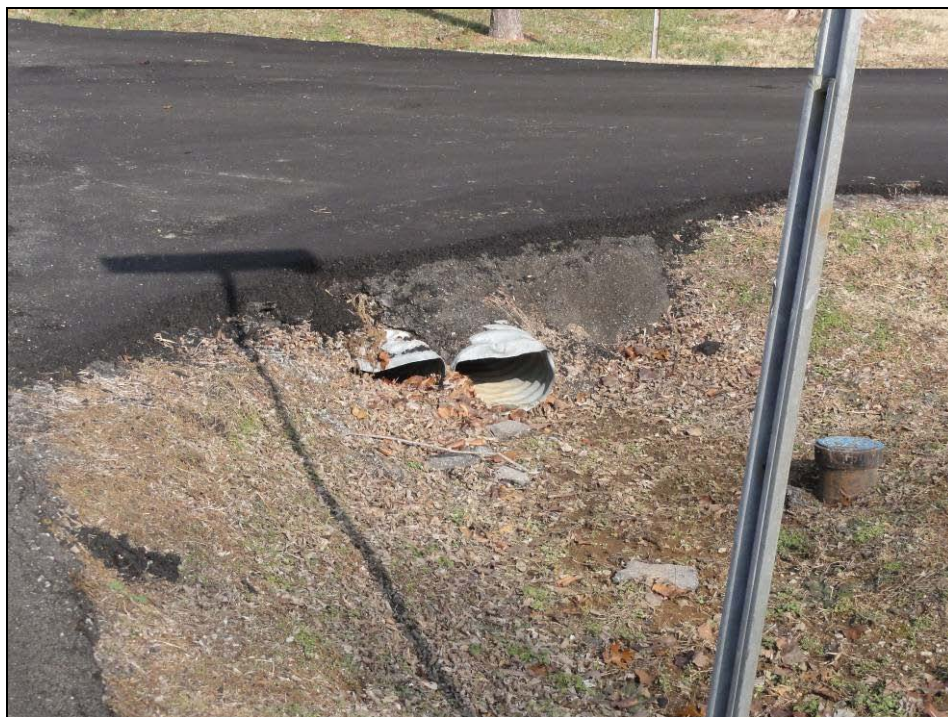
**Item 49 – E. Sunset Dr. at S. Tarver Lane, east bound lane. Clear debris and sediment, repair damaged end sections of 2 – 14" x 10" ellip. CMP's. Picture 2413.**

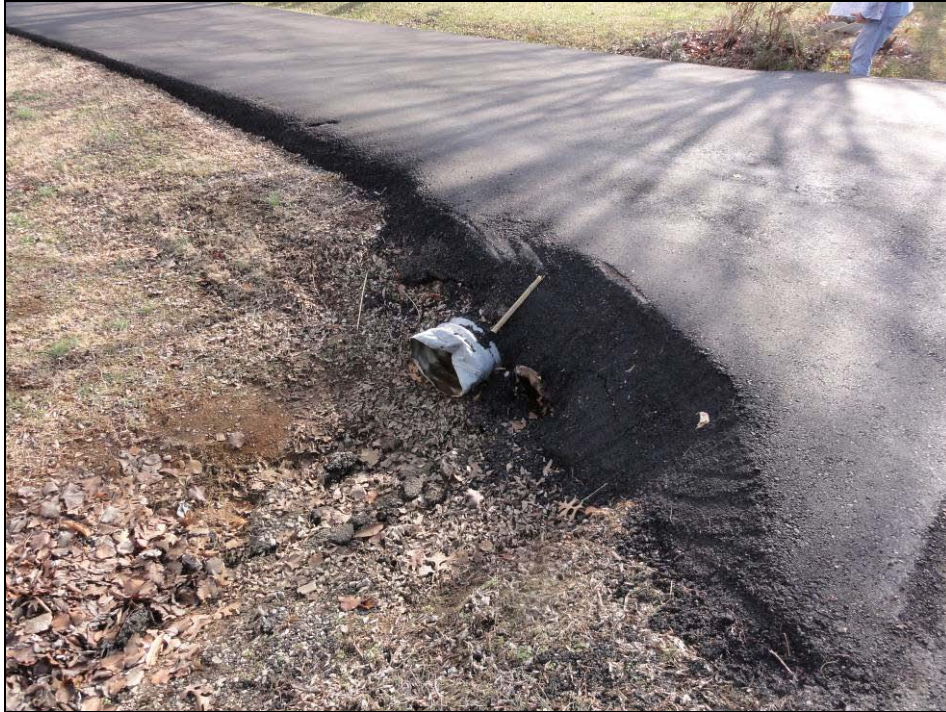
**Item 50 - E. Sunset Dr. at S. Tarver Lane, west bound lane. Clear debris and sediment, repair damaged end sections of 2 – 14" x 10" ellip. CMP's. Picture 2414.**

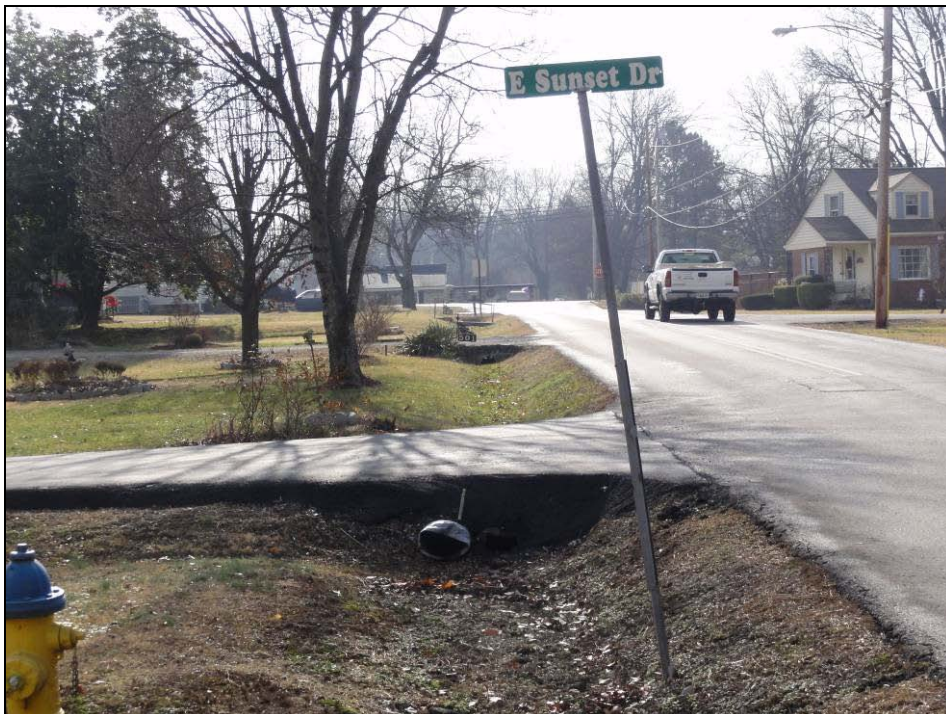
**Item 51 – S. Tarver Ave from E. Sunset Dr. to Leeville Pk. View is looking south from E. Sunset Dr. Repair end sections of all driveway culverts. Picture 2411.**

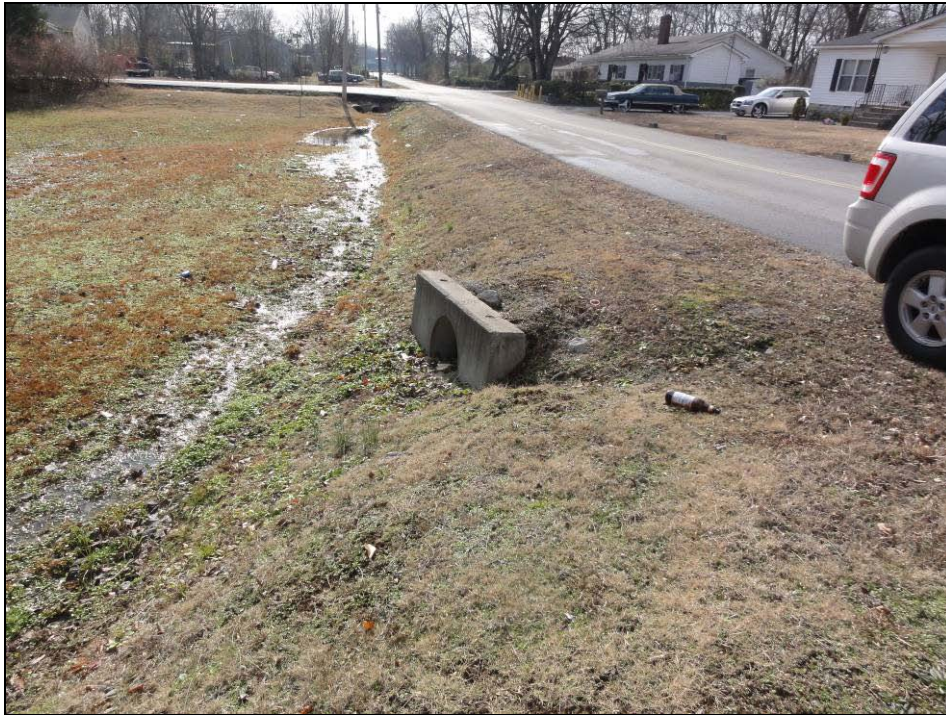
**Item 52 – Leeville Pk. and Cleveland St. Clear sediment from 15” RCP. Picture 2430.**

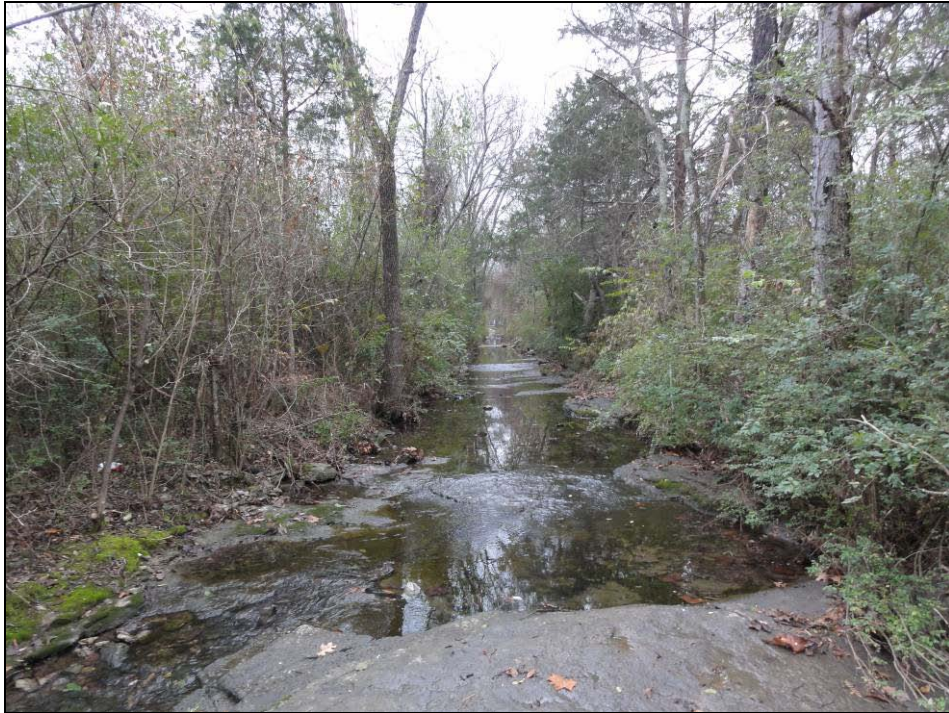
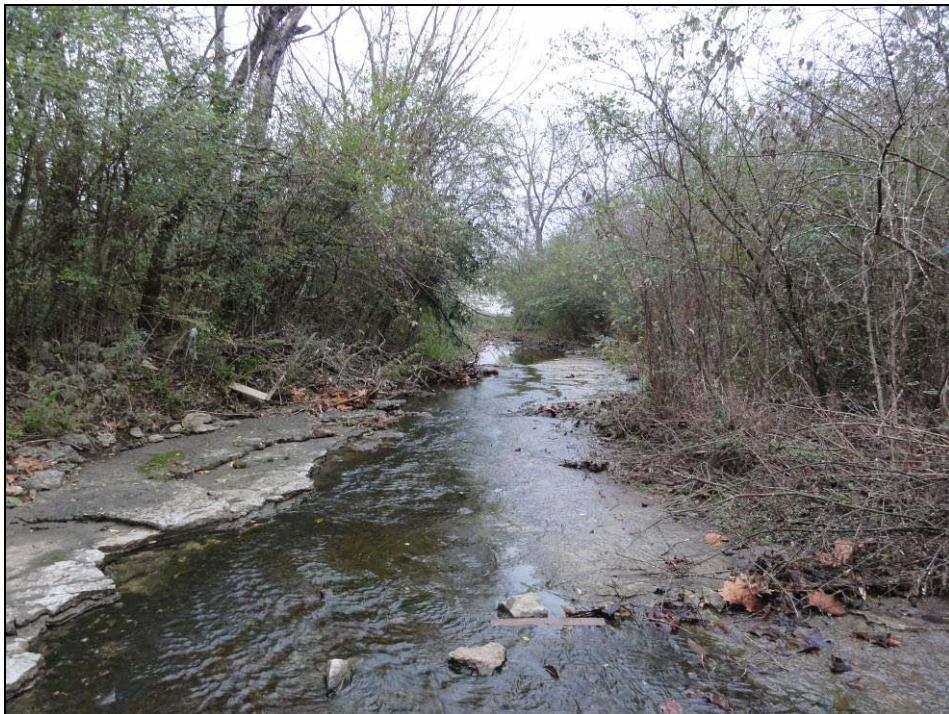
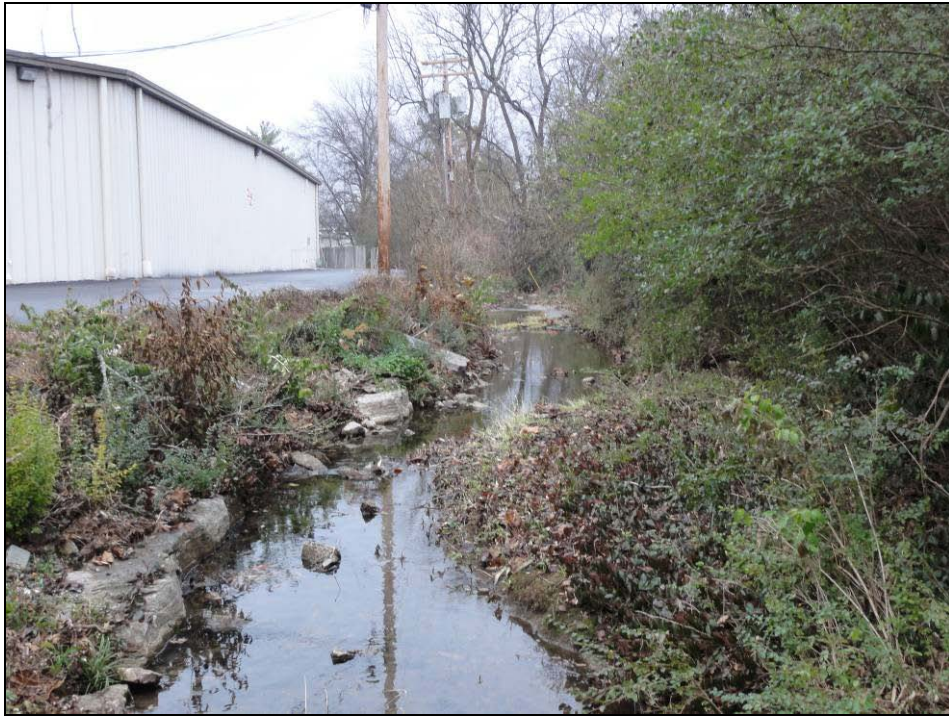
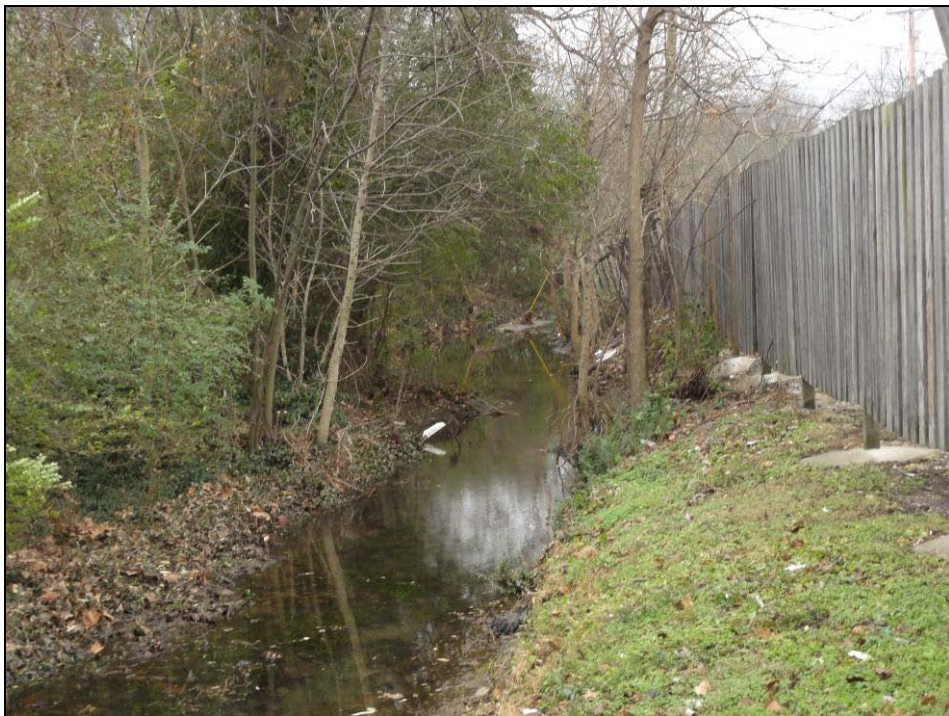
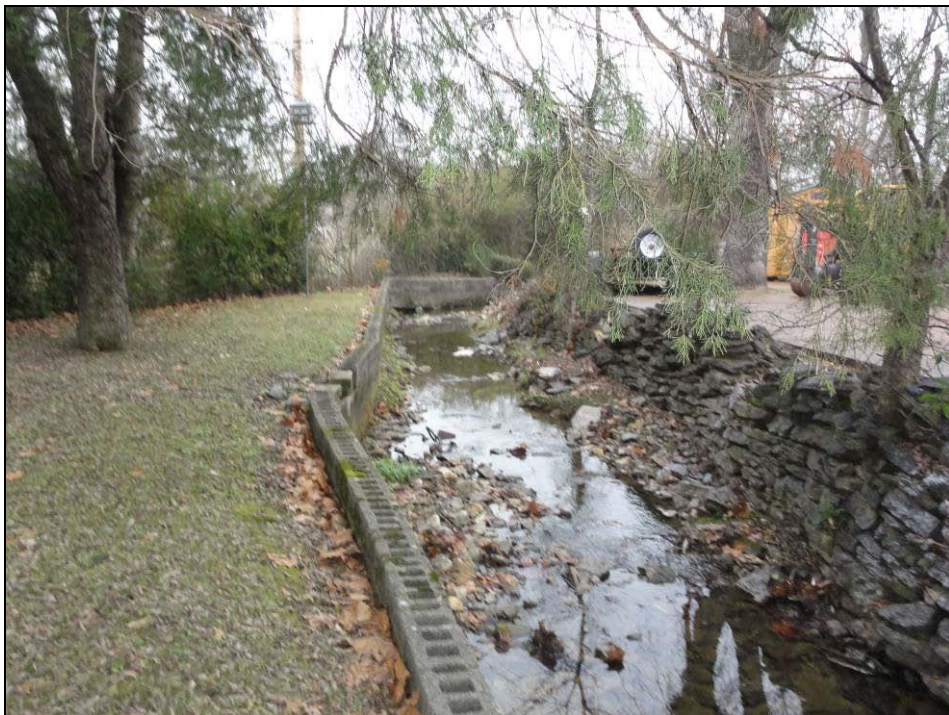
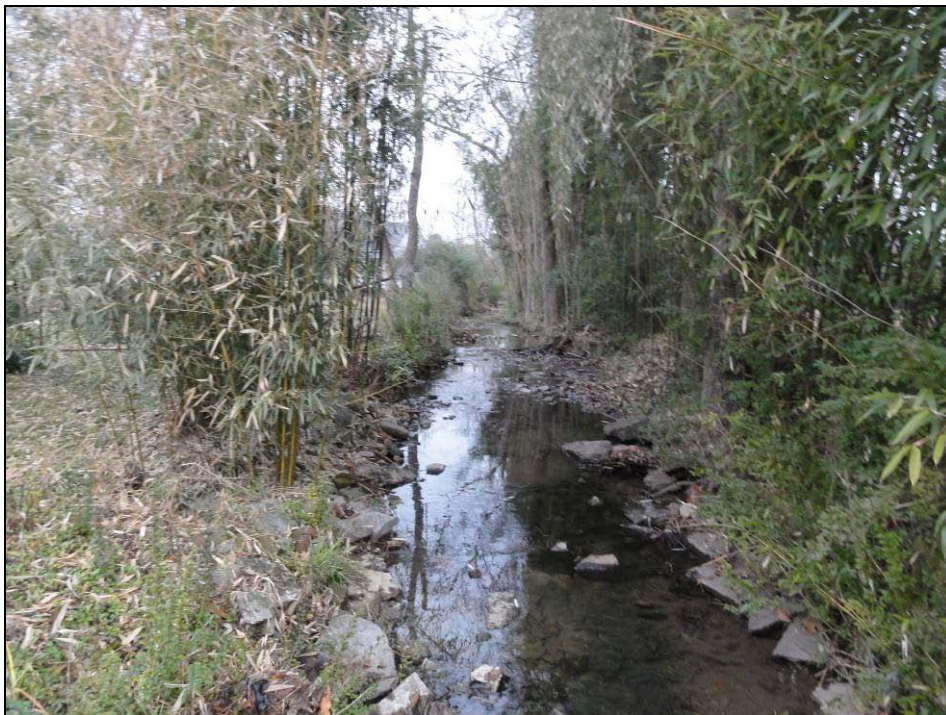
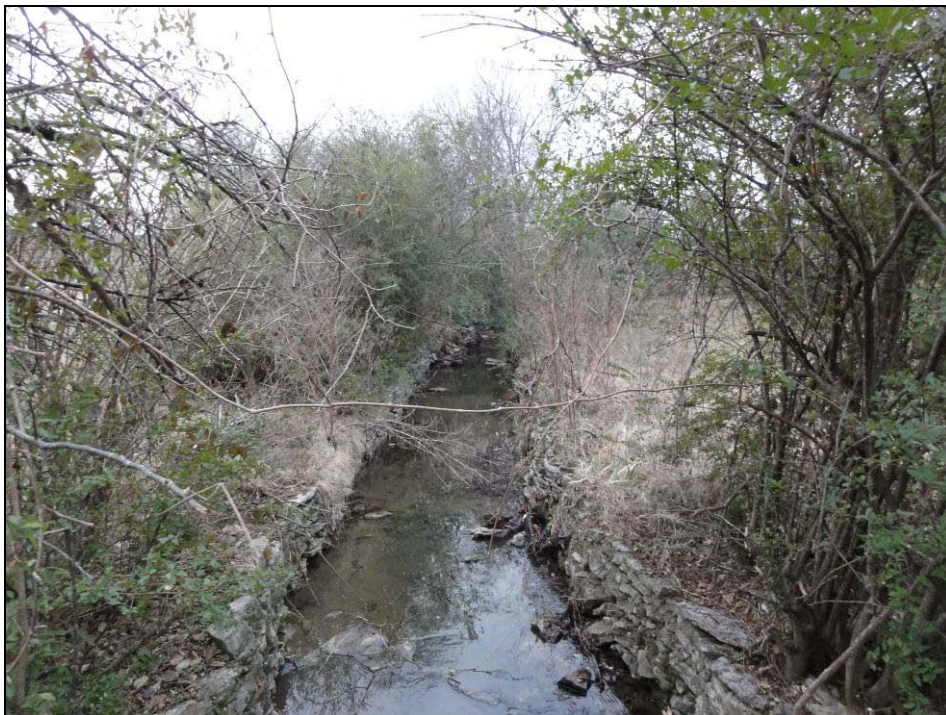
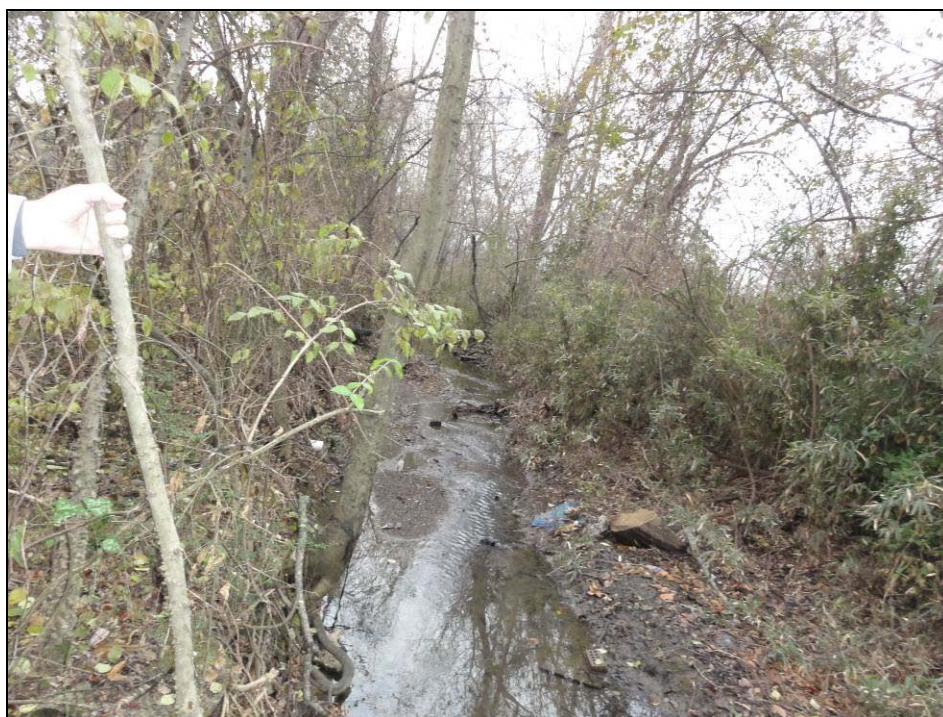
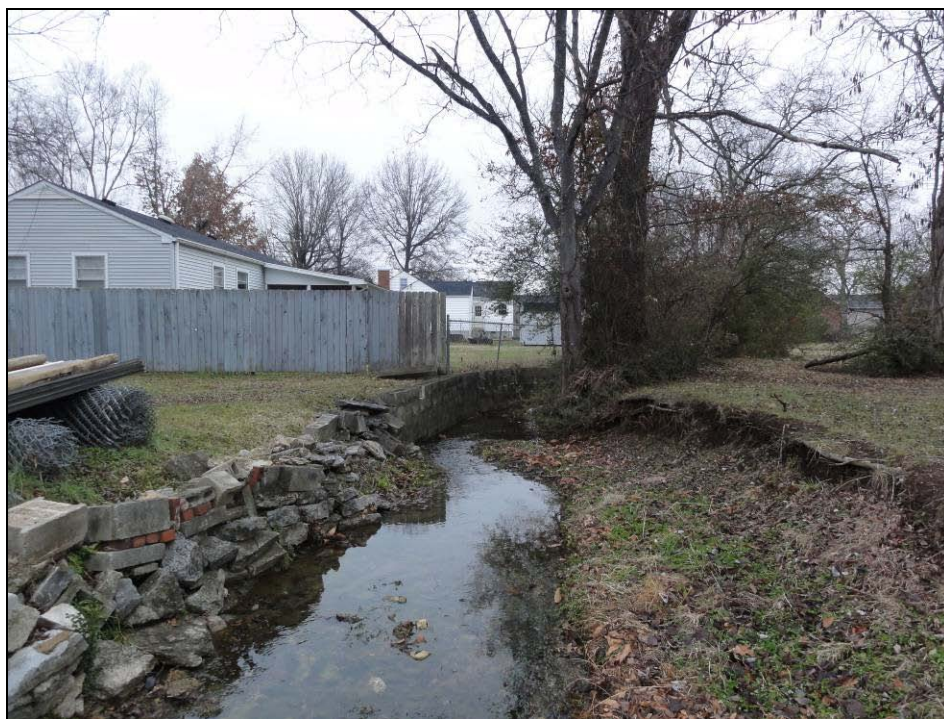
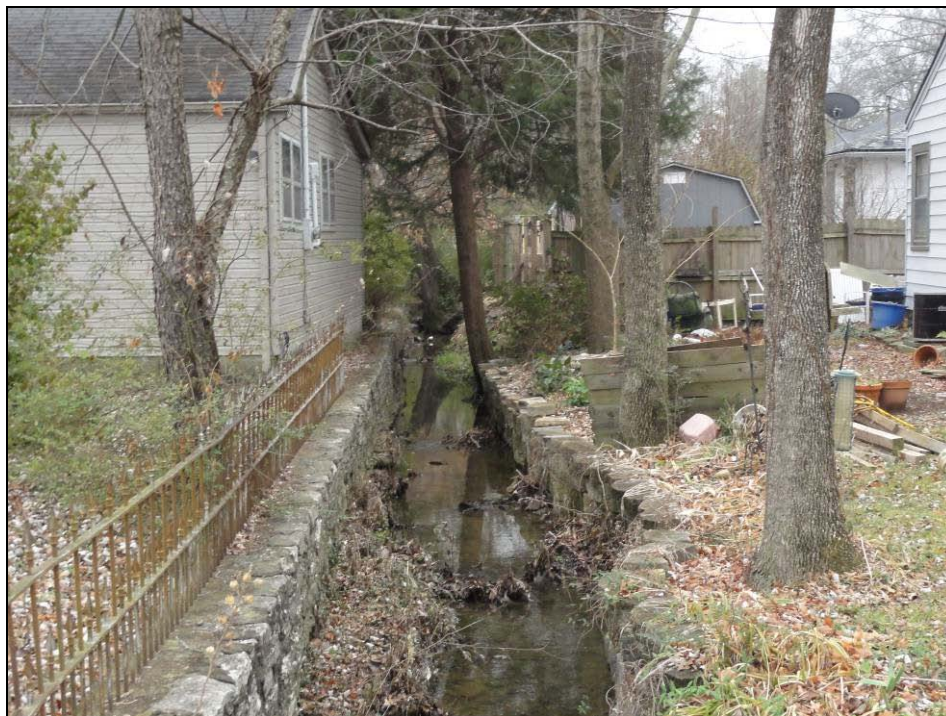
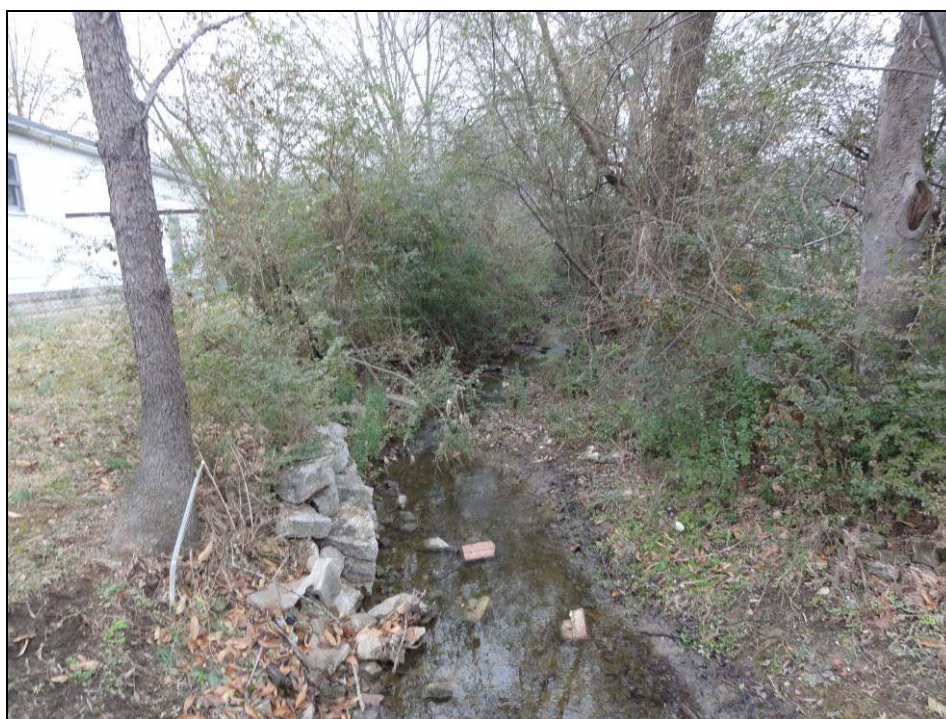
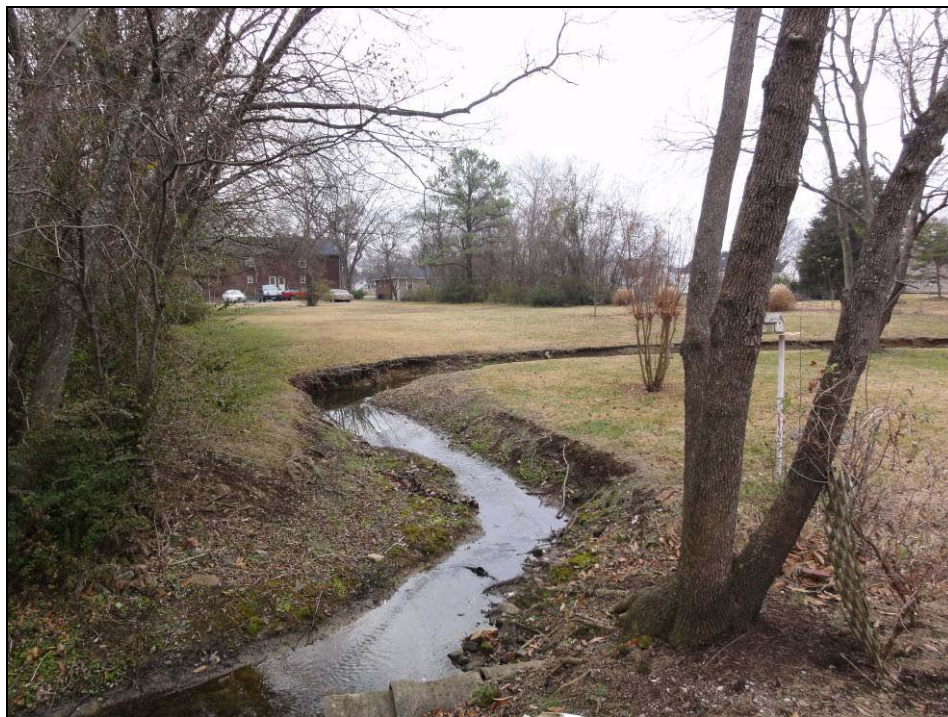
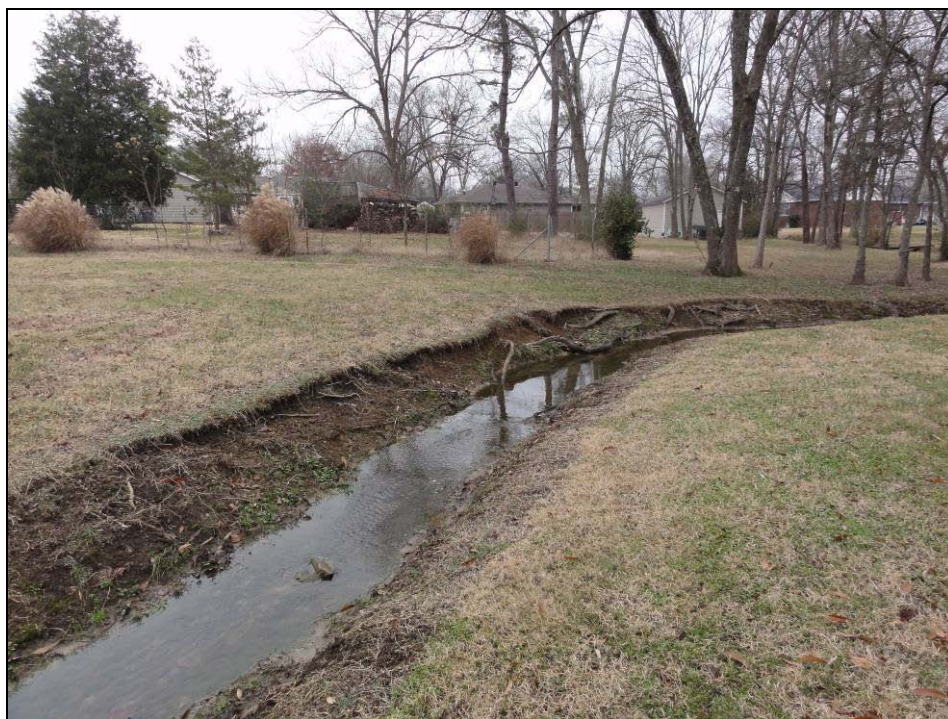
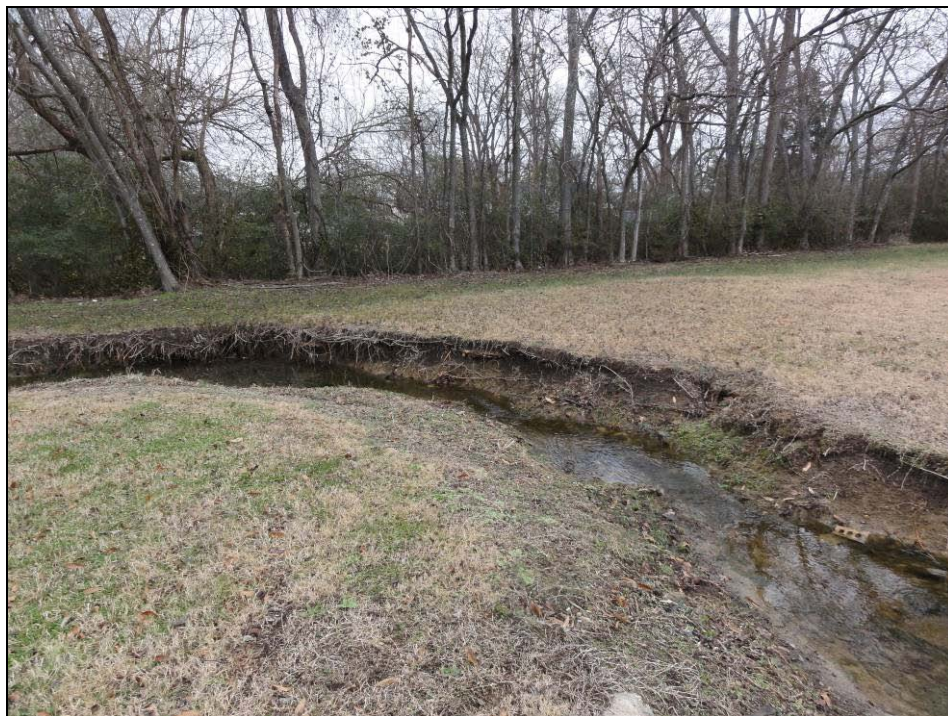
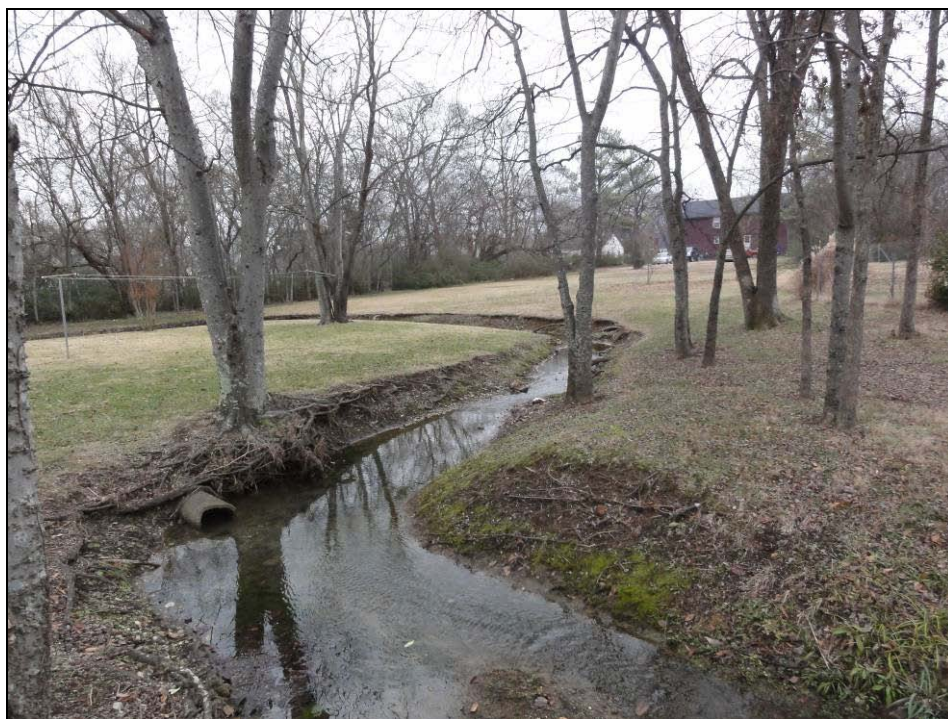
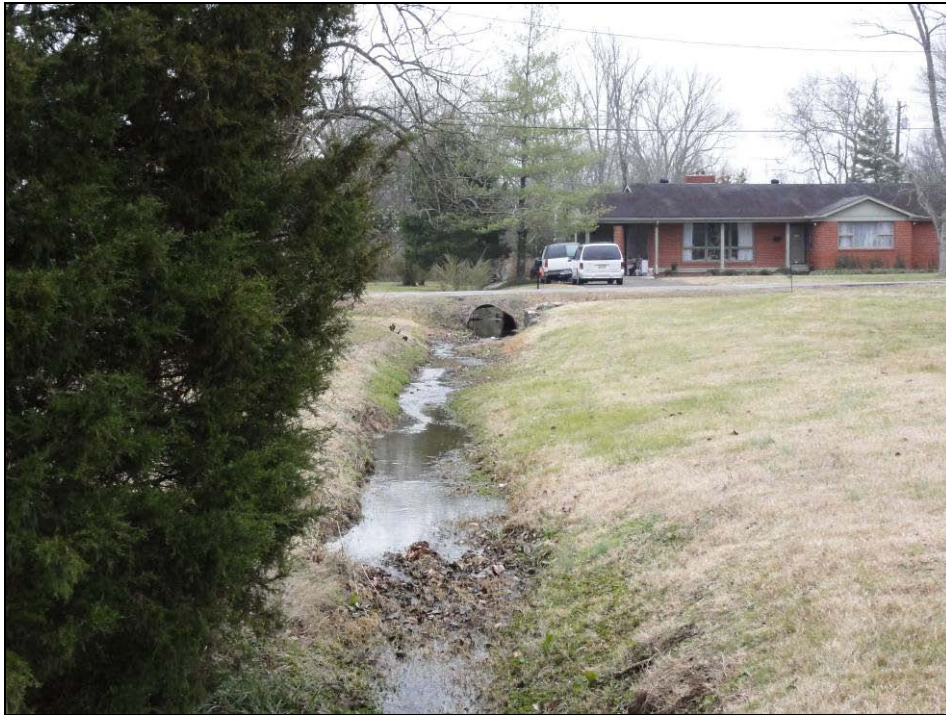
**Item 53 – W. Main St. to W. Sunset Dr. Clear debris, brush and sediment from approx. 3,410 LF of channel. Provide bank stabilization and erosion control measures where necessary.**

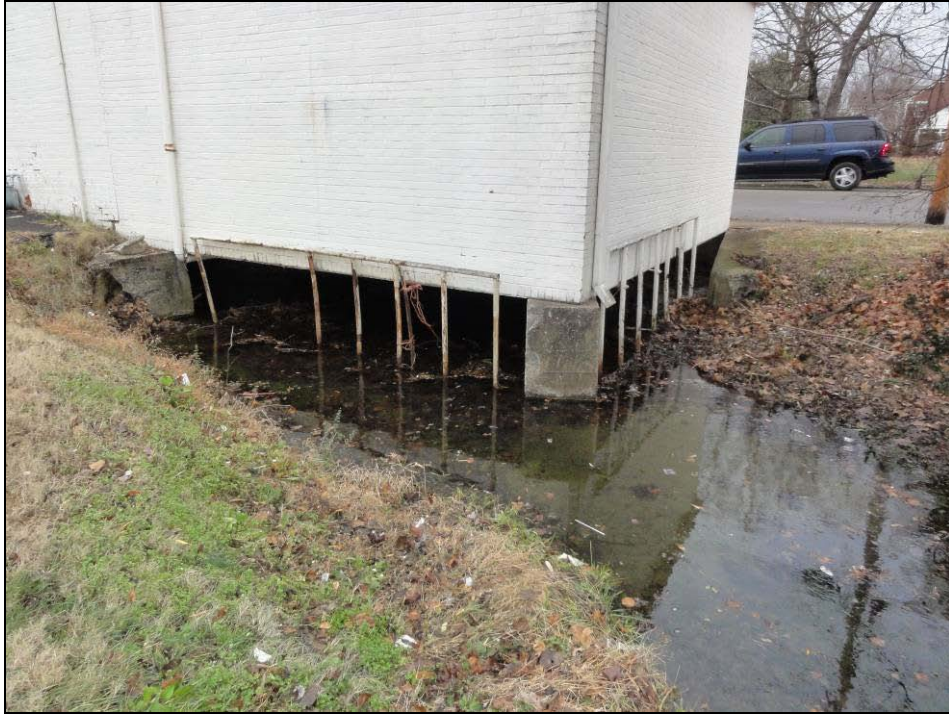
**Looking north the rear of 502 W. Main St. Picture 2278. Bridge inlet is under building. Note bridge abutment footing on right side of photo.**

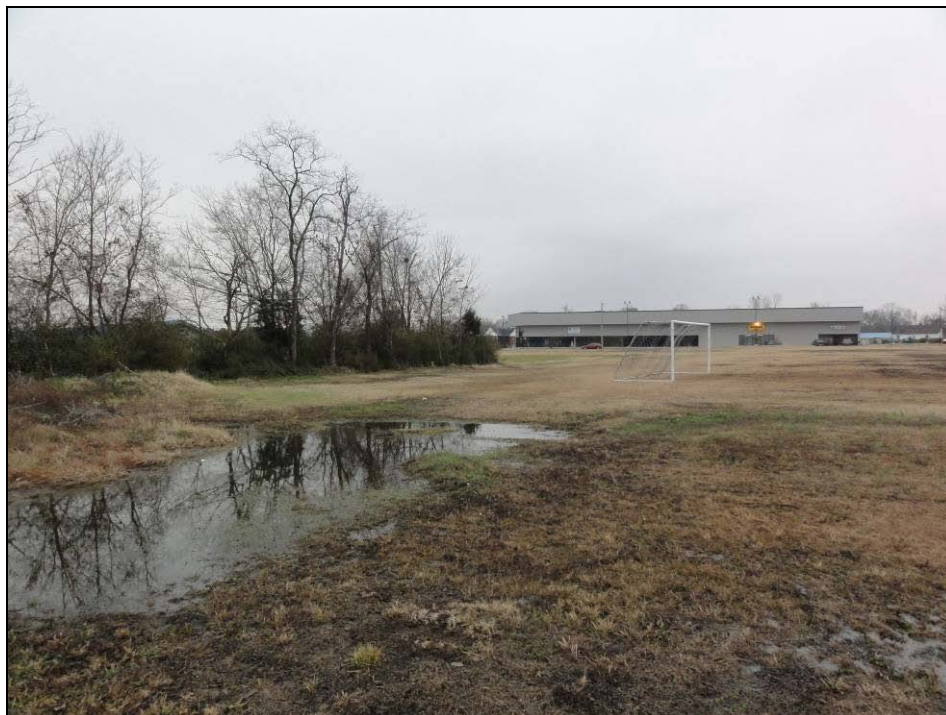
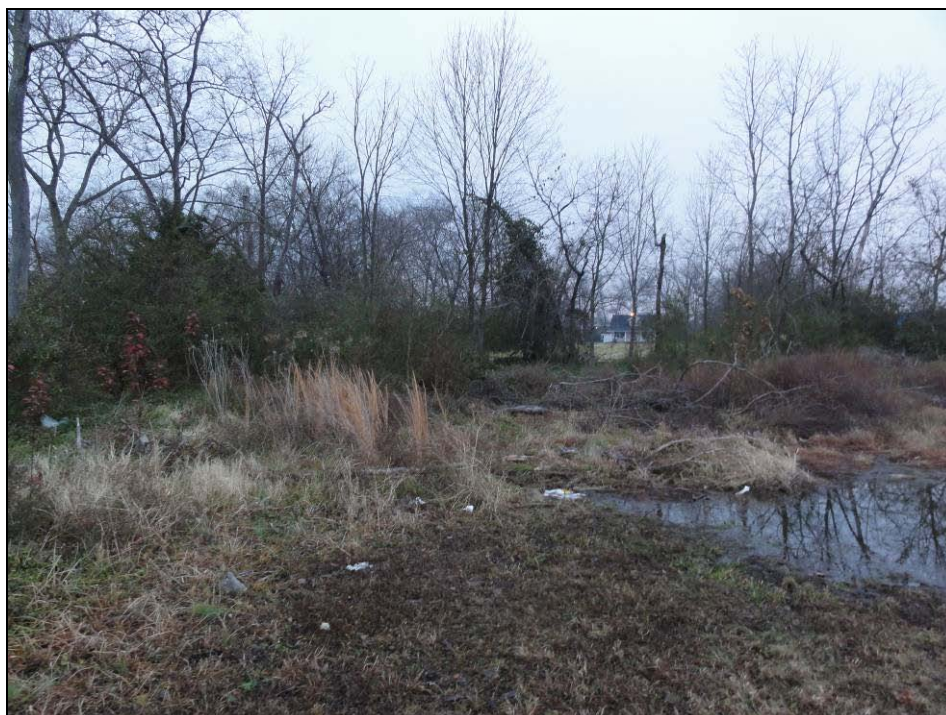
**Item 54 – Restore filled in detention pond at soccer fields to original design specifications. Remove fill material from concrete riser structure and grade to drain into ditch along property lines.**

**Looking east toward former detention pond and concrete riser structure that is filled in with dirt. Picture 2251.**
