## ENGINEERING REPORT

### Johnson Heights Subdivision Drainage Improvements

**Neel-Schaffer, Inc.**

**March 31, 2011**

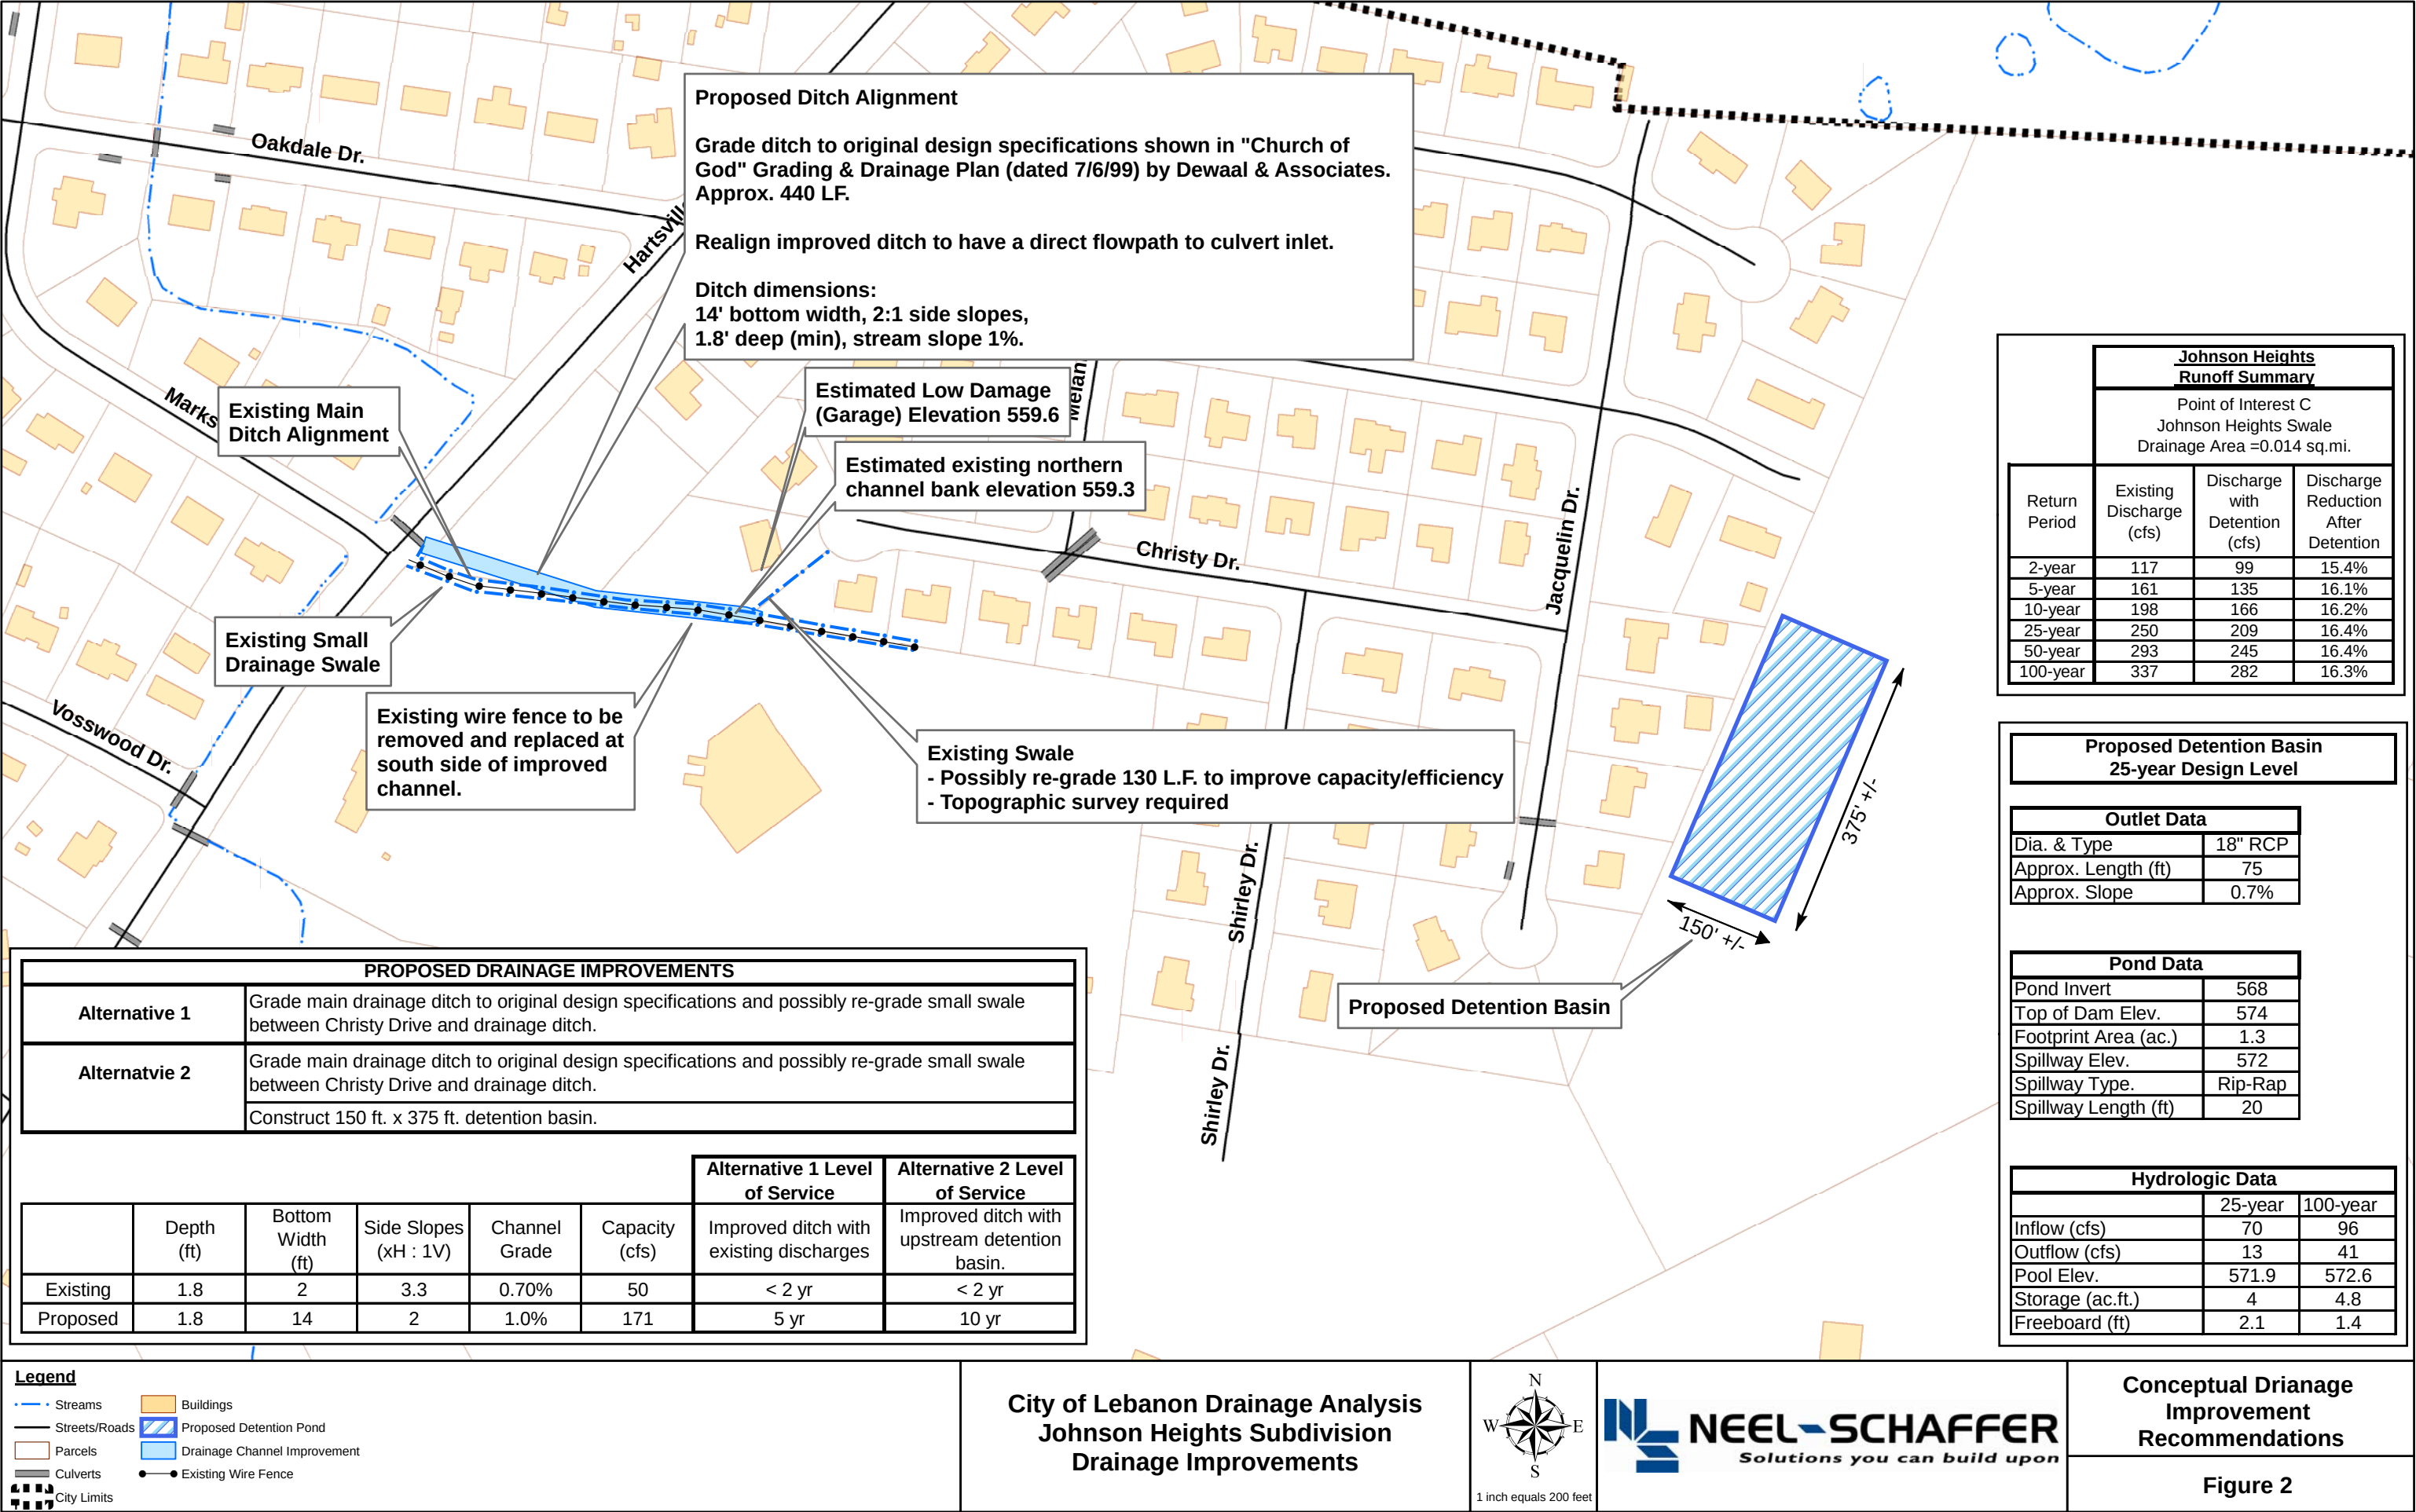
During the technical analysis, it was determined that the drainage ditch south of Christy Drive is undersized in relation to the amount of storm water runoff collected. The swale has a bank-full capacity of 50 cubic feet per second (cfs), which is well below the 2-year runoff of 99 cfs. Measurements taken during the field review also show that the swale was not constructed to the original design specifications shown in the "Church of God" Grading and Drainage Plan (dated July 6, 1999) by Dewaal & Associates. The approved design plan calls for a drainage ditch measuring 14 feet at the bottom and approximately 22 feet at the top. The existing swale measures approximately 2 feet at the bottom and approximately 14 feet at the top. The depth was measured in the field to be 1.8 feet, which slightly exceeds the design depth of 1.55'.

Two alternatives were evaluated to improve the drainage ditch, which should help mitigate the flooding issues on Christy Drive. The first alternative is to grade the drainage swale to the original design specification as shown on the previously referenced drainage plan. This would increase the capacity of the ditch from 50 to 171 cfs, which is slightly higher than the existing 5-year discharge.

The second alternative also requires the ditch to be improved to original design specifications, but adds the construction of a detention basin east of Jacquelin Drive. The detention basin would provide storm water storage for the undeveloped drainage areas to the east and southeast. Construction of the detention basin could result in a reduction of 15.4% to 16.3% in the amount of storm water runoff received by the subject drainage swale. The improved ditch capacity (171 cfs) would be slightly higher than the 10-year discharge resulting from the construction of the proposed detention basin.

In addition to implementing either of the two above alternatives, it is recommended to expand the small swale located between the end of Christy Drive and the aforementioned drainage ditch. This should help improve local flooding problems during intense storms that cause the swale to overtop and flow toward/into the garage at 502 Christy Drive.

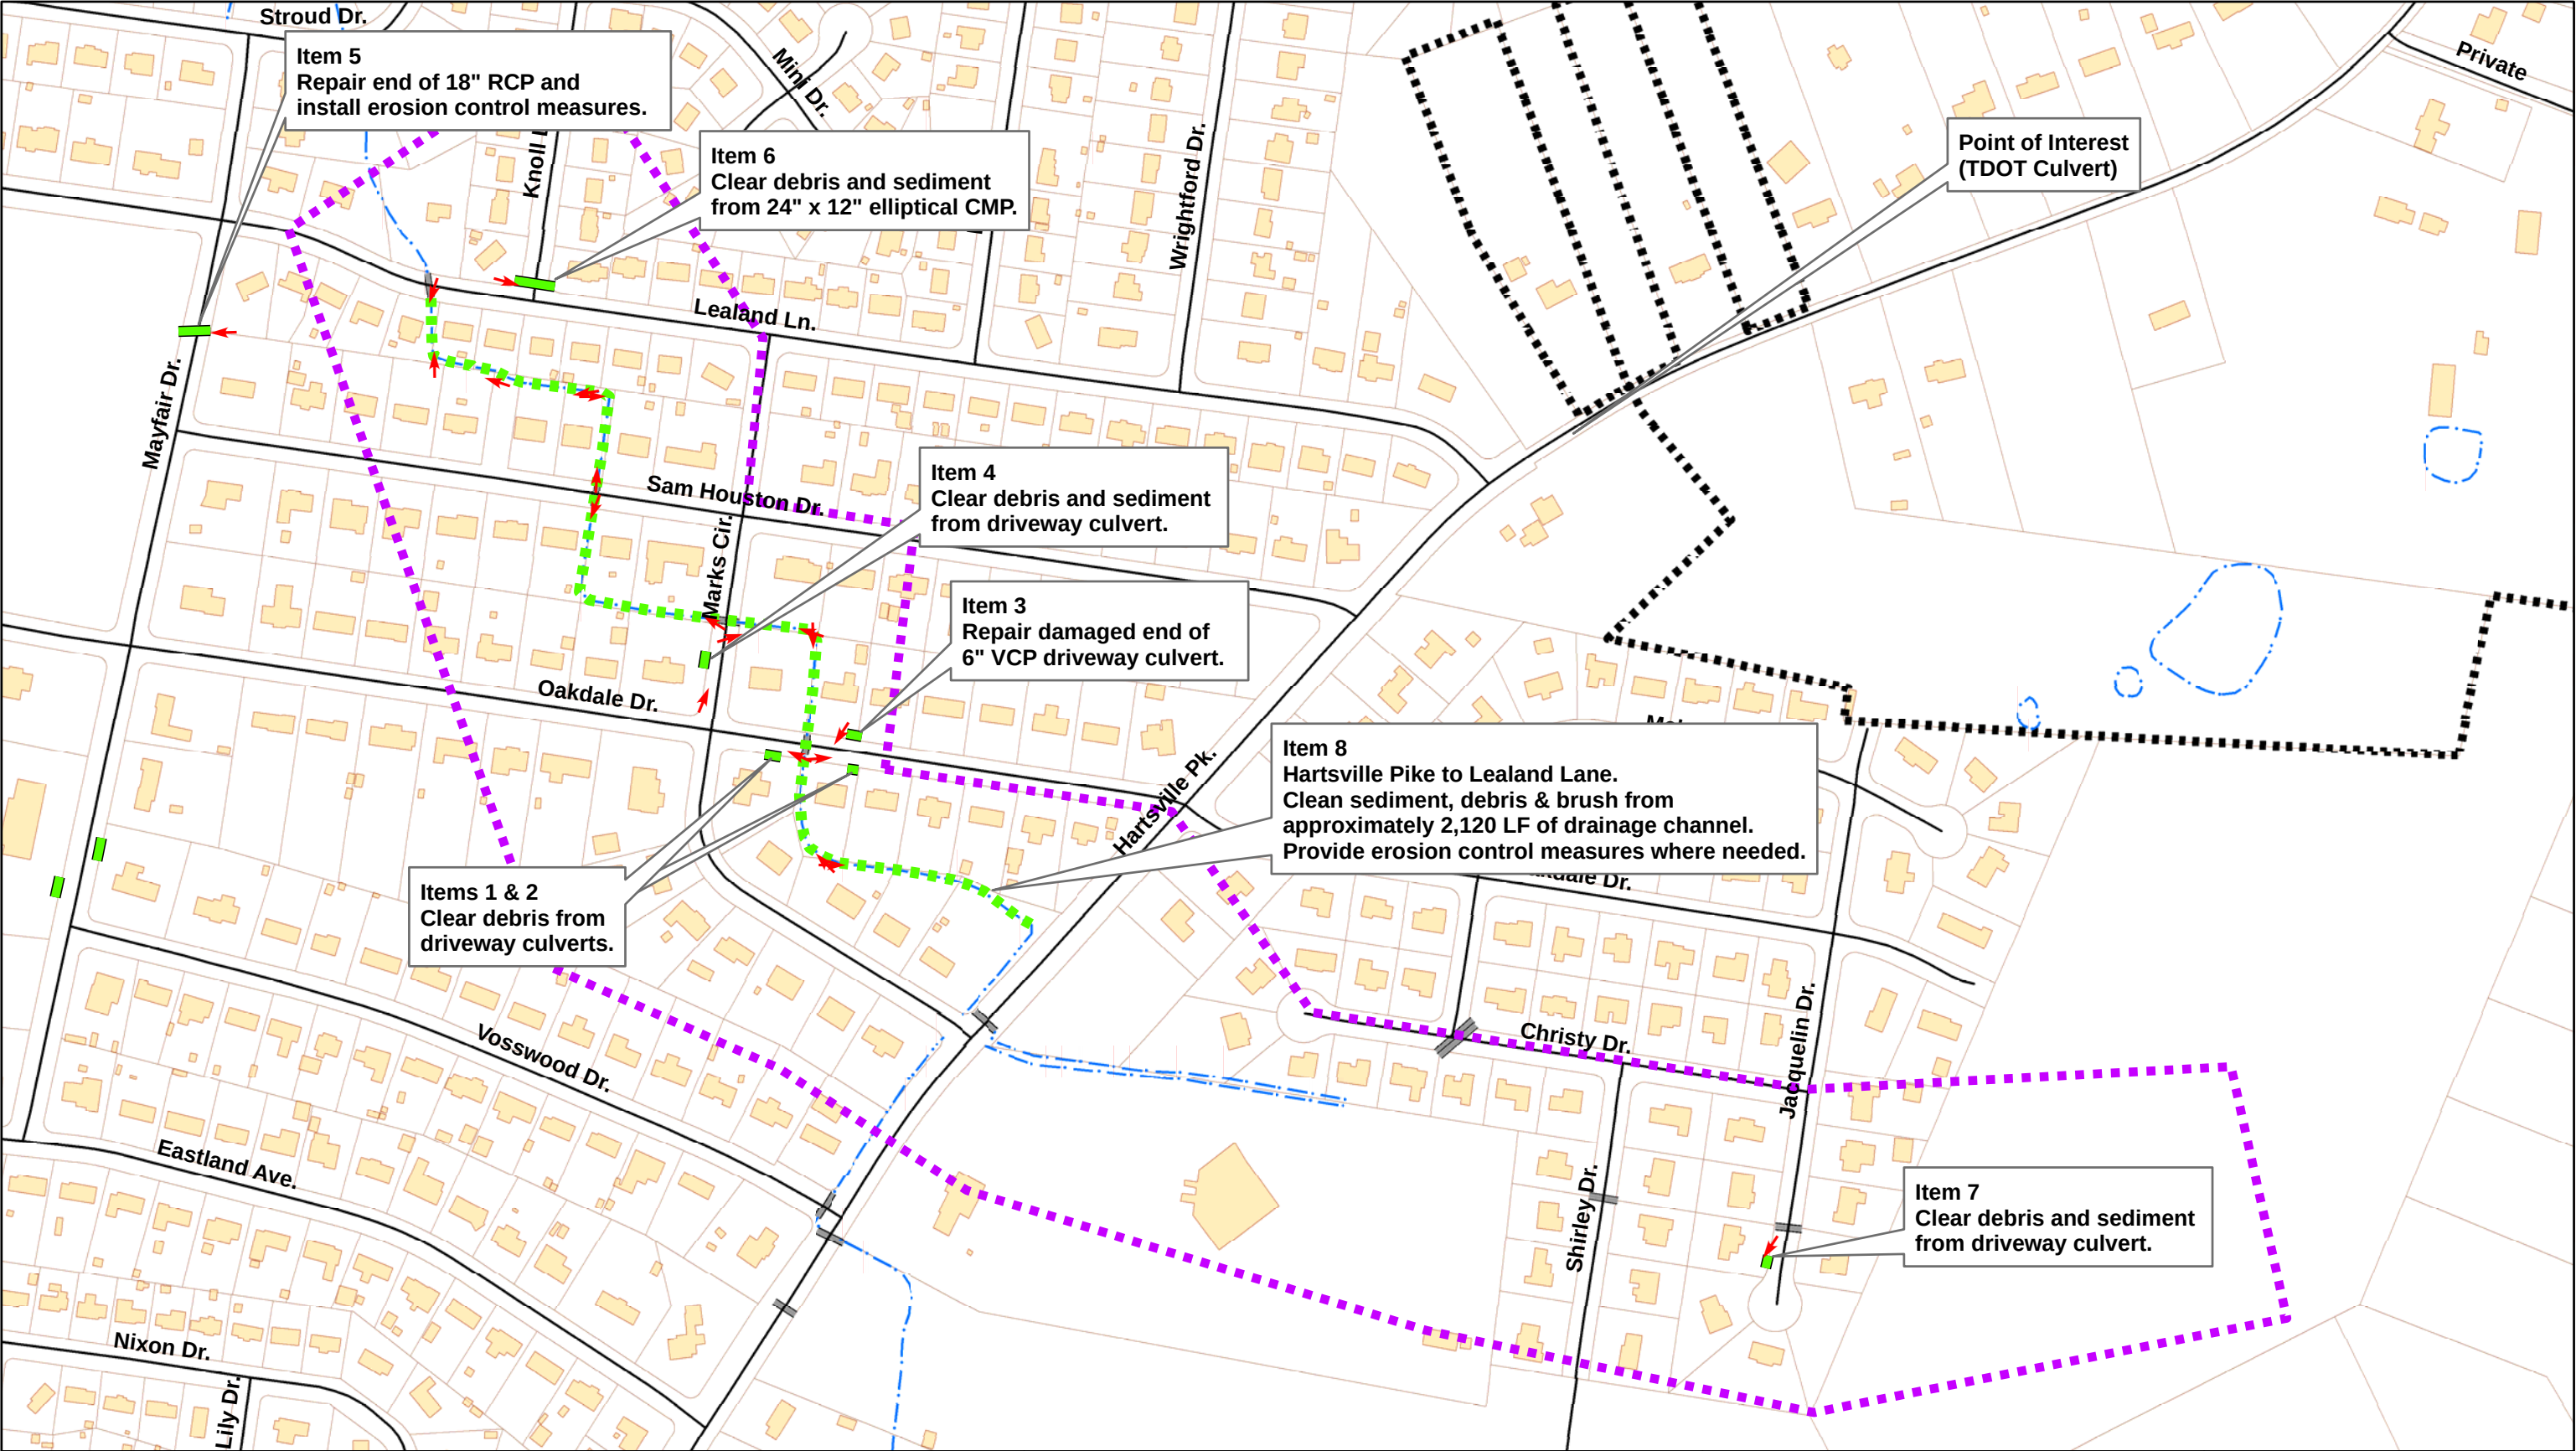
In addition to implementing structural improvements described above, numerous routine maintenance issues were found throughout the study area during the field reconnaissance. Examples of required maintenance items include removing sediment buildup from culvert inlets, removing excess vegetation and debris from culvert inlets, and repairing damaged culvert end sections. While correcting these deficiencies will not solve flooding problems, it is critical to correct them sooner, rather than later, so that the drainage system can function as designed and conditions do not worsen, leading to possible flooding problems in the future. In addition, it is important to note that areas identified as requiring remediation should be regularly scheduled for maintenance by City crews to prevent future buildup of debris and sediment. A map showing locations identified as requiring maintenance is included as Figure 3. In addition, a document containing captioned photographs of each maintenance location is included as Appendix A, with locations and orientations of each photograph indicated with red arrows on Figure 3. A preliminary cost estimate for the proposed maintenance items are shown below:

Although many steps will have to be taken prior to implementing structural drainage improvements in the study area, including survey and design; the infrastructure maintenance items discussed above and shown in Figure 3 can be performed by City crews immediately.

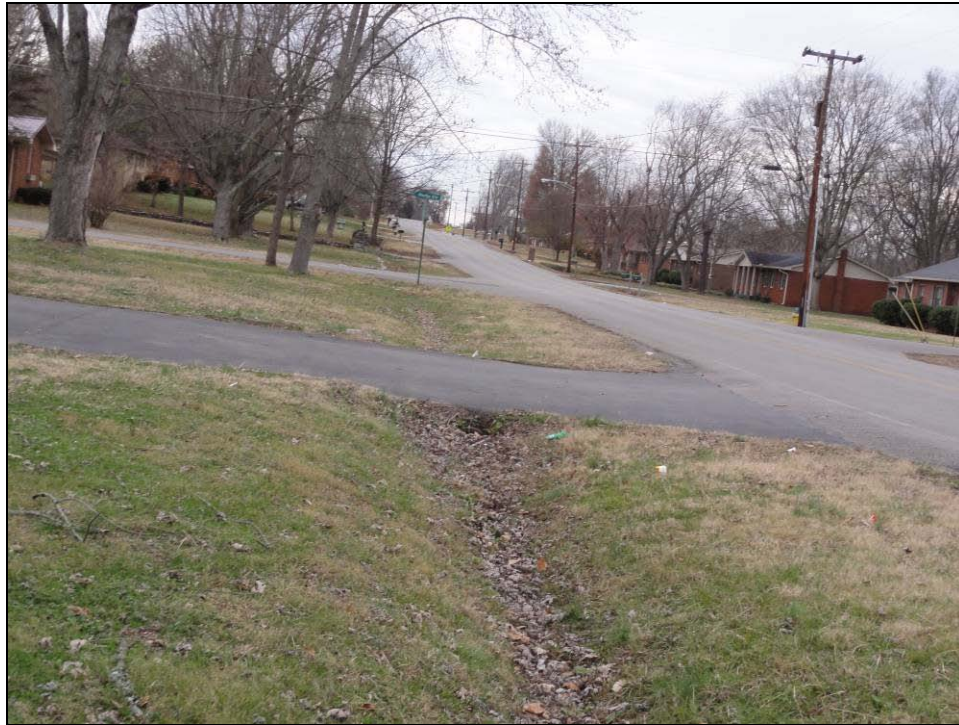
**Item 1 – 107 Marks Cir. Clear debris from driveway culvert. Culvert is located on Oakdale Dr.  
Picture 1797.**

| <b>Infrastructure Maintenance Items (See Figure 3)</b> | <b>Preliminary Estimated Project Cost</b> |
|---|---|
| 1. Debris/sediment removal from culvert ends at five locations (Items 1, 2, 4, 6, 7) | \$ 2,500.00 |

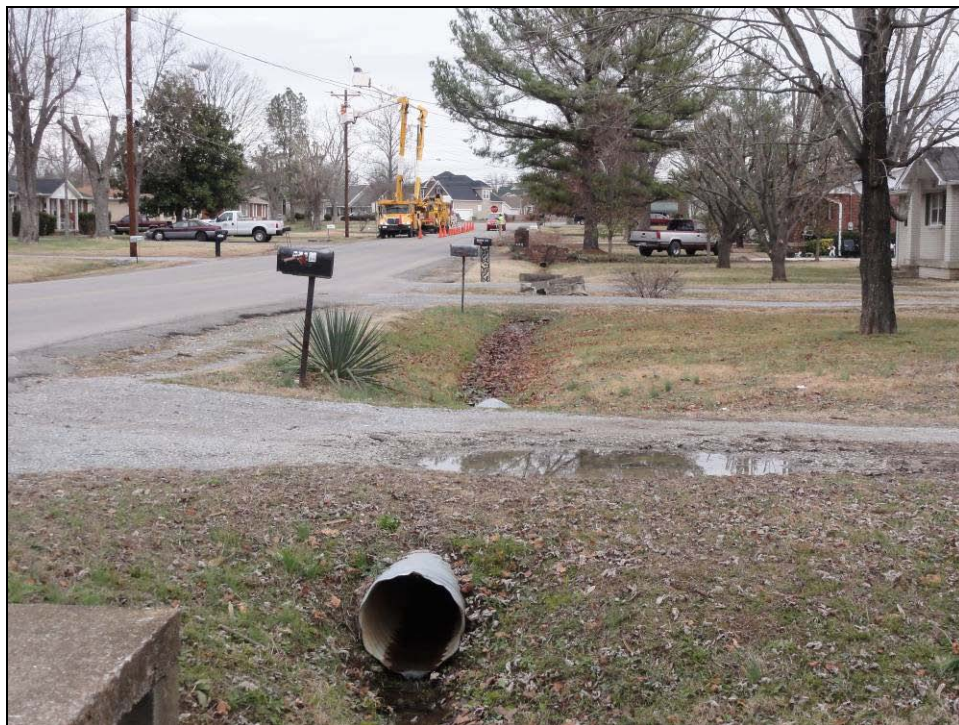
**Item 2 – 418 Oakdale Dr. Clear debris from driveway culvert (shown in background). Picture 1796.**

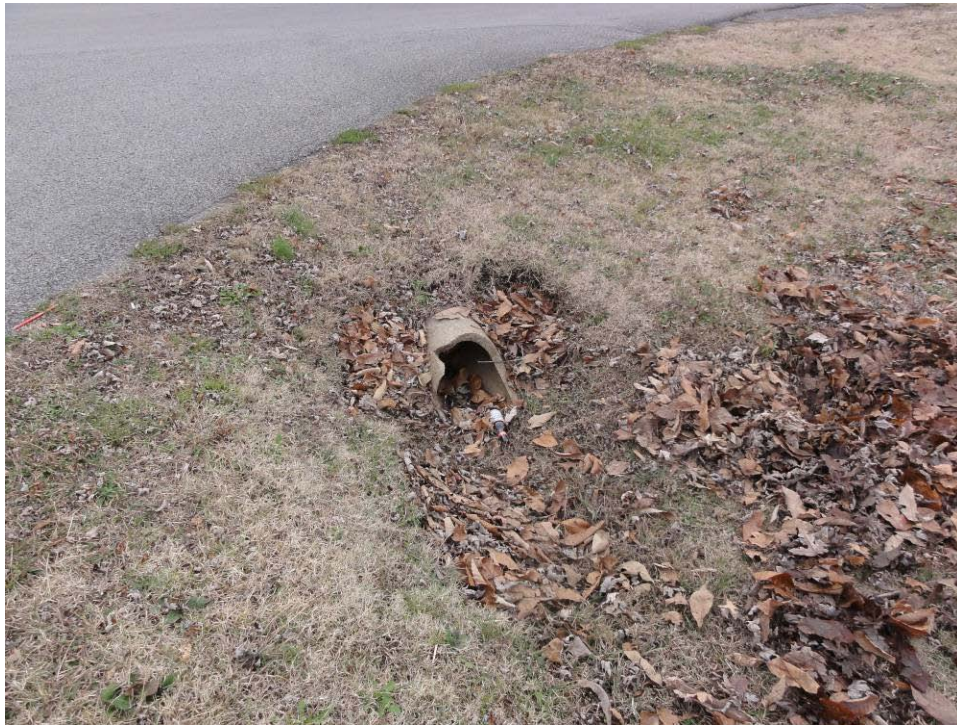
**Item 3 – 421 Oakdale Dr. Repair damaged end of 6” VCP driveway culvert. Picture 1808.**

| <b>Infrastructure Maintenance Items (See Figure 3)</b> | <b>Preliminary Estimated Project Cost</b> |
|---|---|
| 2. Culvert end repair at two locations (Items 3 and 5) | \$ 2,000.00 |

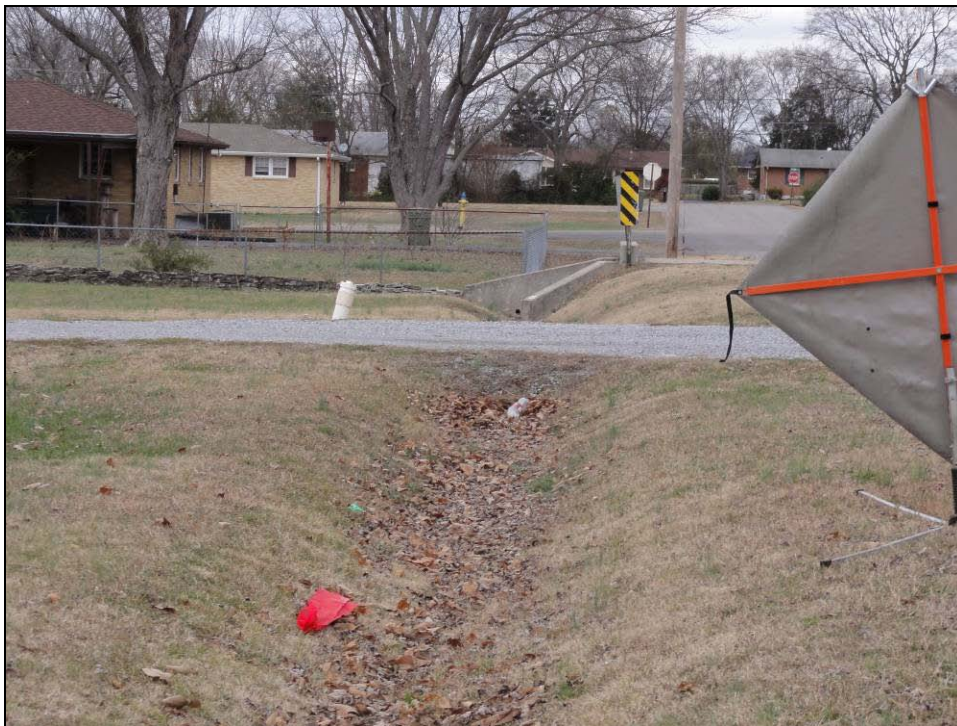
**Item 4 – 417 Oakdale Dr. Clear debris and sediment from driveway culvert adjacent to Marks Cir. Picture 1809.**

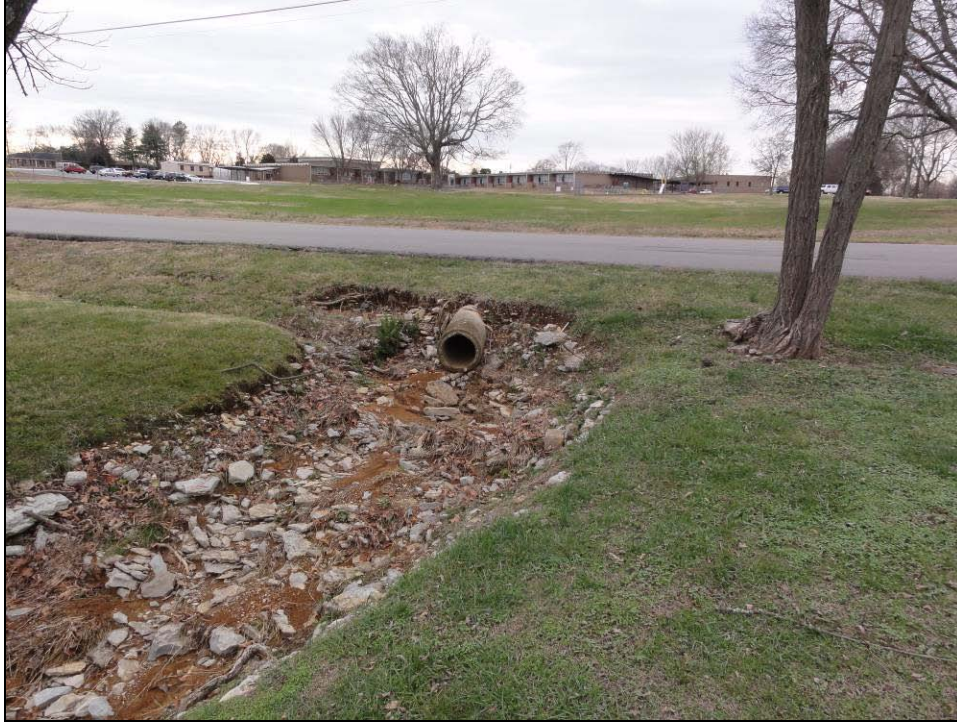
**Item 5 – Mayfair Dr. between Sam Houston Dr. and Lealand Ave. Repair end of 18” RCP and install erosion control measures. Picture 1827.**

| <b>Infrastructure Maintenance Items (See Figure 3)</b> | <b>Preliminary Estimated Project Cost</b> |
|---|---|
| 3. Install erosion control measures at one locations (Item 5) | \$ 400.00 |

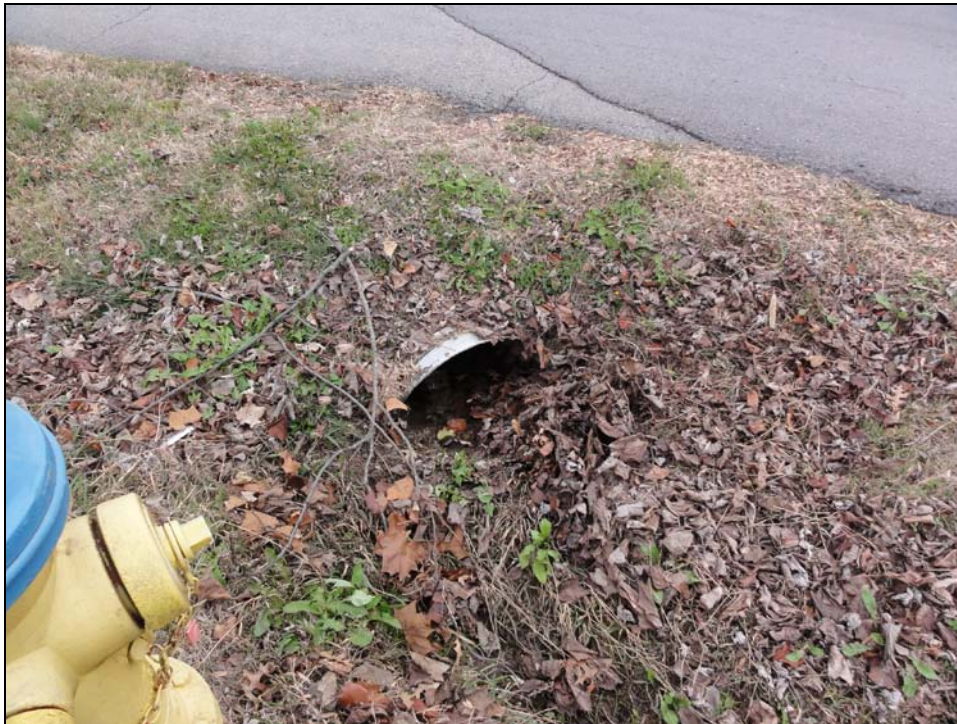
**Item 6 – Lealand Ln. and Knoll Ln. Clear debris and sediment from 24” x 12” elliptical CMP. Picture 1840.**

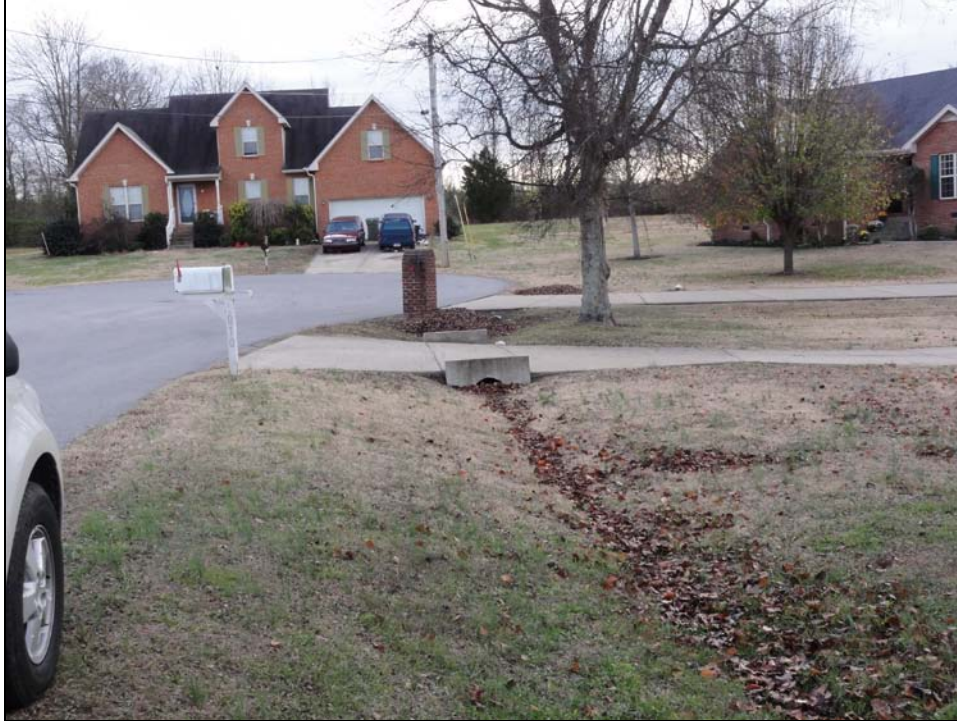
**Item 7 – 1010 Jacquelin Dr. Clear debris and sediment from driveway culvert. Picture 1840.**

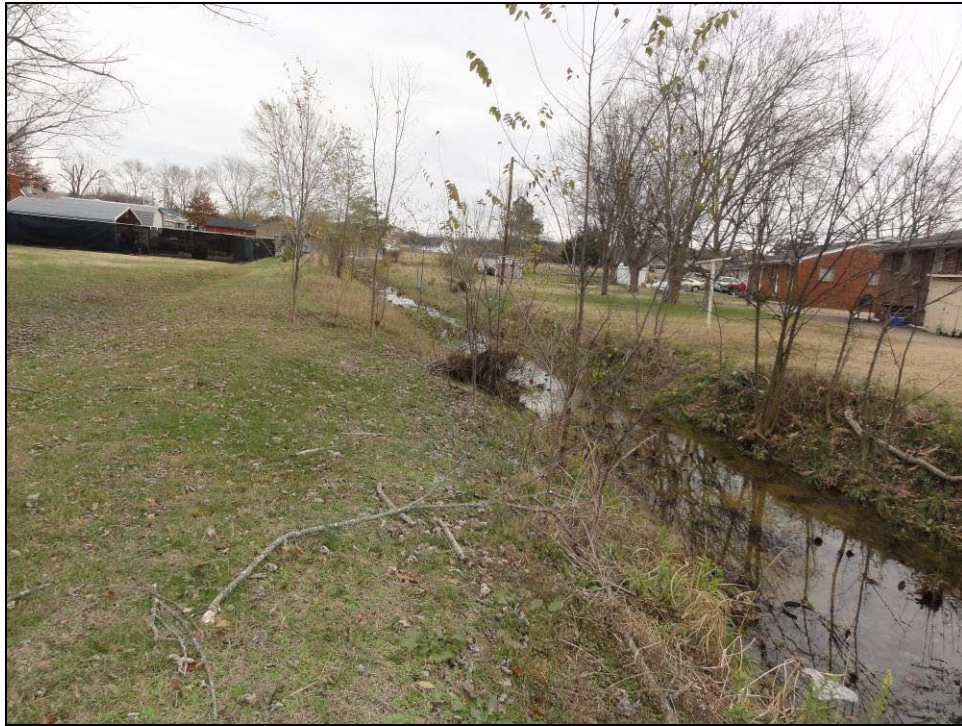
**Item 8 – Hartsville Pike to Lealand Lane. Clean sediment, debris and brush from approximately 2,120 LF of drainage channel. Provide erosion control measures where needed.**

**Behind 418 Oakdale Dr. Looking east towards Hartsville Pike Picture 1800.**

| <b>Infrastructure Maintenance Items (See Figure 3)</b> | <b>Preliminary Estimated Project Cost</b> |
|---|---|
| 4. Debris/sediment removal from channel at one locations (Item 8) – 2,120 L.F. | \$ 10,600.00 |

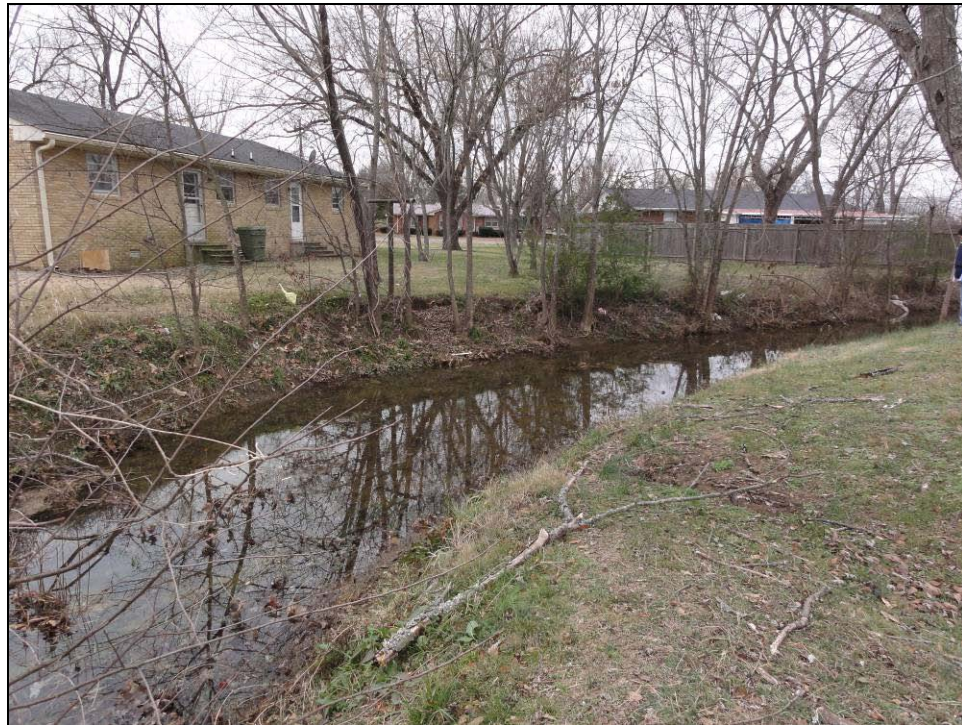
**Behind 418 Oakdale Dr. Looking northwest towards Oakdale Dr. Picture 1801.**

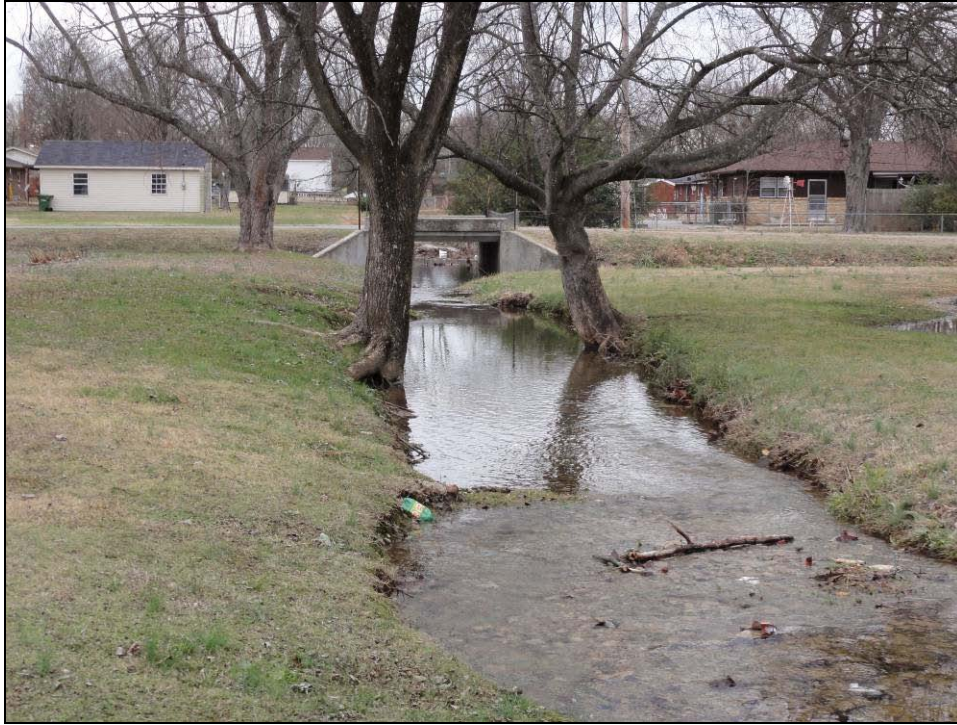
**Item 8 – Continued**

**Looking west towards Mark Cir. from behind 419 Oakdale Dr. Picture 1804.**

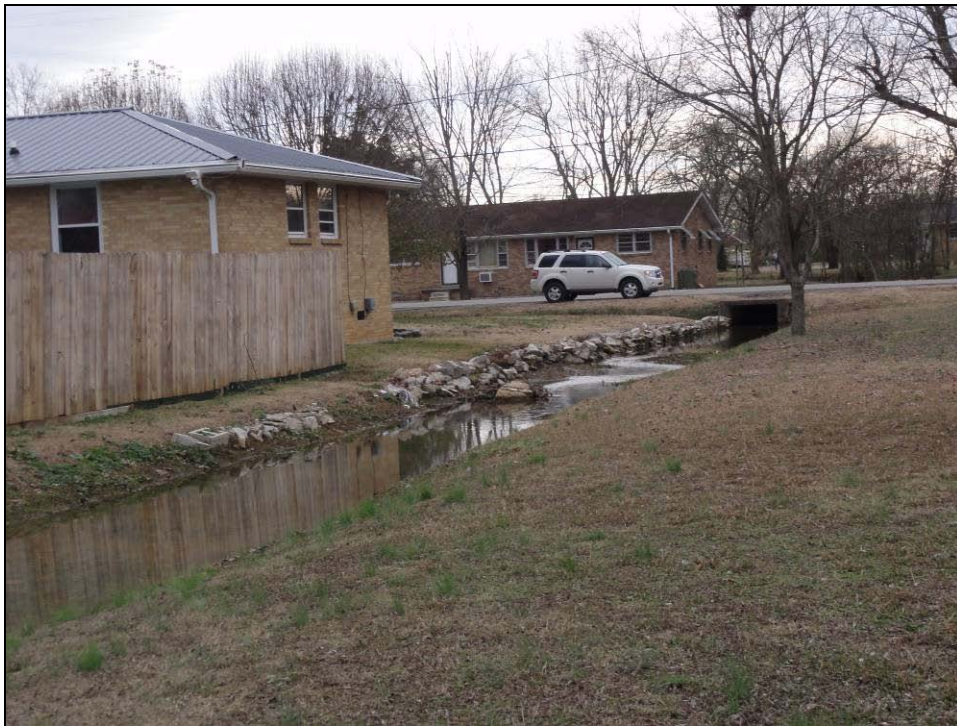
**Looking south towards Oakdale Dr. Picture 1805.**

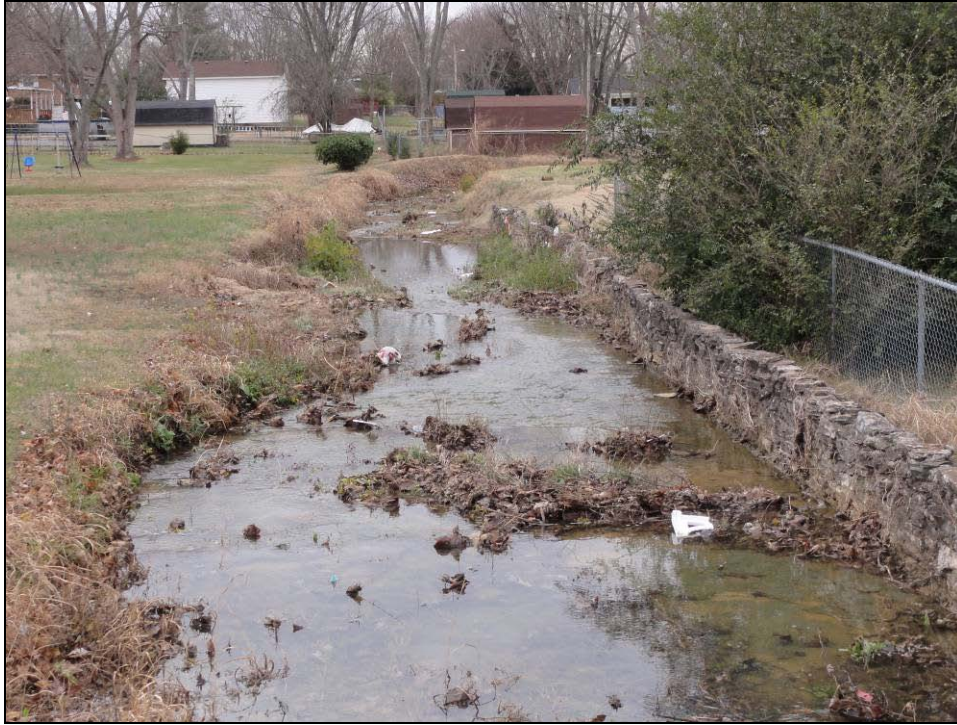
**Item 8 – Continued**

**Looking west from Marks Cir. Picture 1810.**

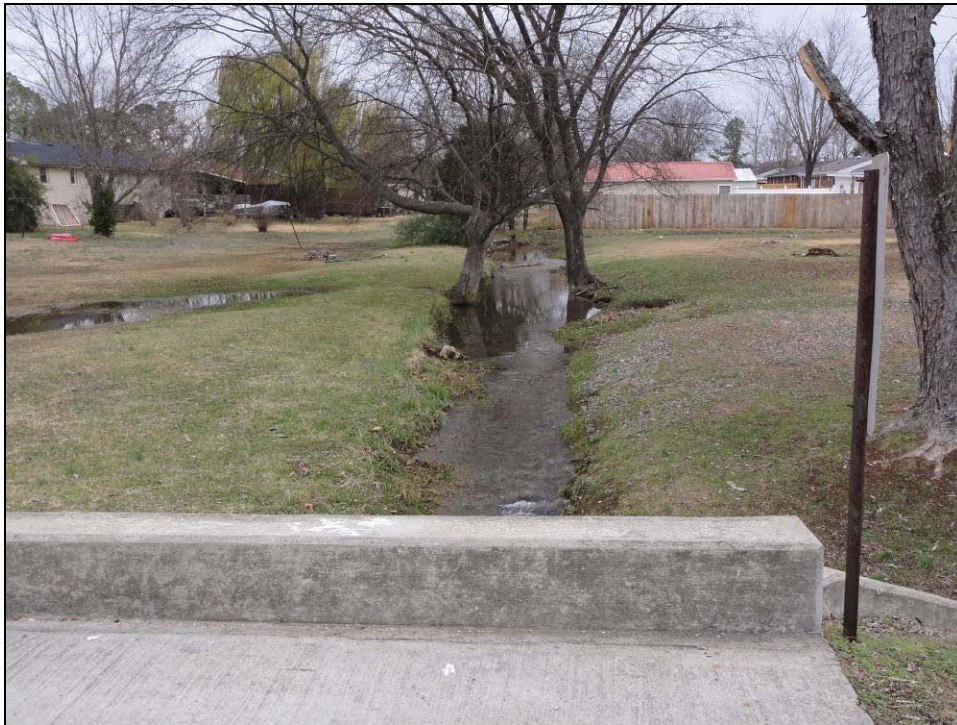
**Looking east from Marks Cir. Picture 1812.**

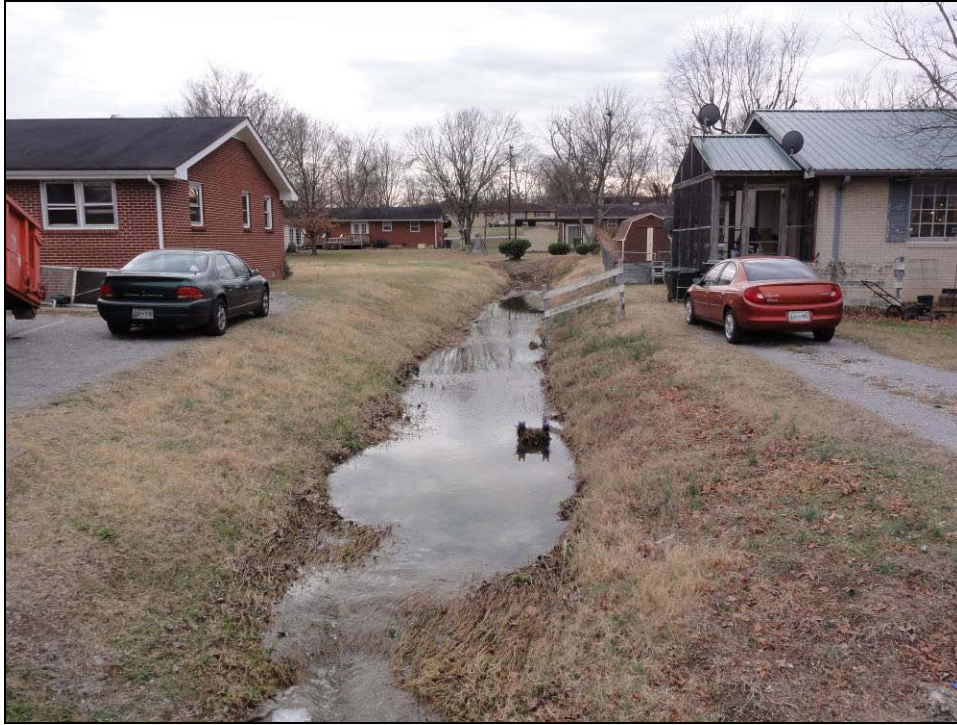
**Item 8 – Continued**

**Looking south from Sam Houston Dr. Picture 1814.**

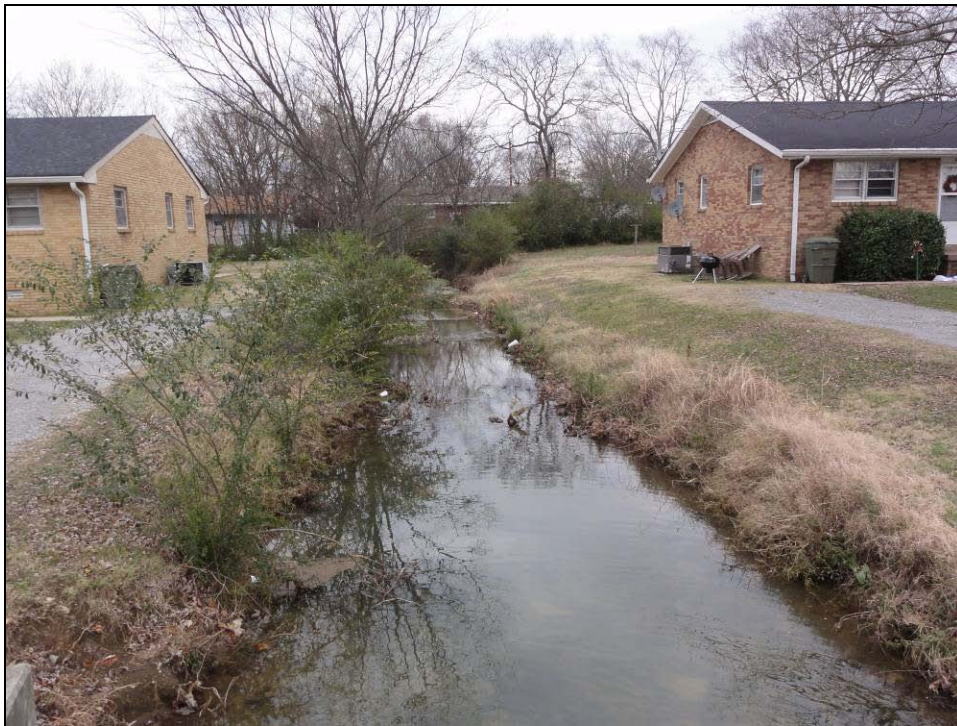
**Looking north from Sam Houston Dr. Picture 1815.**

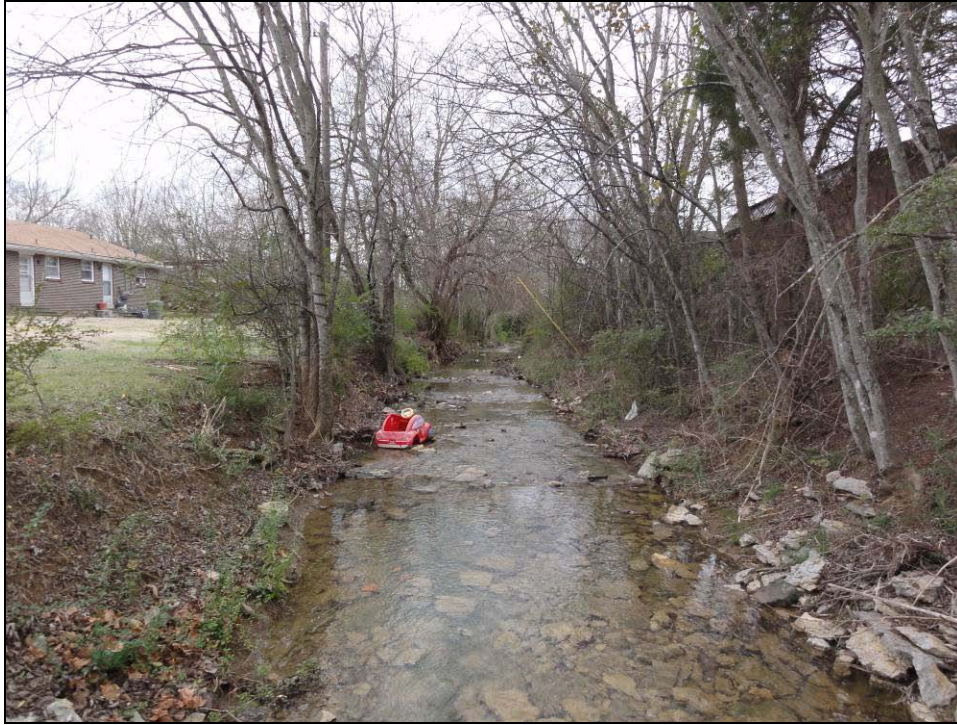
**Item 8 – Continued**

**Looking east from behind 413 Sam Houston Dr. Picture 1820.**

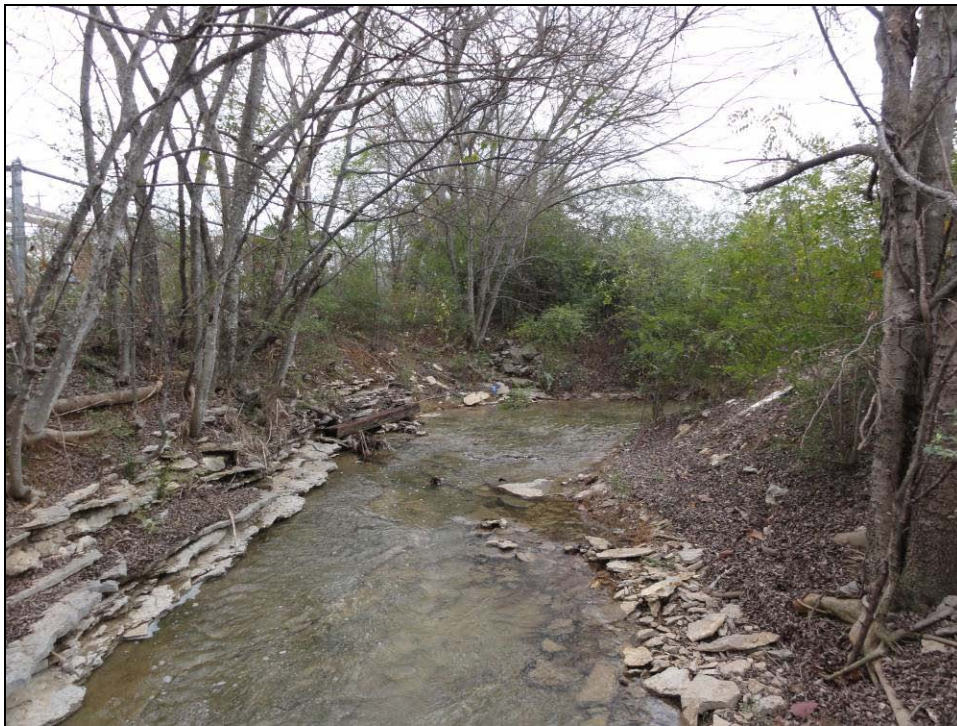
**Looking west from behind 413 Sam Houston Dr. Picture 1821.**

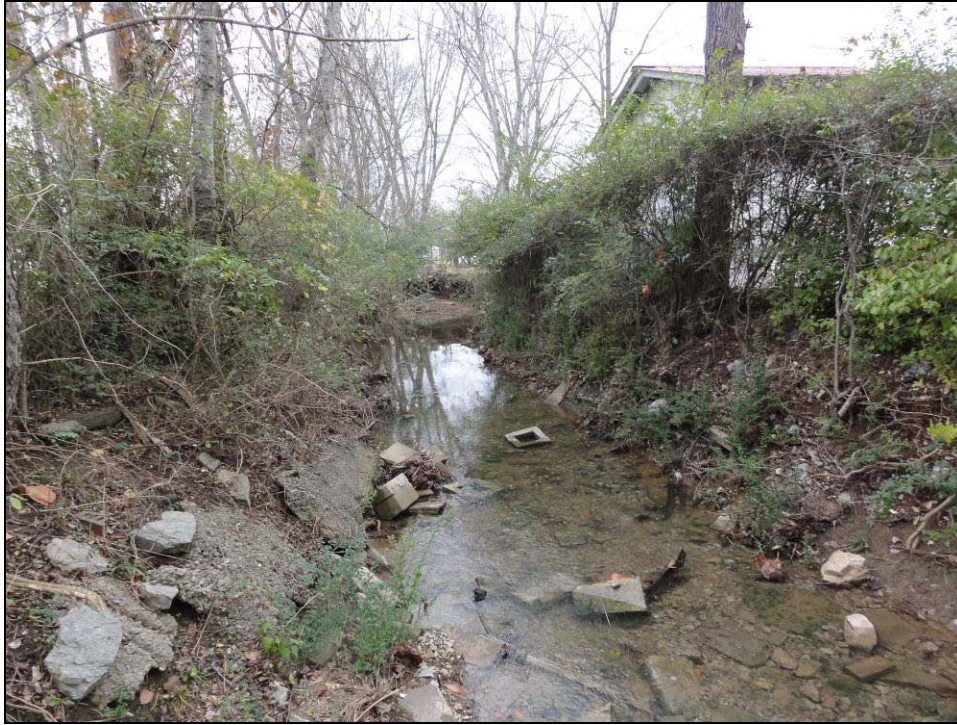
**Item 8 – Continued**

**Looking west from behind 409 Sam Houston Dr. Picture 1823.**

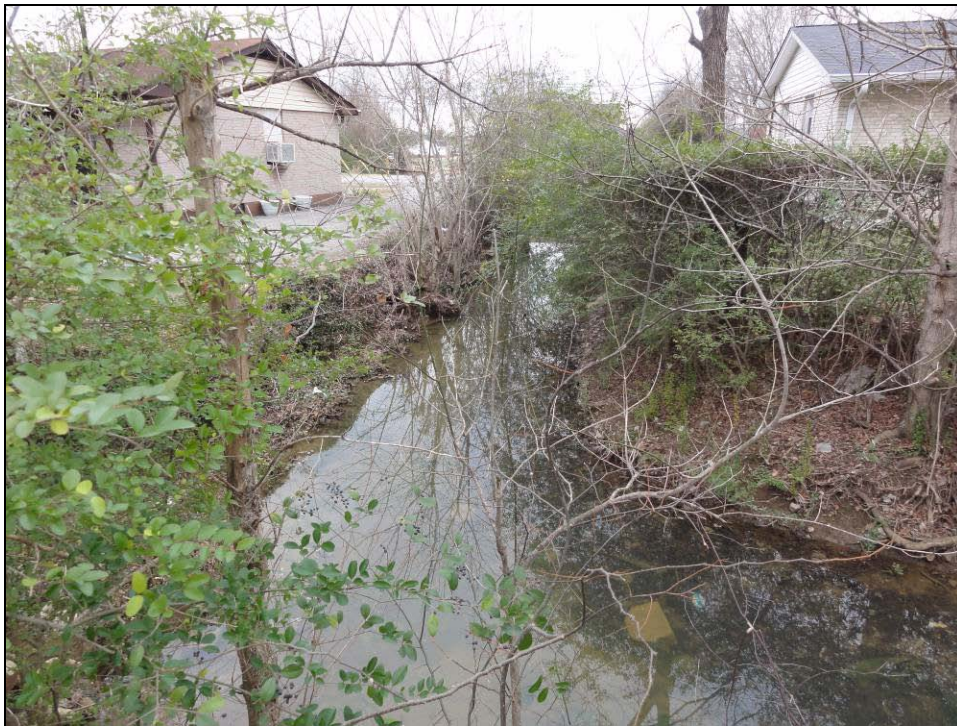
**Looking north towards Lealand Dr. Picture 1824.**

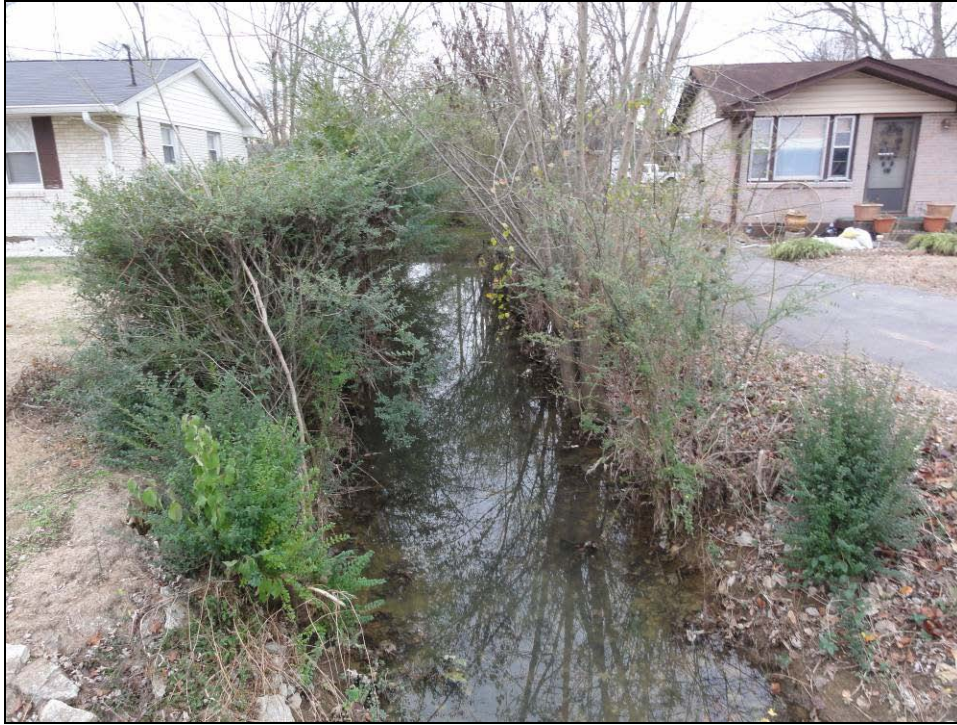
**Item 8 – Continued**

**Looking south from Lealand Ln. Picture 1833.**
