## ENGINEERING REPORT

### Richmond Hills Subdivision Drainage Improvements

**City of Lebanon Engineering Department**

**Neel-Schaffer, Inc.**

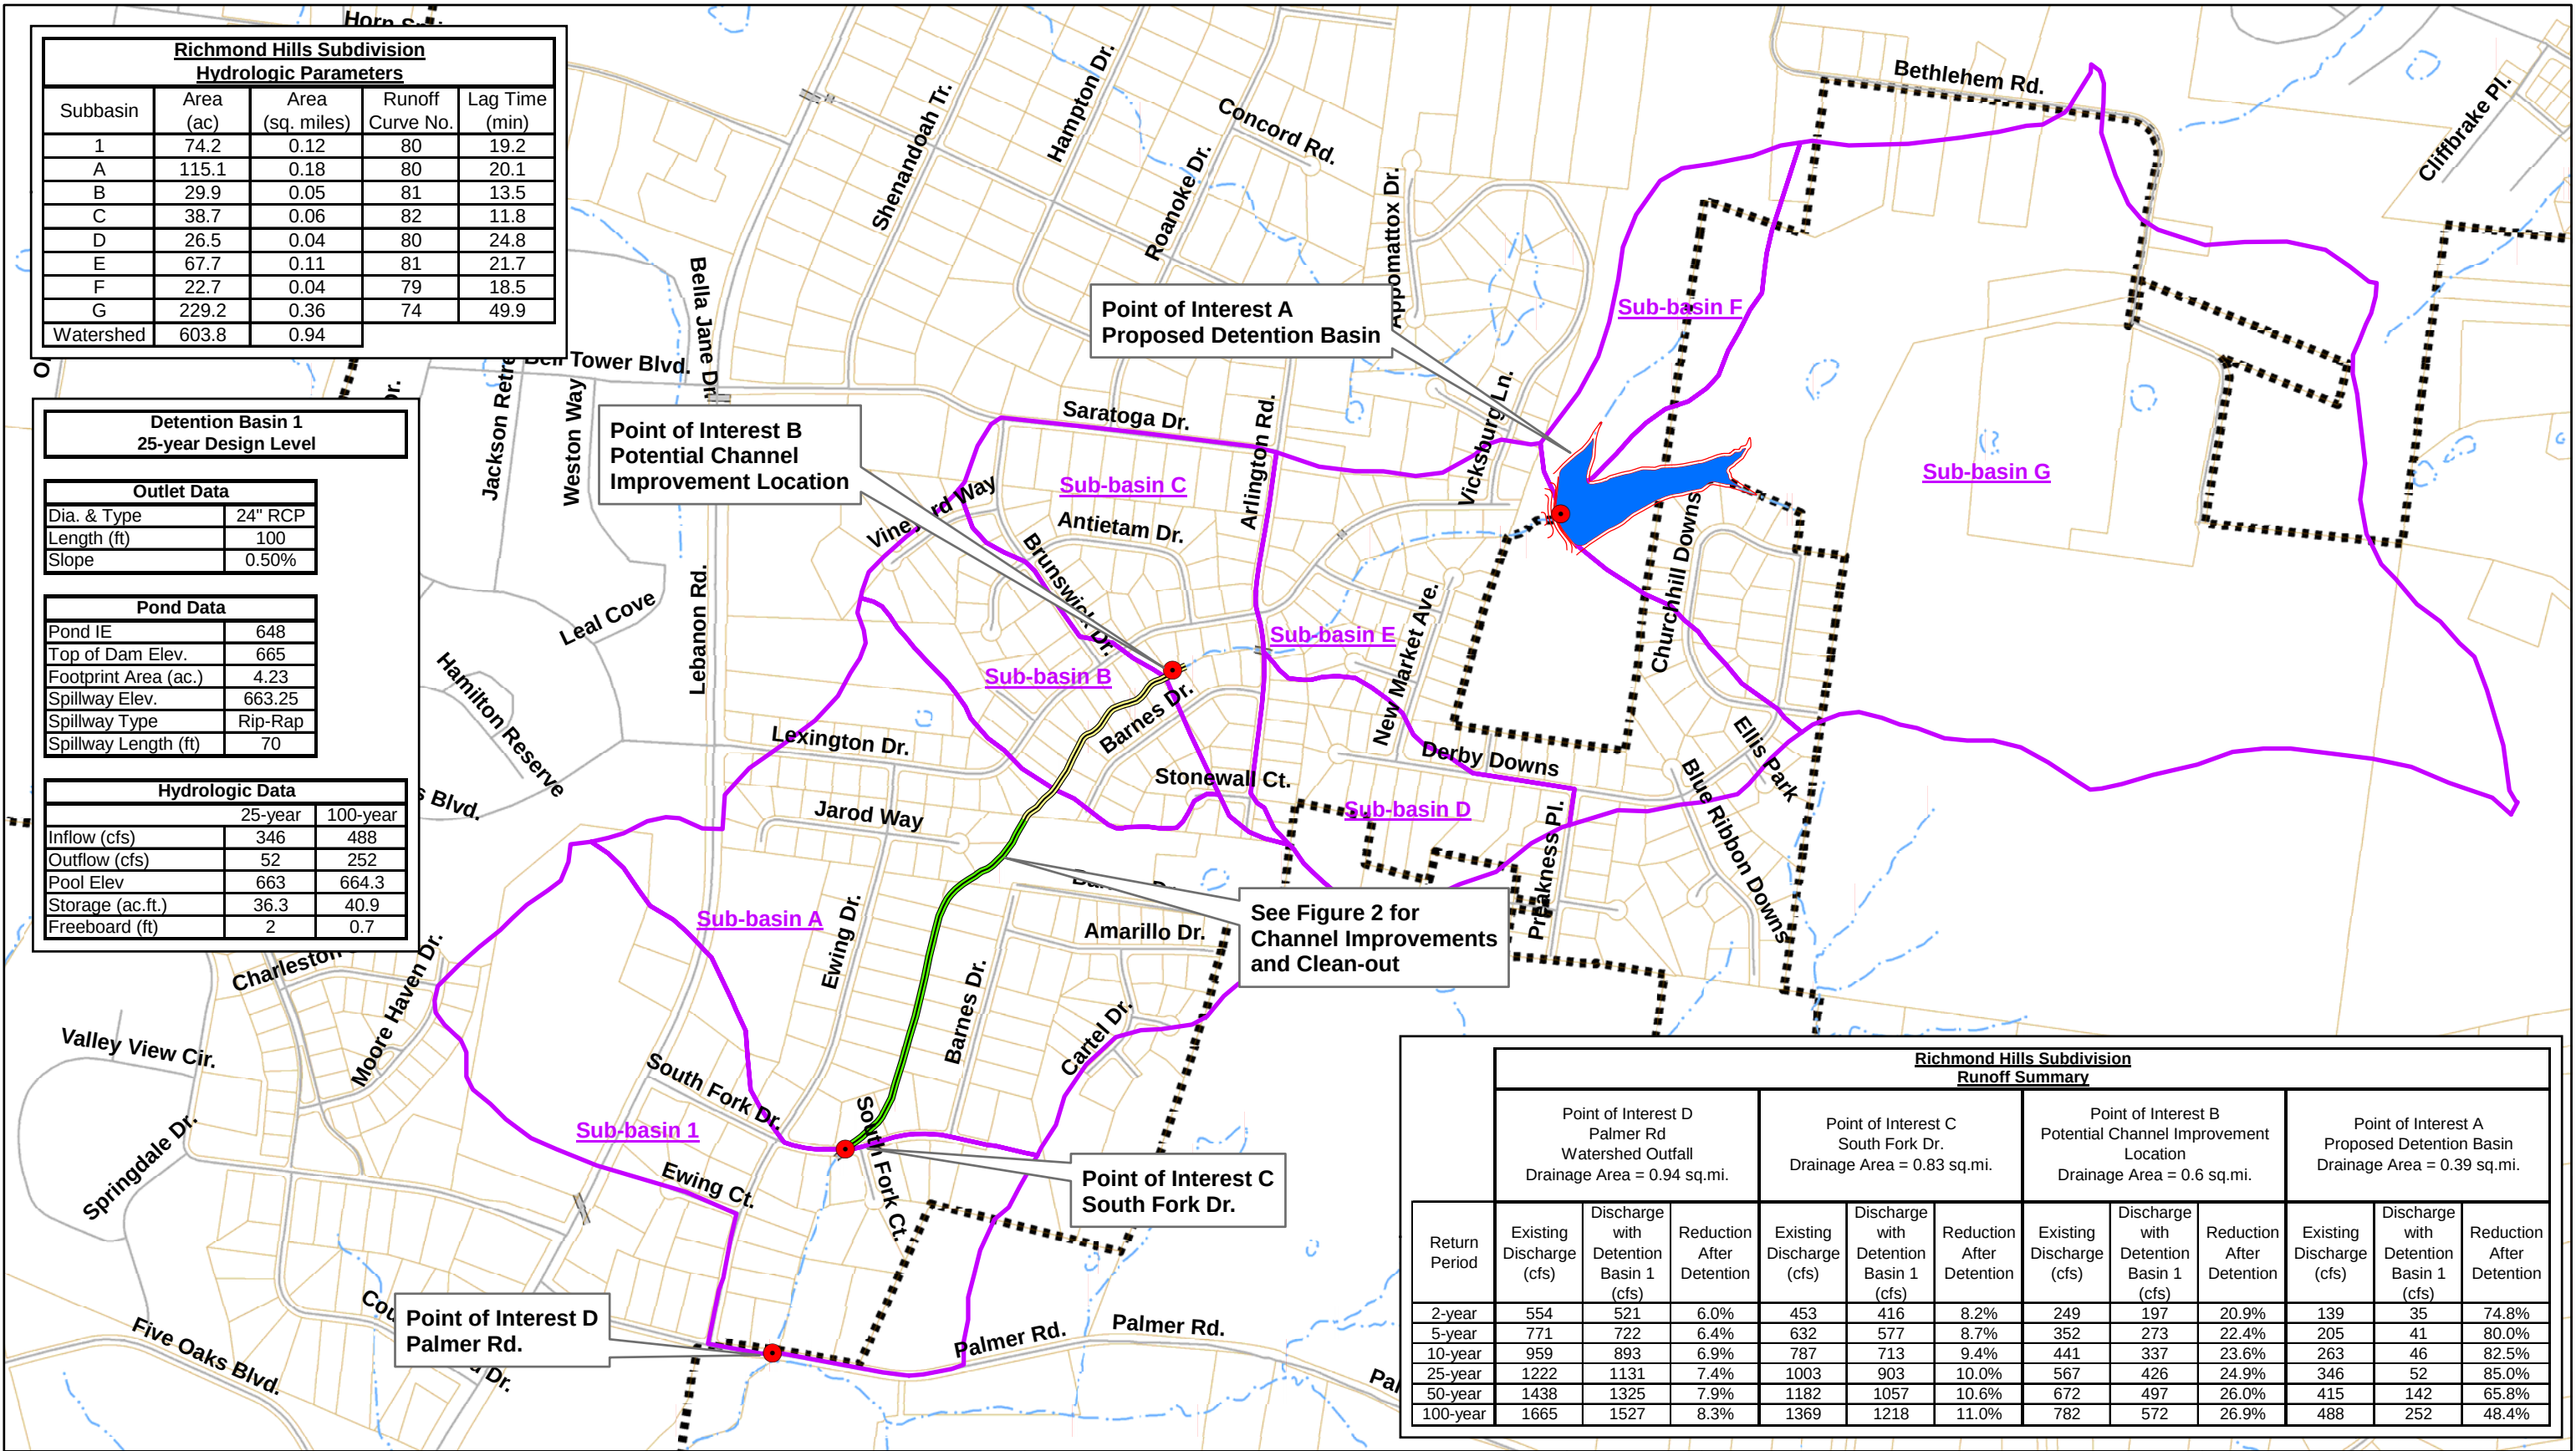
Figure 1

During the initial phases of the project, a location for a potential detention area was identified between the end of Lexington Drive and Churchhill Downs (See Fig. 1). A 4.2 acre detention basin, with a depth of 17 feet, was modeled to intercept flow from the upper reaches of the watershed. Such a detention basin would provide a reduction of almost 27% in the existing discharges at Barnes Drive. However, the detention basin alone would not be sufficient enough to solve all flooding issues at Barnes Drive. This potential detention basin is located on portions of two large, undeveloped tracts of land, and is partially outside of the current Lebanon City Limits. However, it is possible that when the landowner develops the tract in the future, the City may annex this area and negotiate with the owner to build a regional detention basin.

Hydrology  
Results

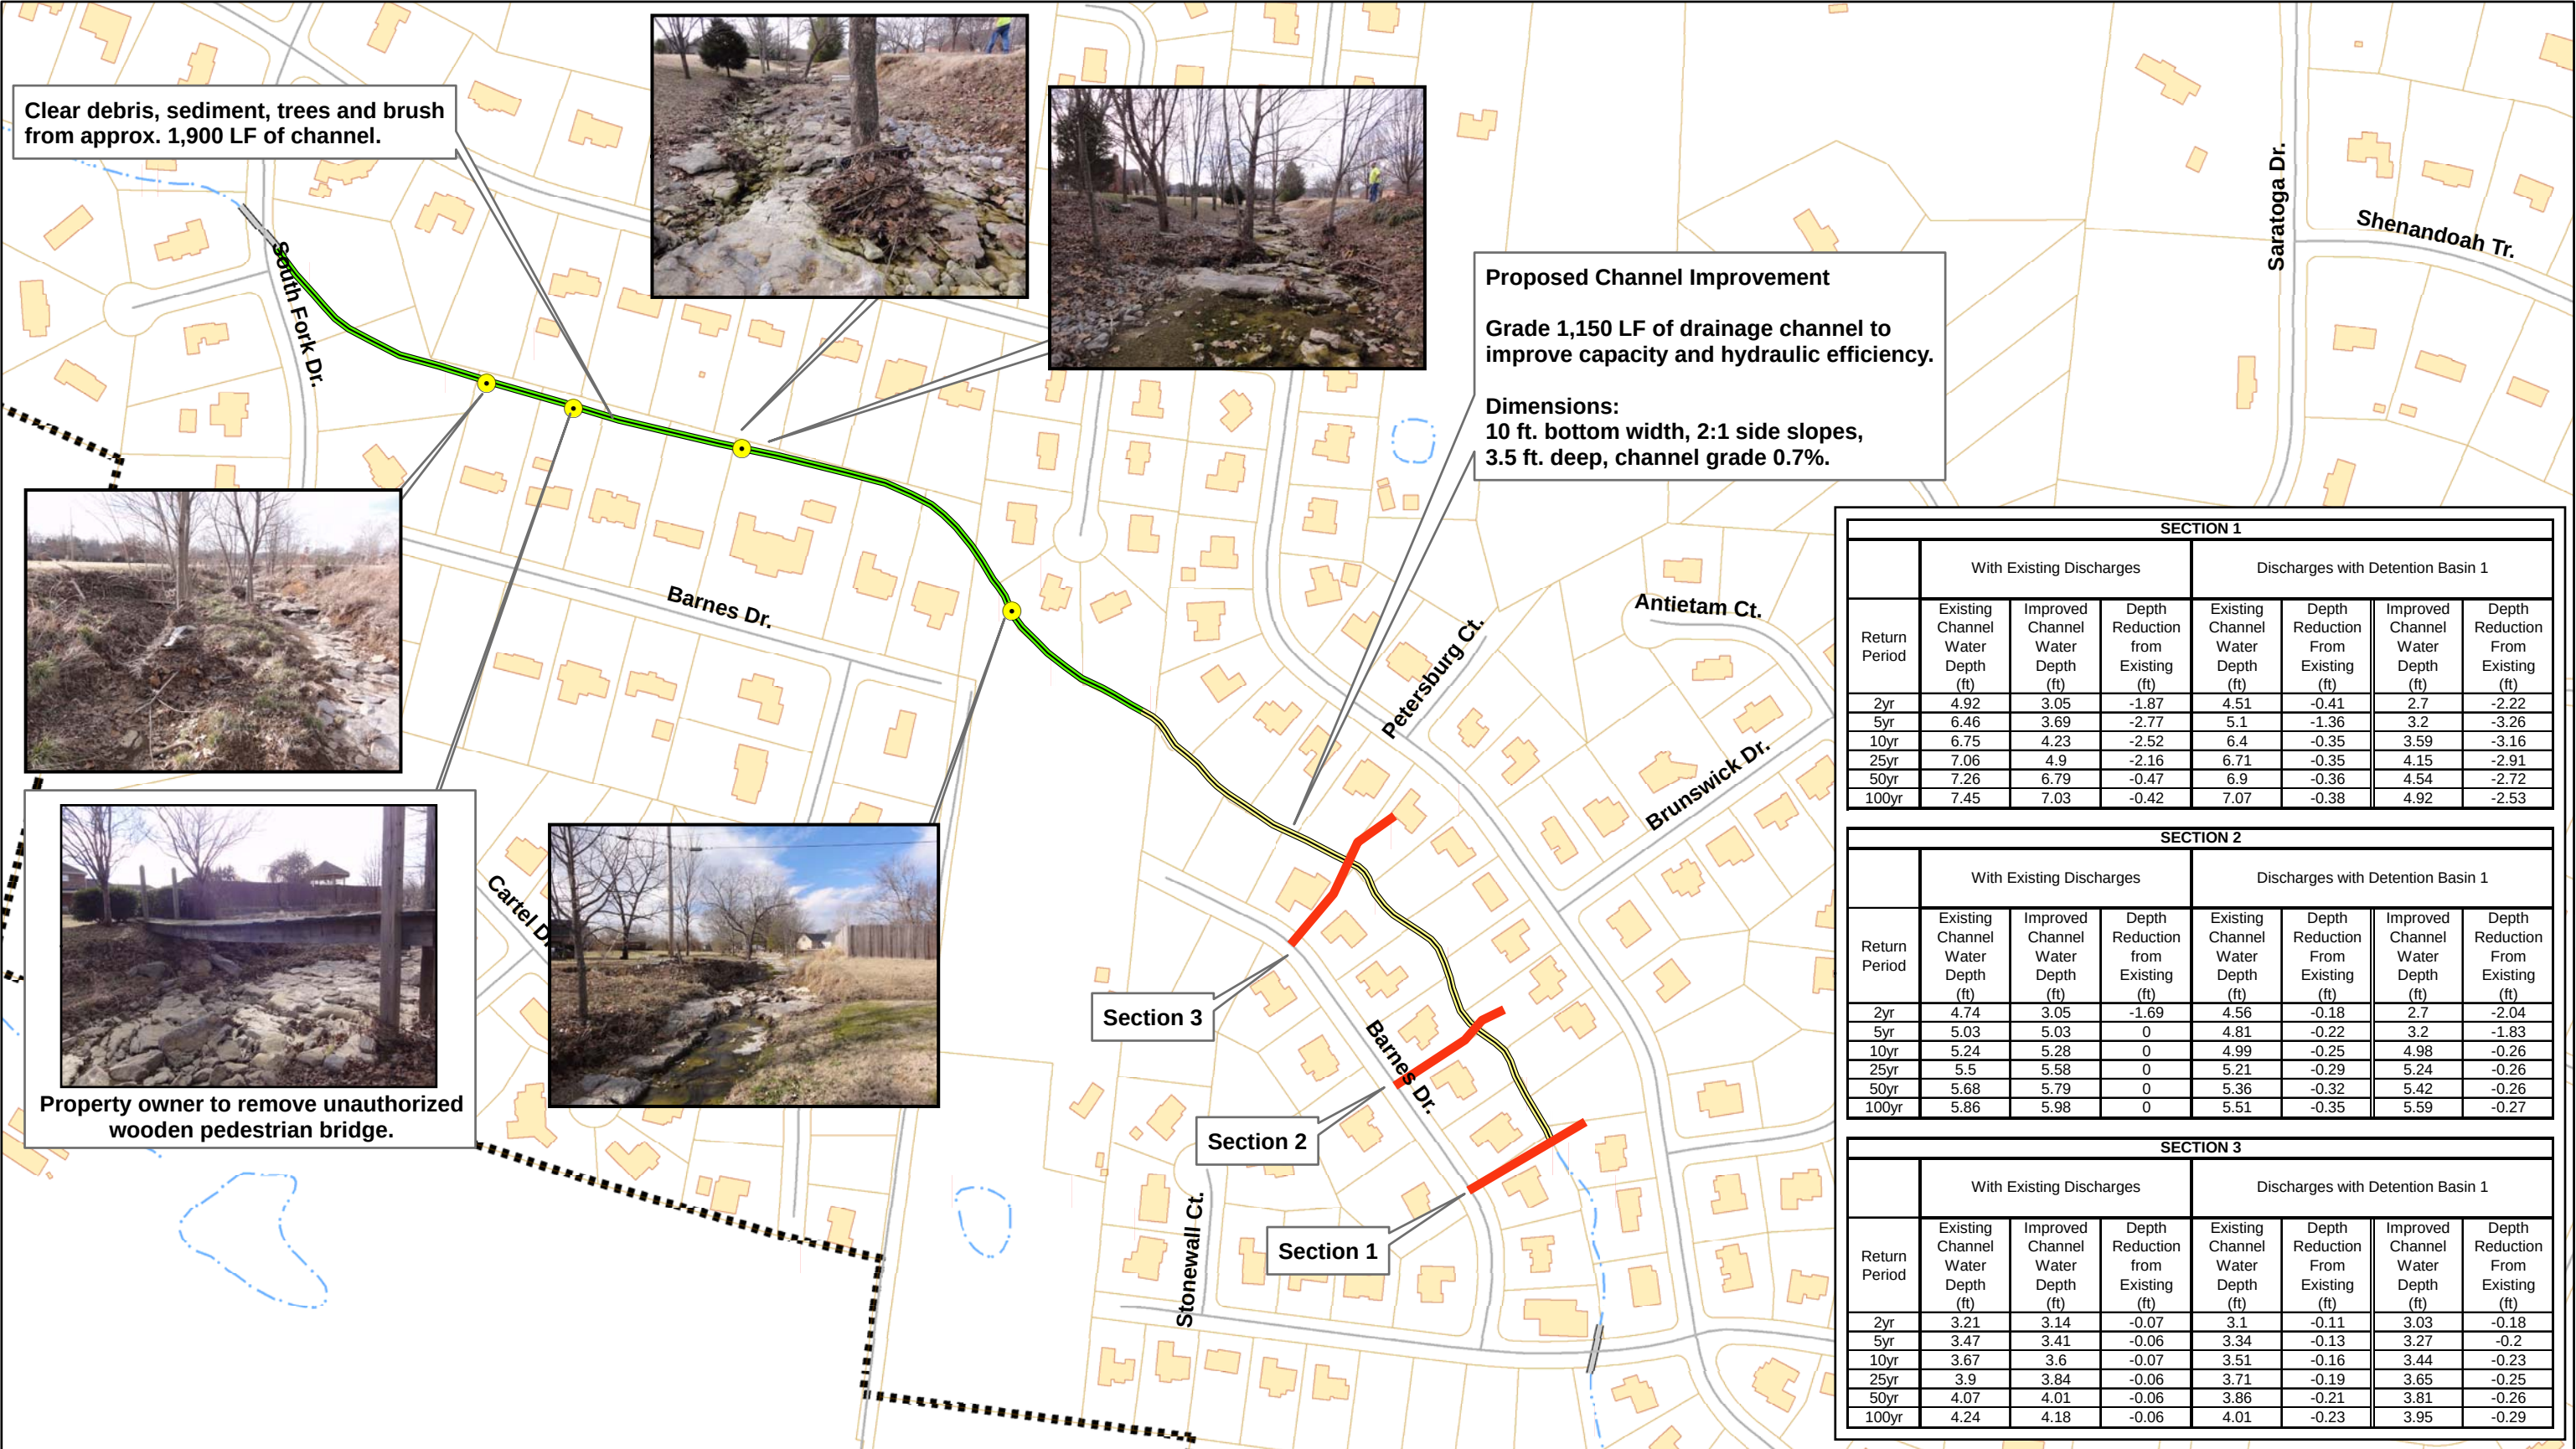
Figure 2

This technique shows that the existing 2-year flood elevation exceeds the elevation of the southern stream bank, and therefore flooding occurs along the properties on the south side of the creek in less than a 2-year storm. To evaluate the benefits of channel improvements, it was assumed that the improved channel would have a 10-foot bottom width, sides sloped of 2:1 (2 feet horizontal for every 1 foot vertical), and have a minimum depth of 3.5 feet. It was determined that the existing 2-year discharges would be contained within the improved channel (i.e. no flooding) by constructing this trapezoidal section for a length of 1,150 feet along the creek. The limits of proposed channel improvement are shown on Figure 2.

During the field reconnaissance it was noted that the channel from approximately the cul-de-sac of Barnes Drive northwestward to South Fork Drive was in need of maintenance. As shown on Figure 2, the channel contains numerous debris piles, sediment and rock deposits, and large diameter trees that are obstructing both normal and flood flows. As stated previously, backwater effects are not the sole cause of flooding along Barnes Drive. However, removing obstructions and cleaning sediment and debris from this reach of channel may yield a small improvement to the flooding depths upstream. In addition, many reaches of the channel banks are severely eroded between the end of Barnes Drive and South Fork Drive (see photographs on Figure 2). This is due in part to the large volumes of storm water runoff, but is also due to these obstructions causing turbulent conditions, which leads to stream bank erosion and scour.

In addition, an unauthorized wooden pedestrian bridge was found that causes a minor constriction during high flood flows (see photograph on Figure 2). This bridge should be removed at the expense of the property owner who installed it. While it is not a major contributor to flooding upstream, removing this manmade obstruction along with the other natural obstructions mentioned above may have small positive impacts to the upstream flooding situation along Barnes Drive.

Conceptual Drainage  
Improvement  
Recommendations

| <b>Structural Alternatives (See Figure 2)</b> | <b>Preliminary Estimated Project Cost</b> |
|---|---|
| Alternative 1: Grade 1,150 L.F. of main drainage channel to dimensions shown on Figure 2. Clear debris, sediment, trees and brush from approximately 1,900 L.F. of main drainage channel. | \$ 40,700.00 |

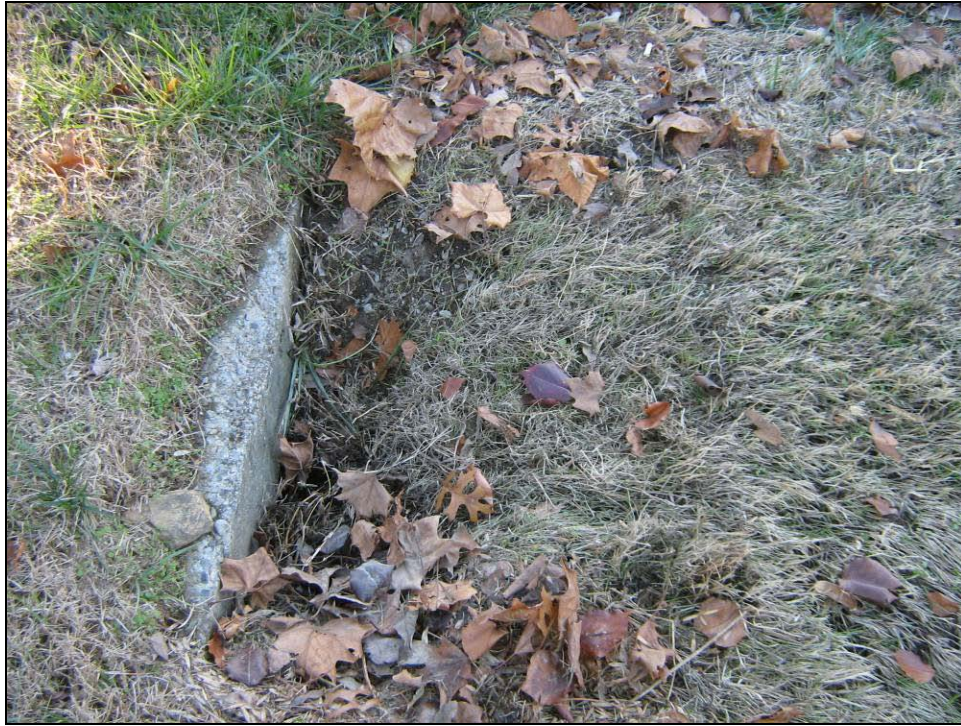
**Item 1 - 18" RCP on Lexington Dr. north of Vicksburg Ln. Clear debris and sediment from 18" RCP culvert. Picture 2312.**

| <b>Infrastructure Maintenance Items (See Figure 3)</b> | <b>Preliminary Estimated Project Cost</b> |
|---|---|
| 2. Debris/sediment removal from culvert ends at five locations (Items 1, 2, 3, 6, and 7) | \$ 2,500.00 |

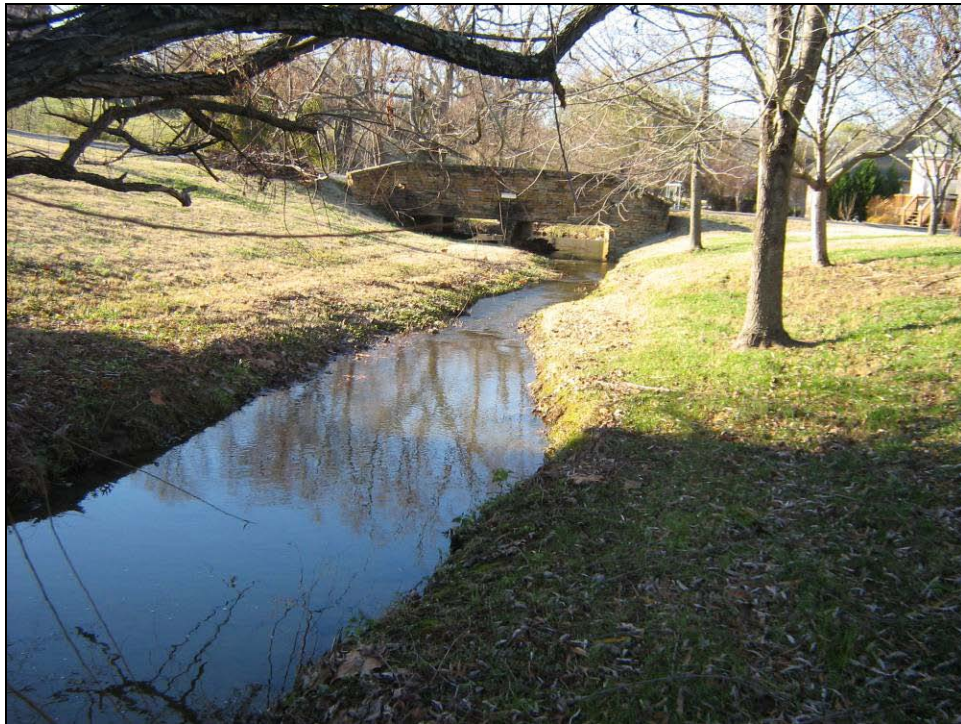
**Item 2 – Looking north at Letcher Ave. Clear sediment from west span of double 8' x 3' RCB. Picture 2318.**

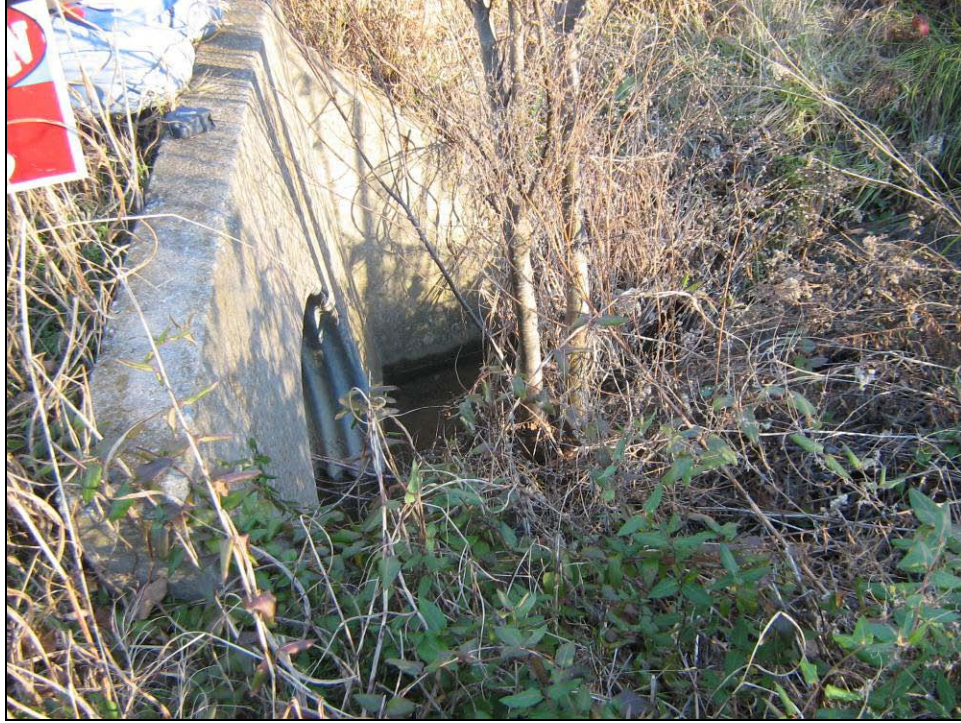
**Item 3 - Arlington Rd. and Barnes Dr. Remove brush from inlet of 36" CMP. Picture 2333.**

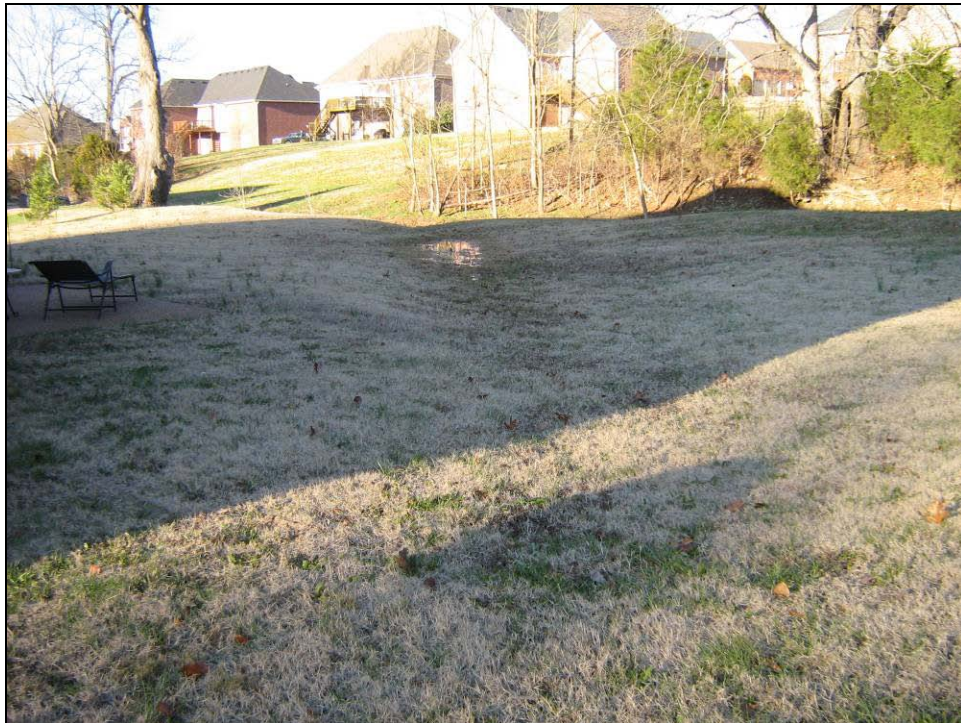
**Item 4 - 413 Barnes Drive. Grade ditch to drain into creek. Note standing water. Looking downstream (east) from Barnes Dr. Picture 2350.**

| <b>Infrastructure Maintenance Items (See Figure 3)</b> | <b>Preliminary Estimated Project Cost</b> |
|---|---|
| 1. Ditch grading at four locations (Items 4, 5, 8, and 9) – 750 L.F. | \$ 3,750.00 |

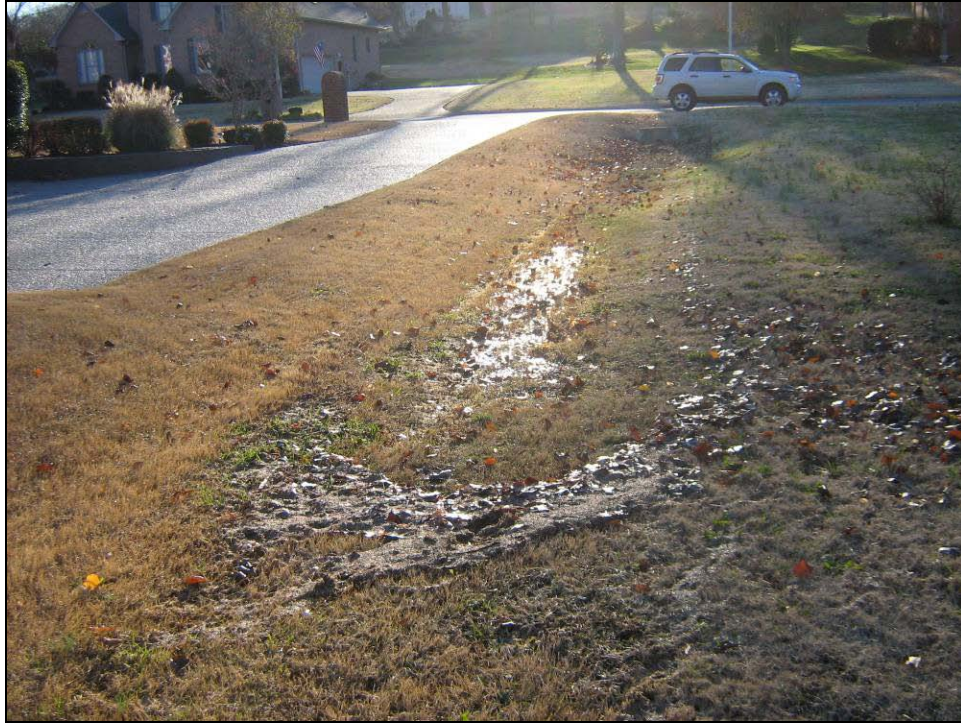
**Item 5 – 409 Barnes Drive. Grade ditch to drain into creek. Looking upstream (west) toward Barnes Drive. Note standing water and debris. Picture 2352.**

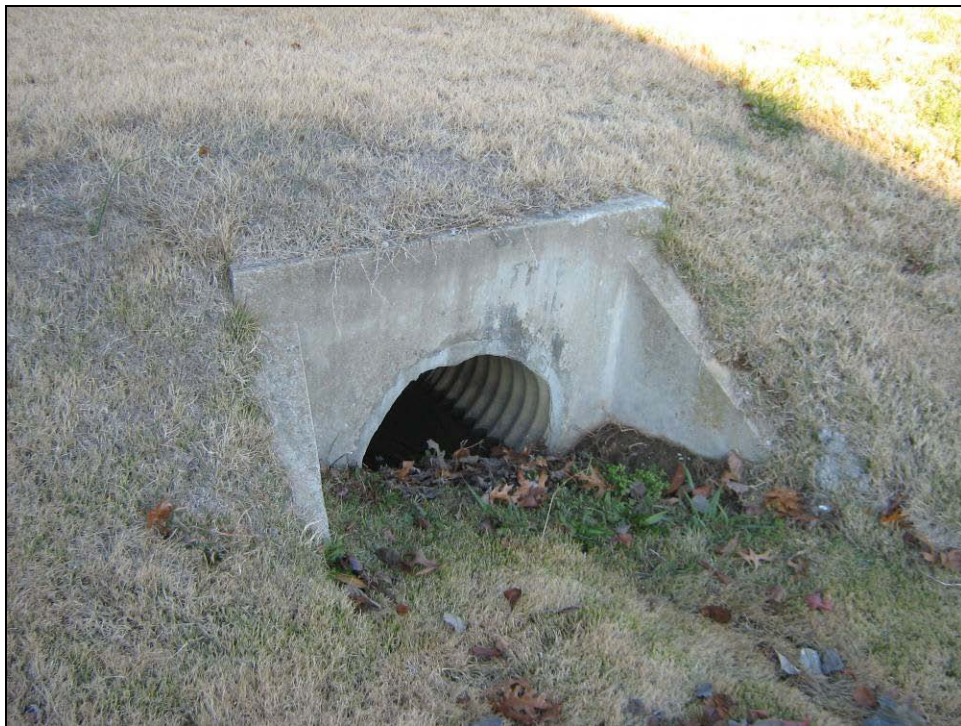
**Item 6 - Lexington Dr. north of Antietam Dr. Clean silt from 36" CMP outlet. Picture 2368.**

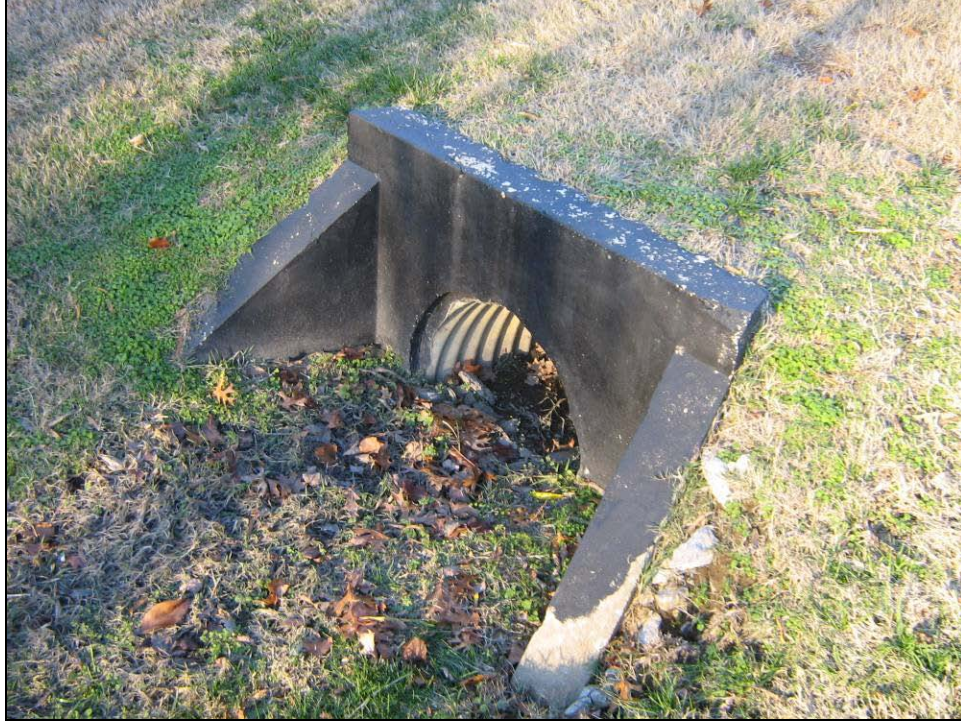
**Item 7 - Lexington Dr. at Brunswick Dr. Clean out silt at outlet of 18" CMP. Picture 2370.**

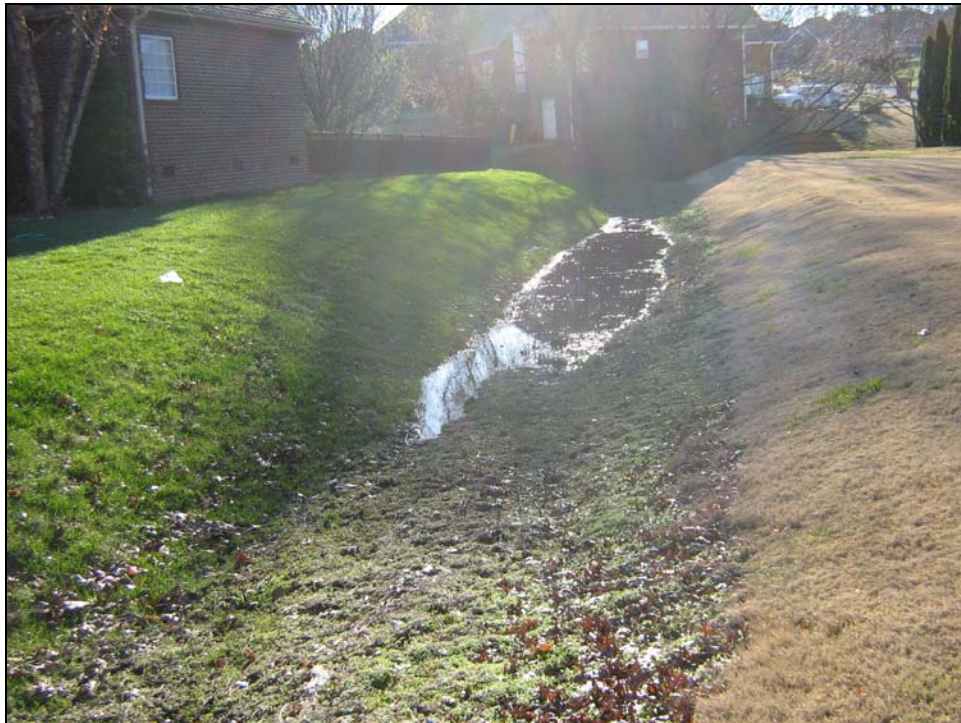
**Item 8 – Looking west from Lexington Dr. cross drain (south of Letcher Ave). Grade ditch to drain into creek. Note standing water. Picture 2315.**

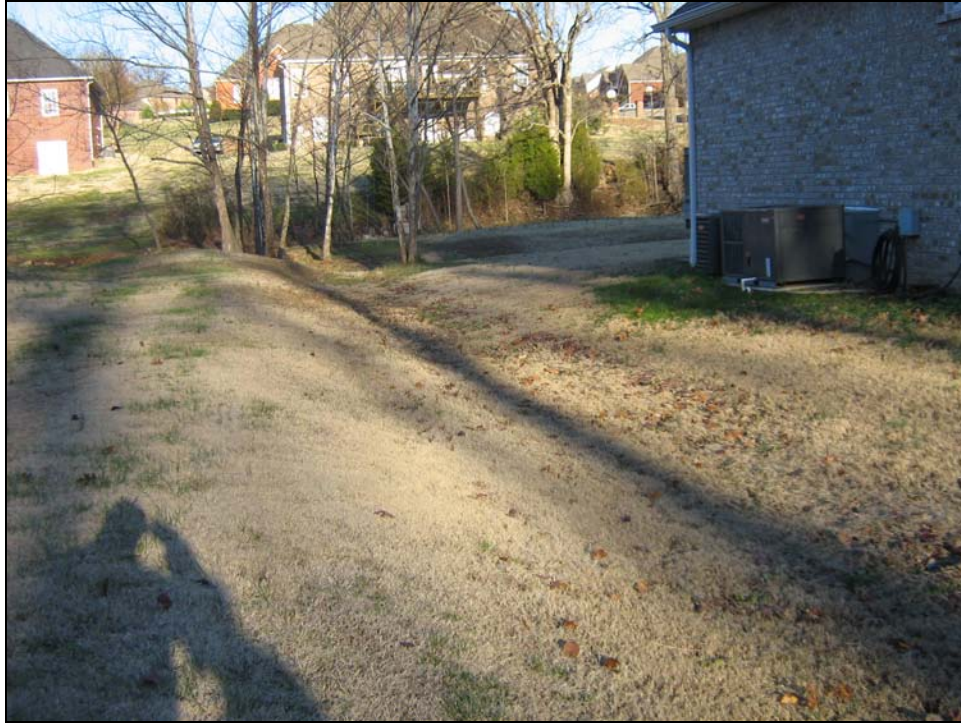
**Item 9 – 407/409 Barnes Dr.. Grade ditch to drain into creek. Picture 2356.**
