THE SECRETARY
OF THE INTERIOR'S
STANDARDS FOR
REHABILITATION &

GUIDELINES
ON **FLOOD**
ADAPTATION FOR
REHABILITATING
HISTORIC
BUILDINGS

U.S. Department of the Interior
National Park Service
Technical Preservation Services

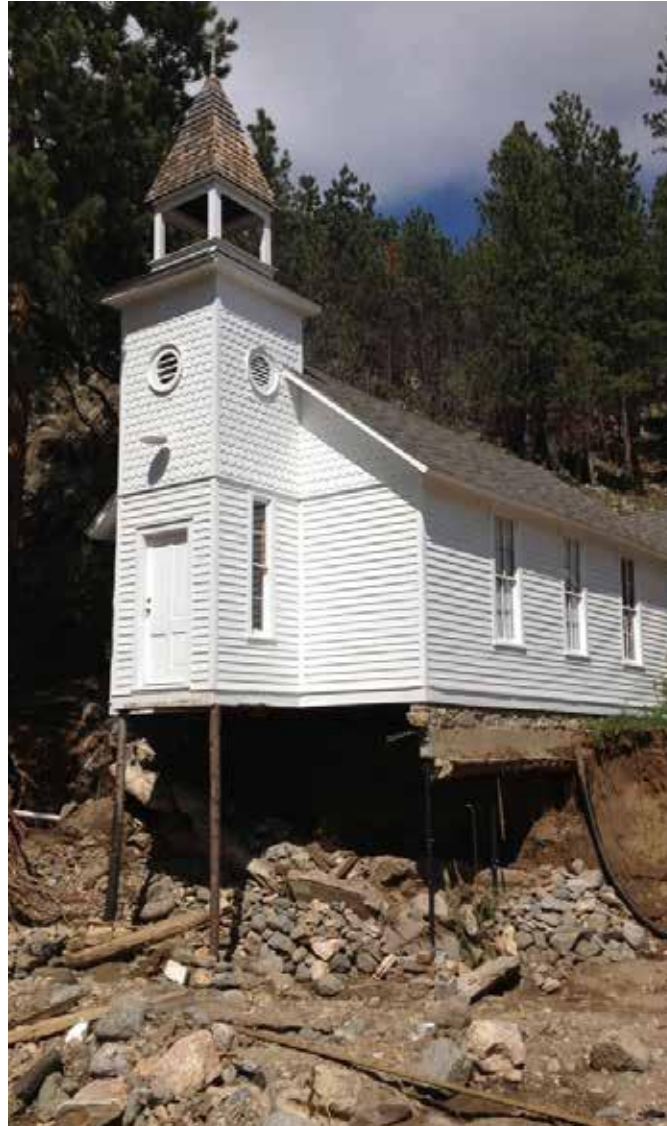
[9] Fast-moving flood waters can undermine a foundation or scour out land around a building. The Little Church of the Pines in Salina, CO, was left structurally compromised after heavy rains caused flooding in the Front Range of the Rocky Mountains in 2013. *Photo: Burton Construction burton-construction.com*

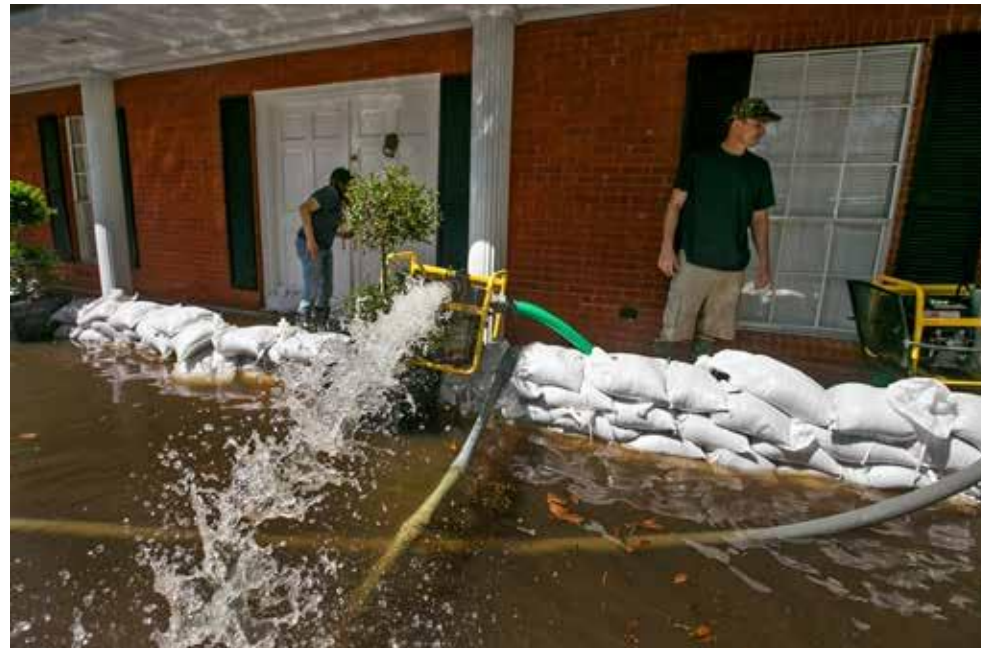
[26] Water can still seep through sandbag barriers. A property owner should have a pumping system with back-up generators to remove water from behind the barrier. Photo: Ted Jackson, NOLA.com | The Times-Picayune. The Advocate, 7/29/2019. The Times-Picayune/The Advocate

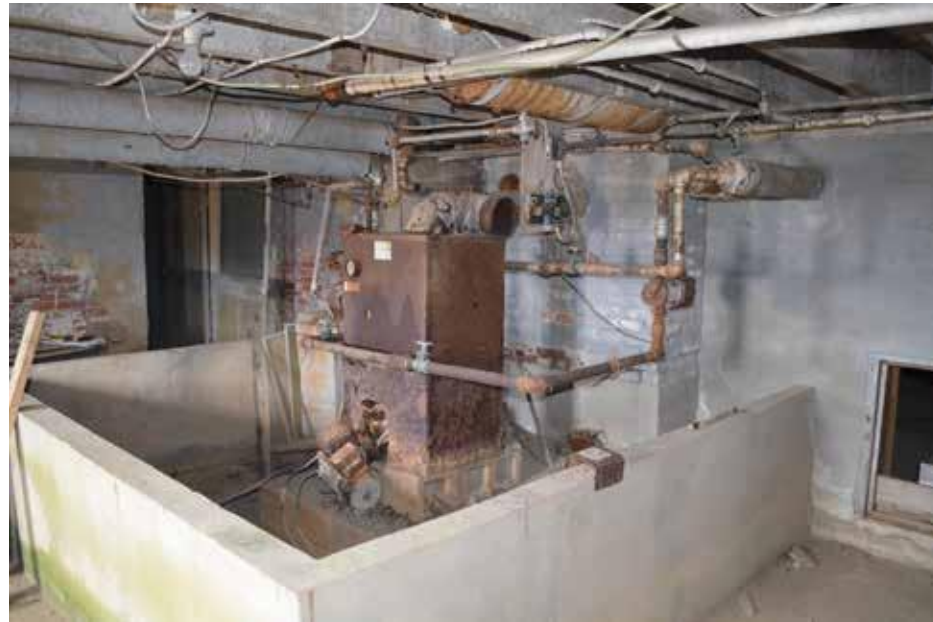
[42] Mechanical equipment that remains in a basement that is likely to flood should be enclosed behind waterproof walls. The walls may be partial height, as shown in this example, if flood waters are not expected to exceed that height. In other cases, waterproof enclosures must fully surround the equipment, which can be accessed by submarine-quality doors or hatches. *Photo: Quinn Evans*

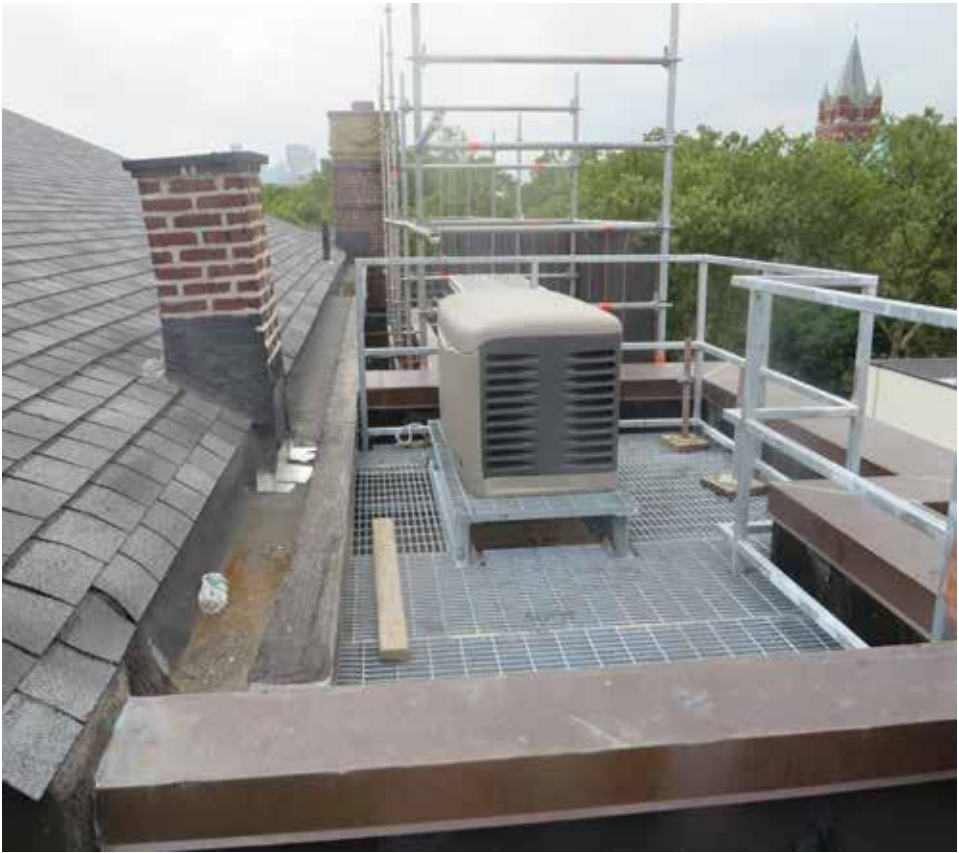
[46] For many buildings in flood-prone areas, having a generator on site may be a necessity to provide emergency power for pumps and other mechanical equipment. This public library in Hoboken, NJ, has a generator located on a flat roof high above any flood waters and not visible from the street. *Photo: David V. Abramson for Hoboken Public Library*

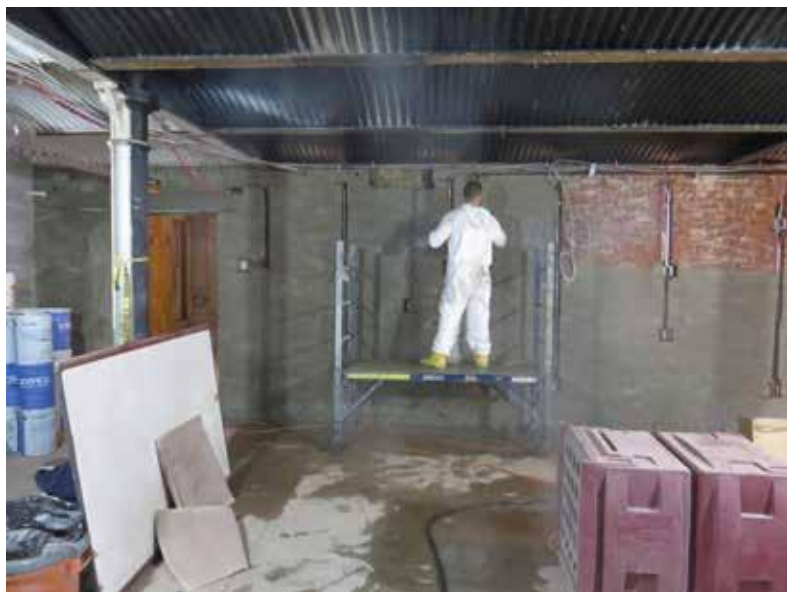
[48] A waterproof coating is applied to the interior surface of lower-level walls of the public library in Hoboken, NJ. Prior to applying such a coating, the product should be researched by building science professionals with knowledge of historic materials and methods to ensure that the coating will not cause damage to or accelerate deterioration of the structure. Photo: David V. Abramson for Hoboken Public Library

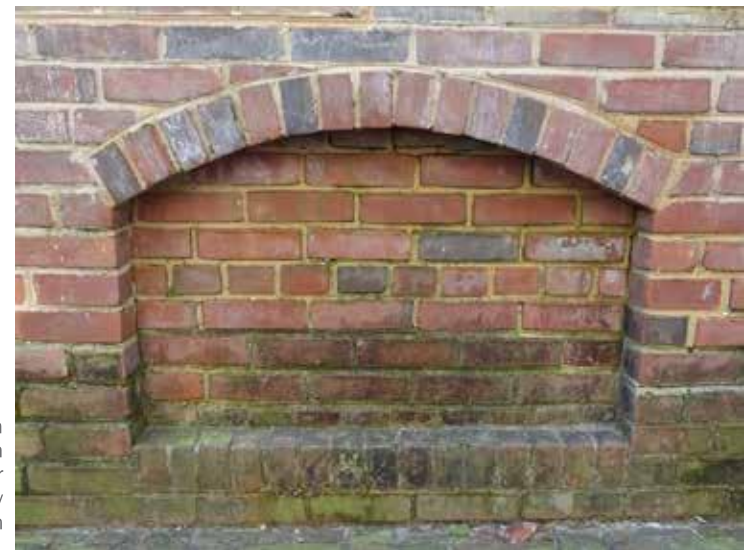
[50] To keep water out of a building, openings on secondary elevations may be permanently infilled with masonry to match or blend in with the walls. Any sills or lintels should be preserved in place, and the masonry infill should be inset to preserve the historic fenestration pattern. *Photo: Jennifer Parker/NPS*

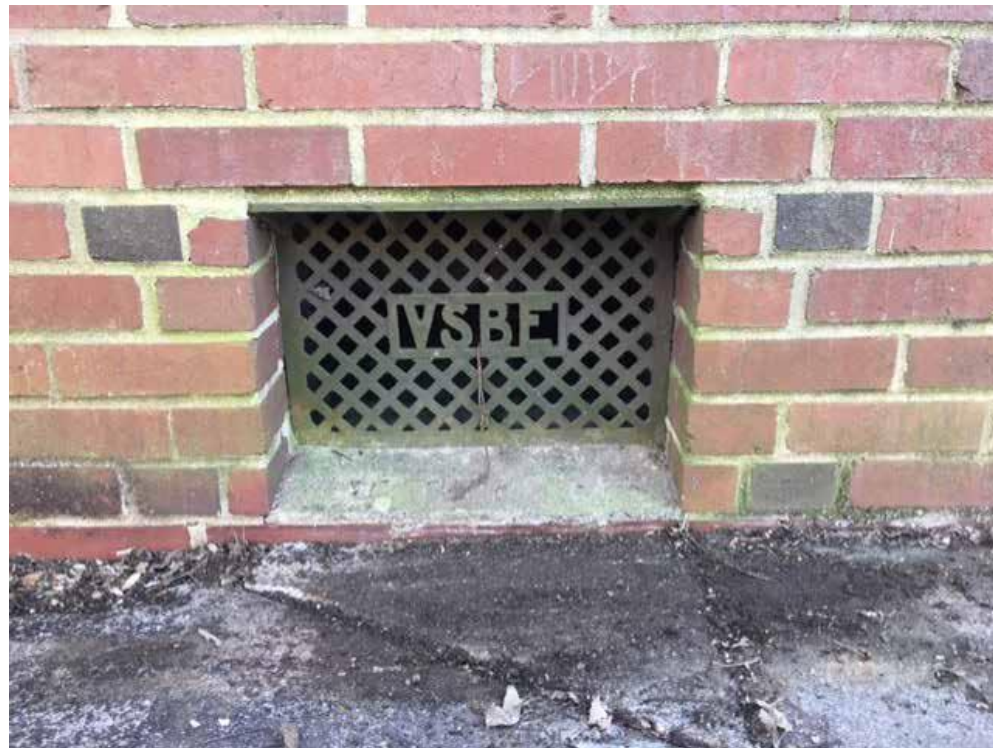
[56] To create a watertight seal around the building, any existing vents or openings below the established flood risk level must be sealed during a flood. Vents that cannot be sealed internally will require an exterior and/or interior cover to keep water from entering the building. *Photo: Chelius Carter*

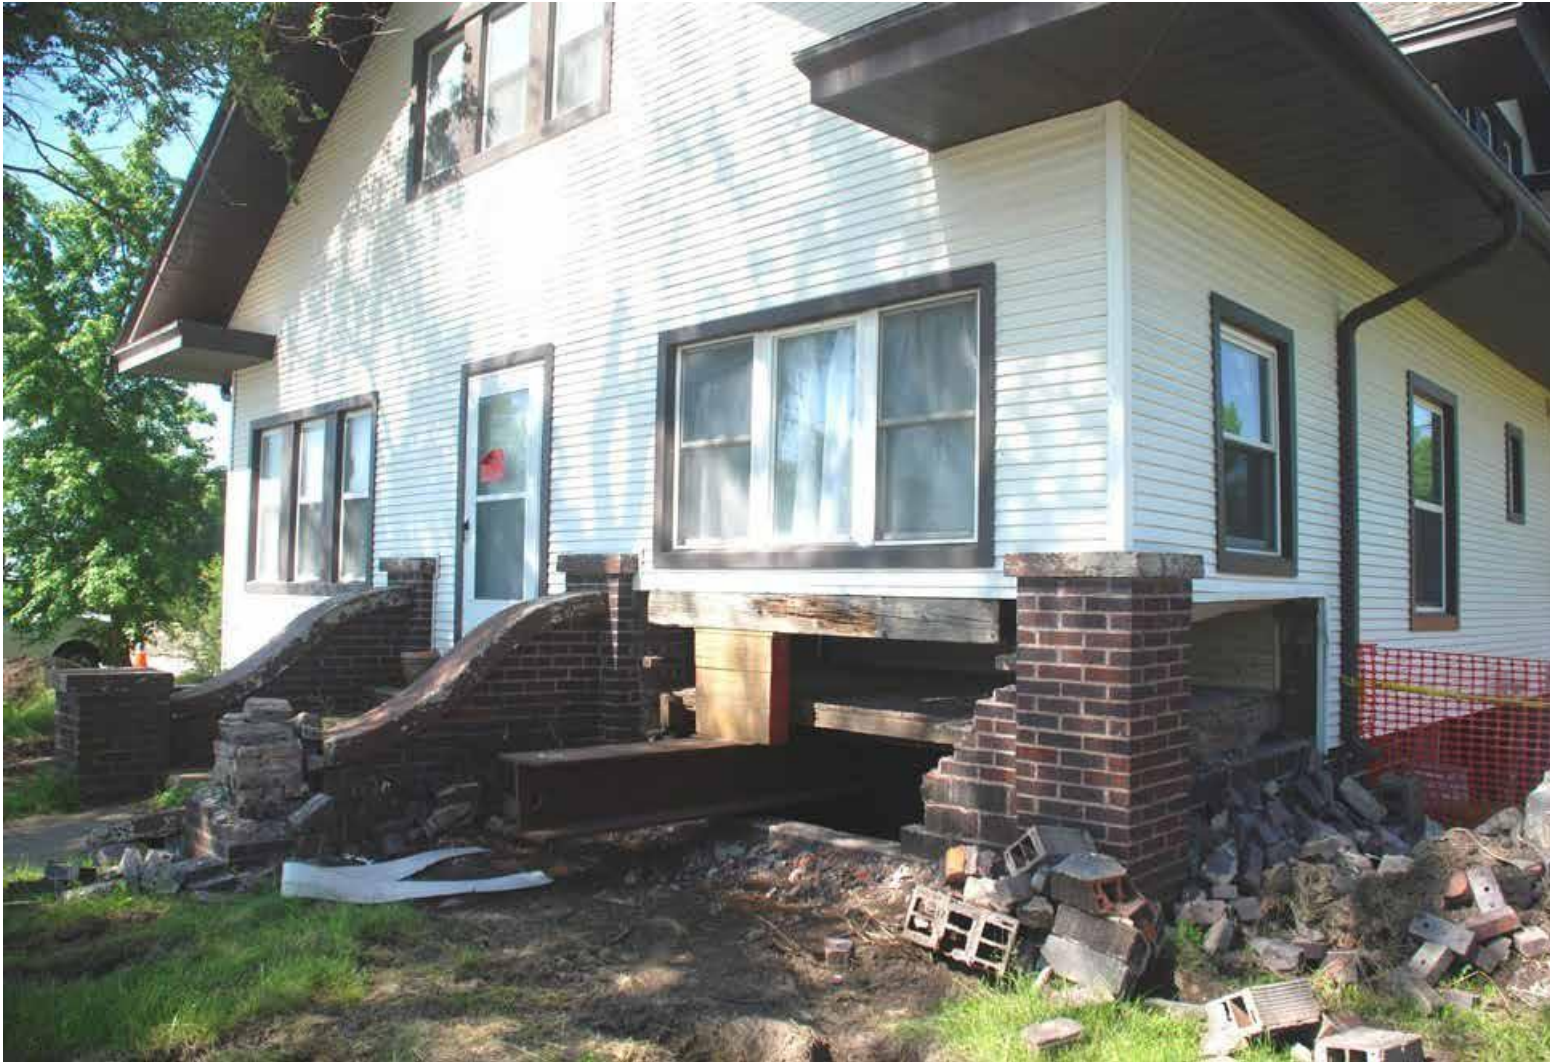
[72] Filling a basement requires access to bring the fill below grade and to maneuver compacting equipment in the space. In this example, a prior flood-damaged section of the foundation wall created an opening that allowed earthmoving equipment access to the basement. The exterior will be repaired once work is complete below grade.
Photo: Mitch Paine

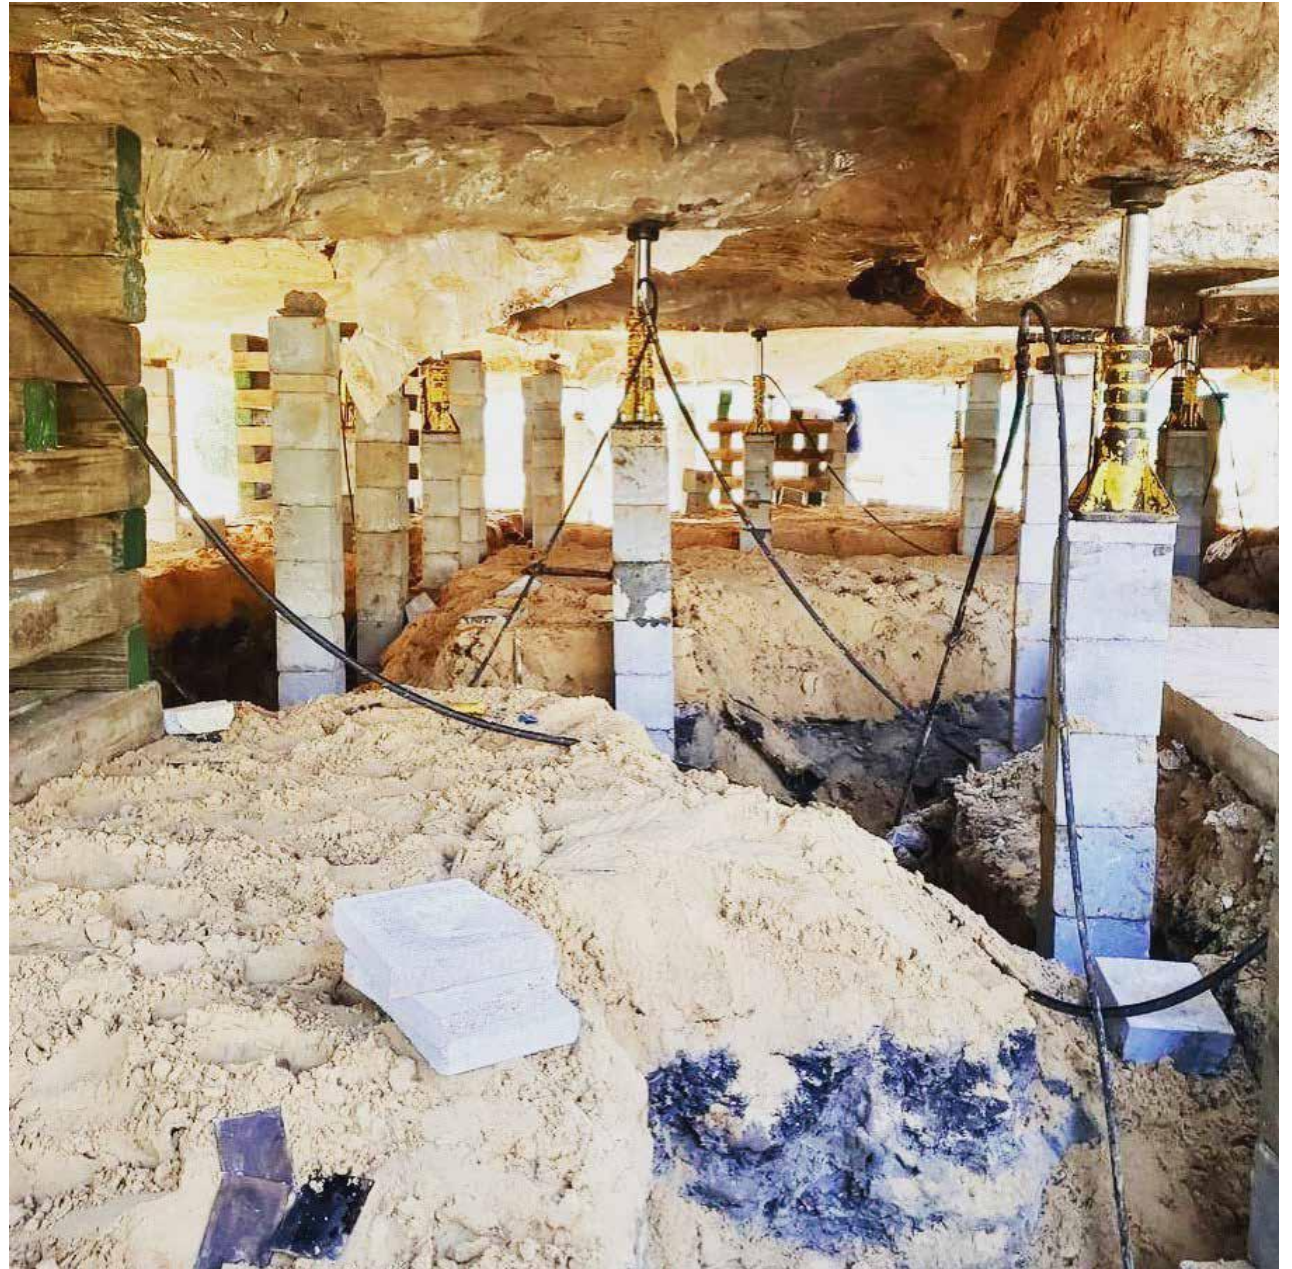
[79] Buildings on a concrete slab can be more challenging to lift. In some cases, as shown in this example, the existing slab can be lifted and still remain the floor for the interior spaces. In other instances, the slab may need to remain at grade, with a new elevated floor structure constructed above. *Photo: p3elevation.com*

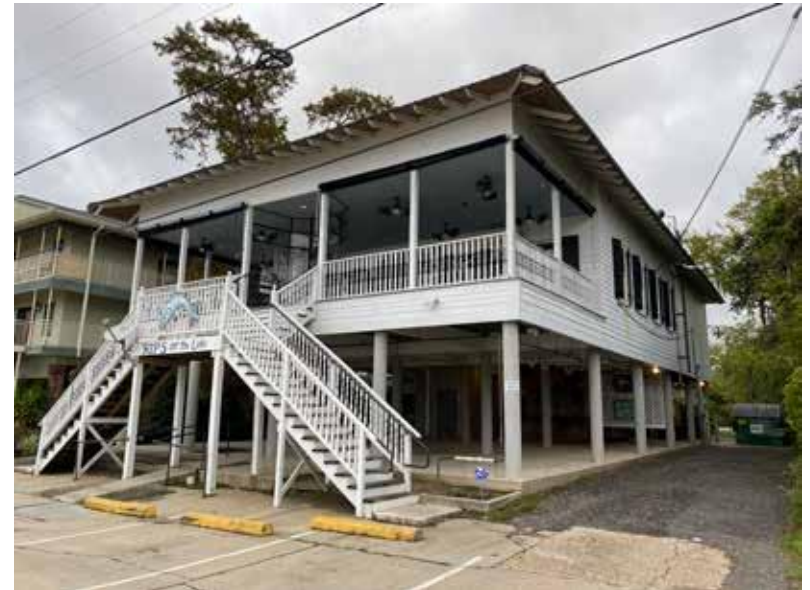
[89] This building in Louisiana has been raised on piers, but the foundation piers are set back from the face of the building, do not line up with the porch posts, and are visually undersized. New foundation piers, posts, and columns should have a visual appearance that more closely matches traditional foundation placement, size, and materials, even if that requires wrapping more modern, slender steel members with a masonry veneer. Photo: Roderick Scott

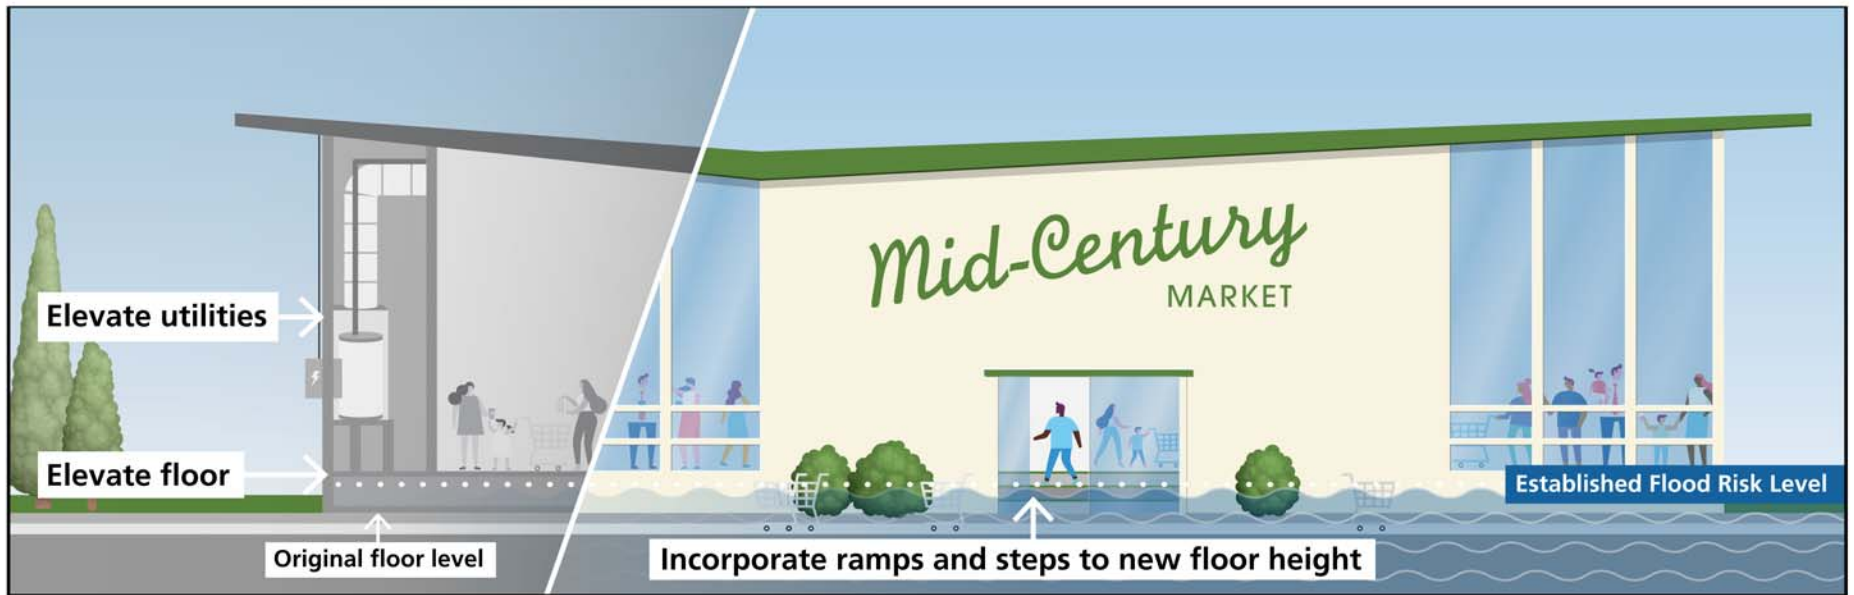
[100] Elevating the interior floor level above the established flood risk requires several building alterations, including constructing a new floor, elevating any utilities, and creating access to the new floor level. The original floor to ceiling height must be substantial enough to allow space for the new elevated first floor. *Graphic: Blank Space LLC for NPS*

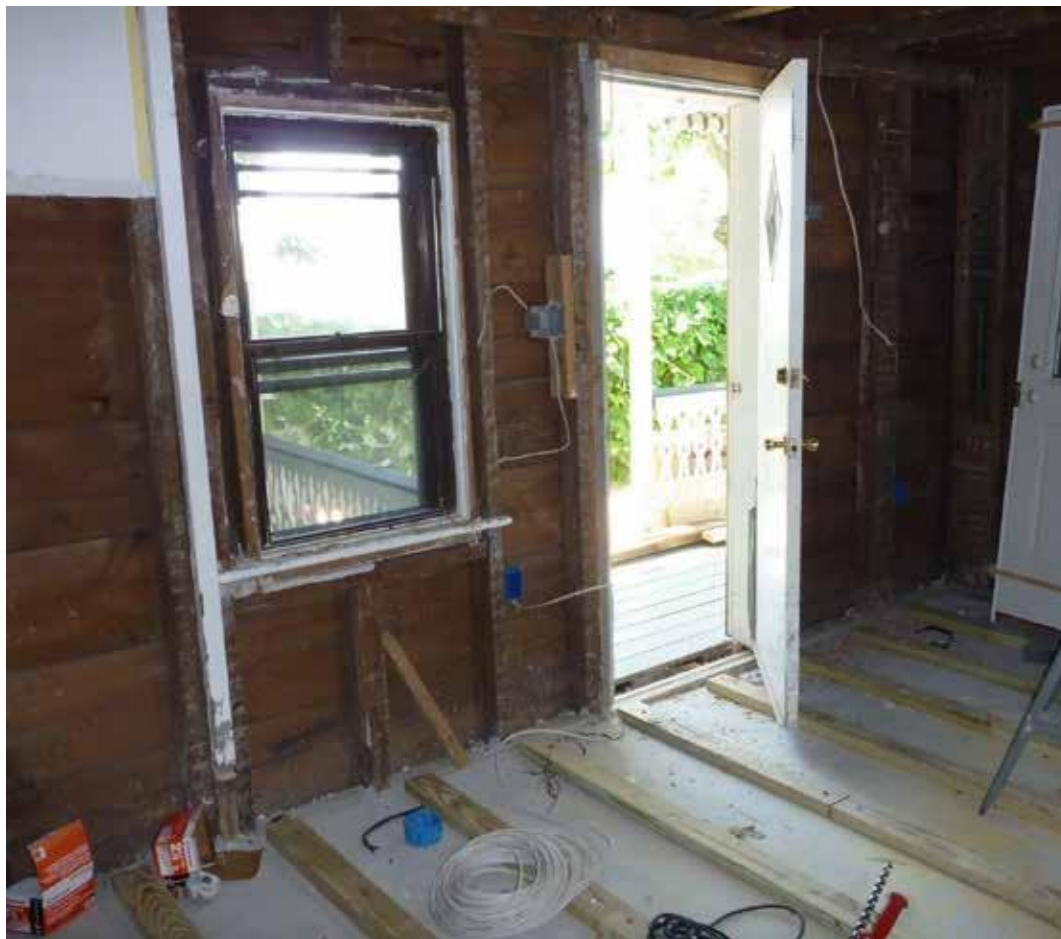
Figure 2: In-progress repairs after Hurricane Sandy. Walls are open to the interior for initial drying. A new concrete structural slab has been topped with treated wood sleepers in preparation for a new flood-damage resistant mahogany floor. Photo: Mary Delaney Krugman, JD, MSHP

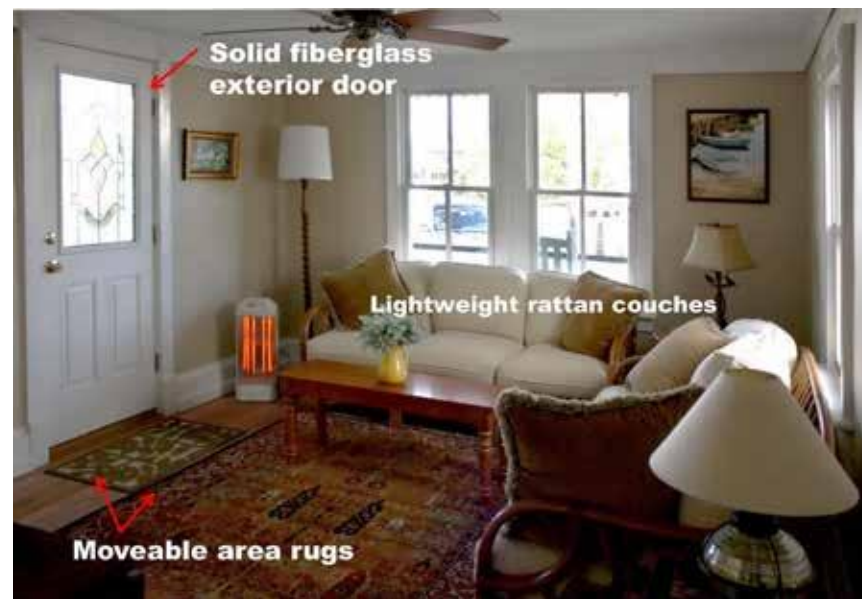
Figure 7: After repairs and wet floodproofing measures have been implemented, the new floor and wall surfaces are flood-damage resistant. The front door and windows were also replaced with more compatible designs using flood-damage resistant materials *Photo: Mary Delaney Krugman, JD, MSHP*

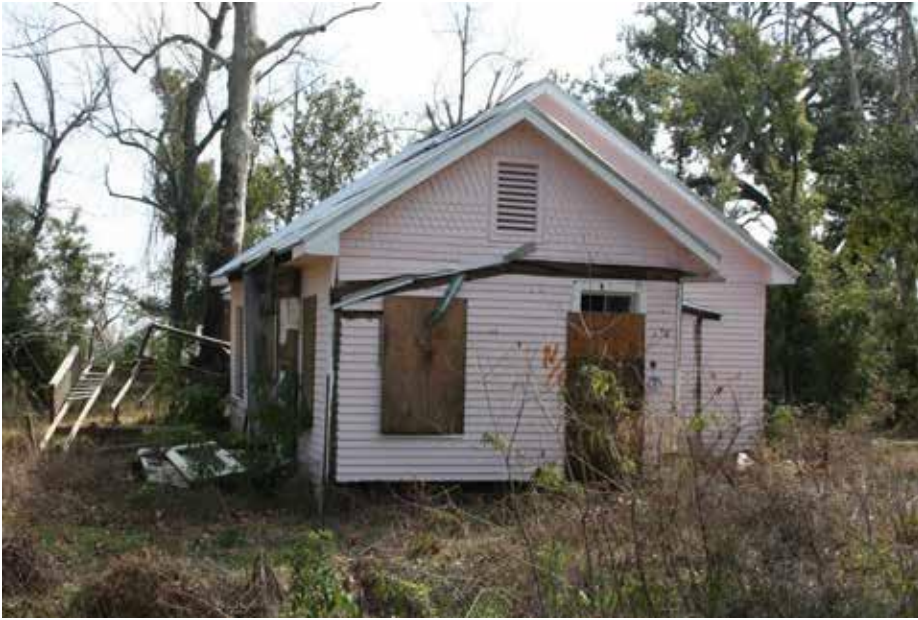
Figure 3: Hurricane Katrina destroyed the wrap-around front porch and knocked the house off the pier foundation. This photo was taken after the site had been cleared and windows and doors were temporarily boarded. *Photo: Mississippi Department of Archives and History, Mississippi Historic Resources Inventory (HRI) Database. <http://www.apps.mdah.ms.gov/Public>*

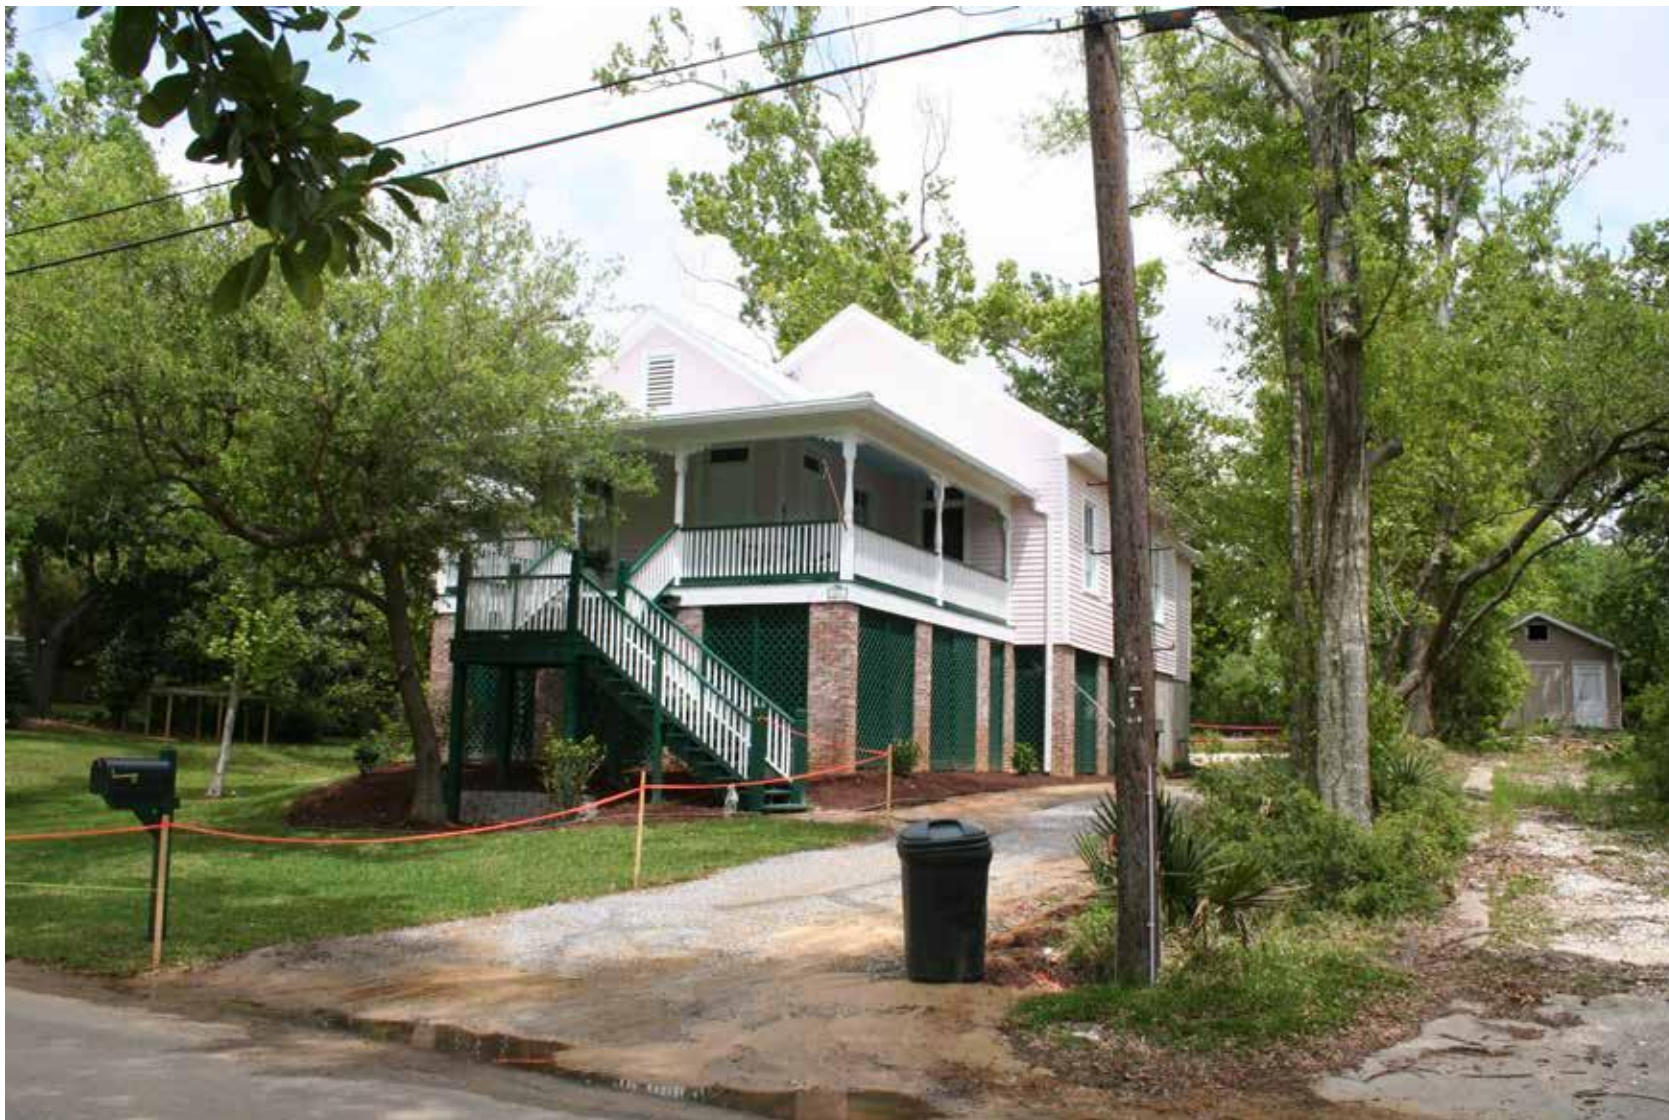
Figure 5: A taller foundation was constructed to elevate the house above the established flood risk level. While the house is higher than it was historically, the change is still in keeping with the historic character of the house, which had been on a tall foundation historically. The change is also consistent with historic regional traditions of adapting buildings to flood events. Additionally, the details of the foundation, with the brick piers and painted lattice, matches features of the historic design. The stairs access the porch in the historic location, but the extended run required by the taller foundation is turned 90 degrees below the landing to allow a surviving tree to remain in front of the house. A small retaining wall behind the tree holds fill that was added around the house to mask some of the change in height. *Photo: Mississippi Department of Archives and History, Mississippi Historic Resources Inventory (HRI) Database. <http://www.apps.mdah.ms.gov/Public>*

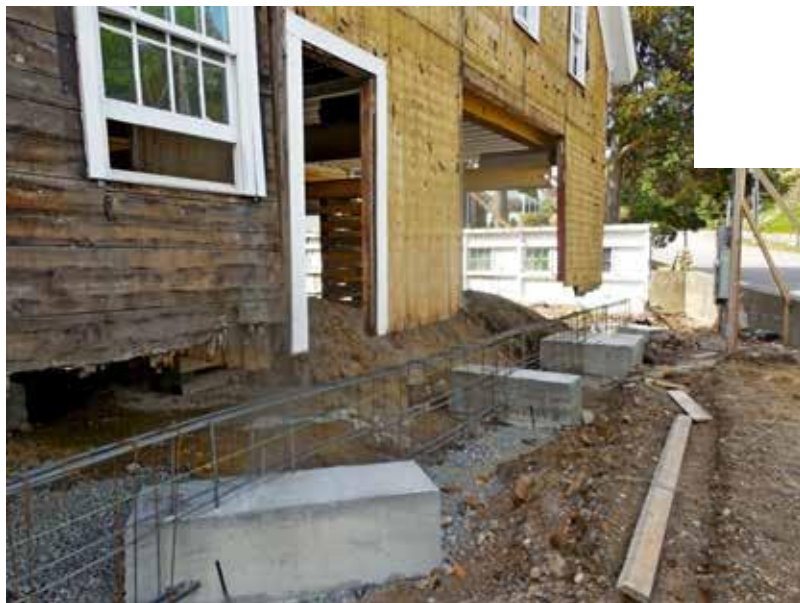
Figure 3: The structure was lifted in sections several feet in the air to provide space and access for foundation work. *Photo: GNCB Consulting Engineers*

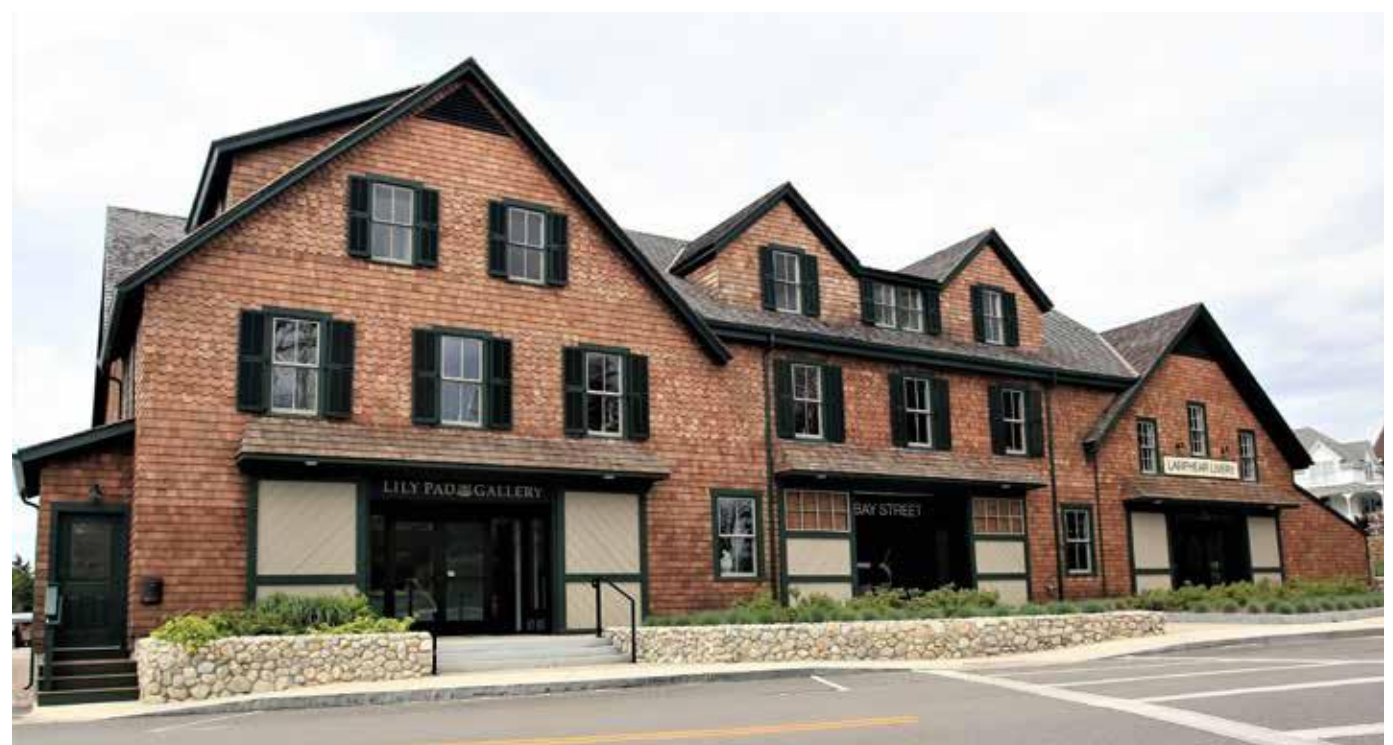
Figure 5: View of the building after the floodproofing and rehabilitation project was complete. The historic barn doors and many historic windows were preserved. Damaged or missing shingle siding was replaced in kind. The foundation is now two feet taller than it was at the start of the project. Wet floodproofing of the first floor provides additional resiliency and protection for floods that exceed the new elevation height. Photo: Pariseault Builders

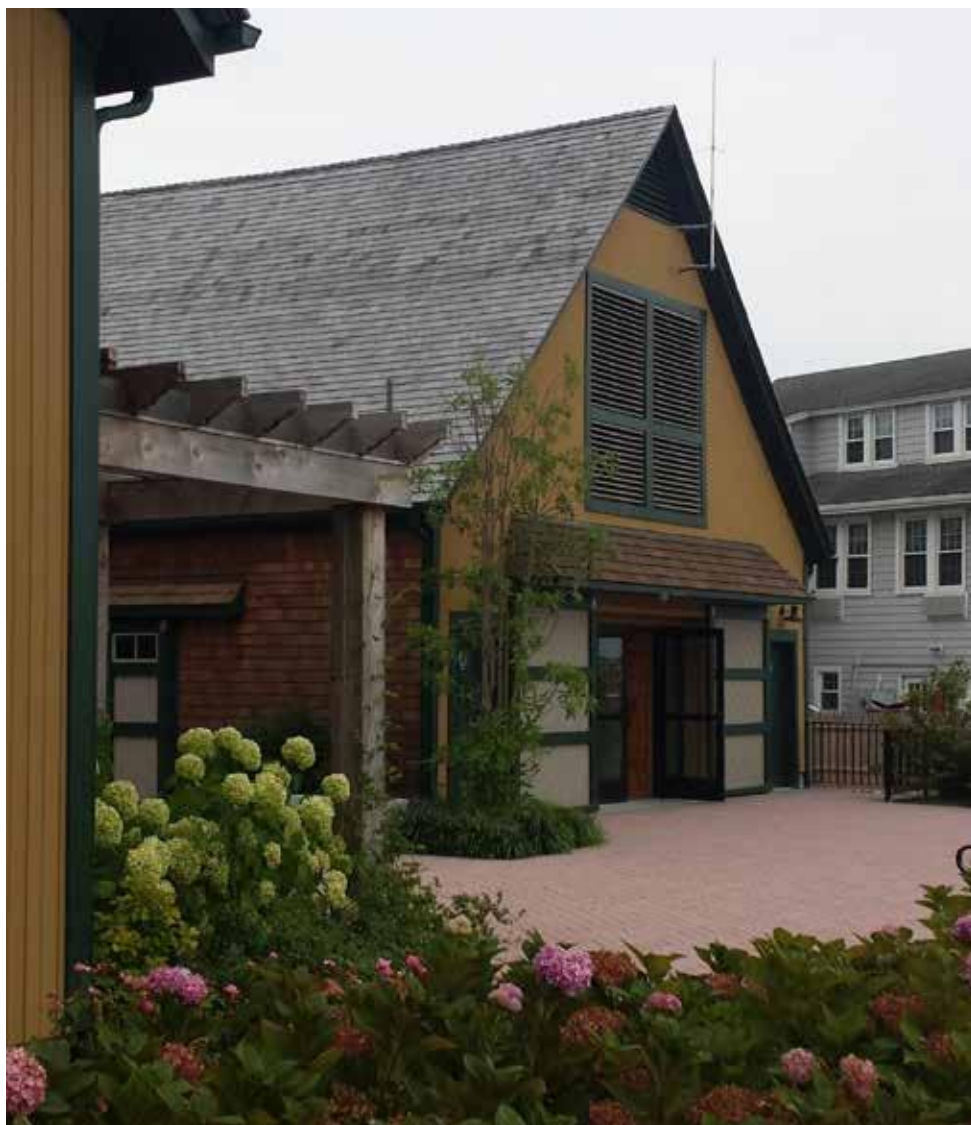
Figure 6: The mechanical room was relocated to the upper floor at the back of the building, discernible in this photo by the louvered vents. *Photo: Jennifer Wellock/NPS*
