## ENGINEERING REPORT

### Cumberland University Drainage Improvements

**City of Lebanon Engineering Department**

**Neel-Schaffer, Inc.**

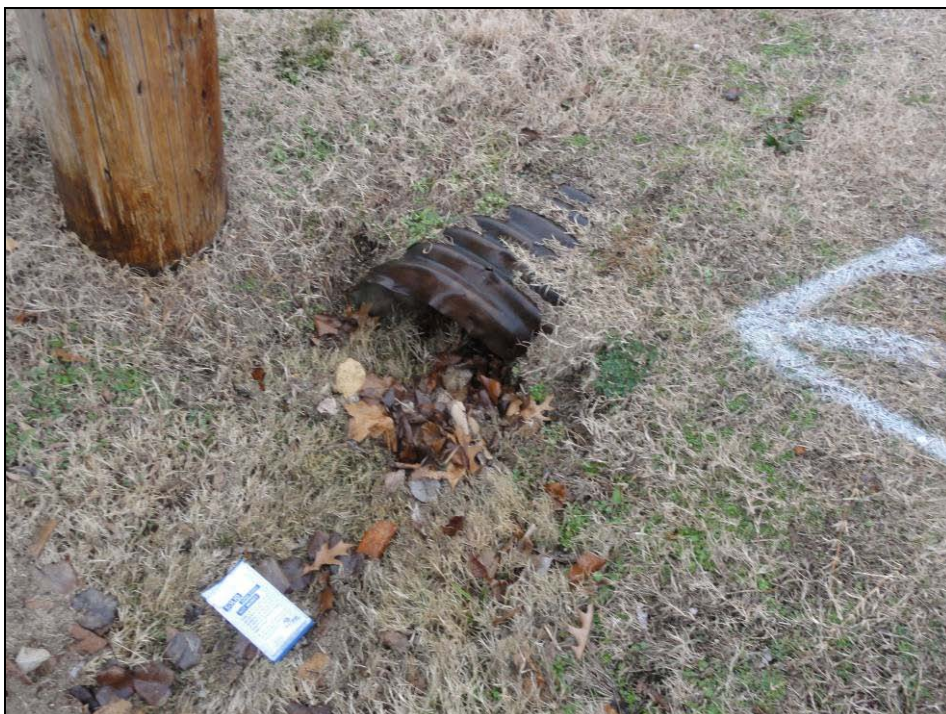
**Item 5 – West side of S. Greenwood St. just north of University Ave. Clear sediment and debris from 12" CMP under parking lot access drive. Picture 2176.**

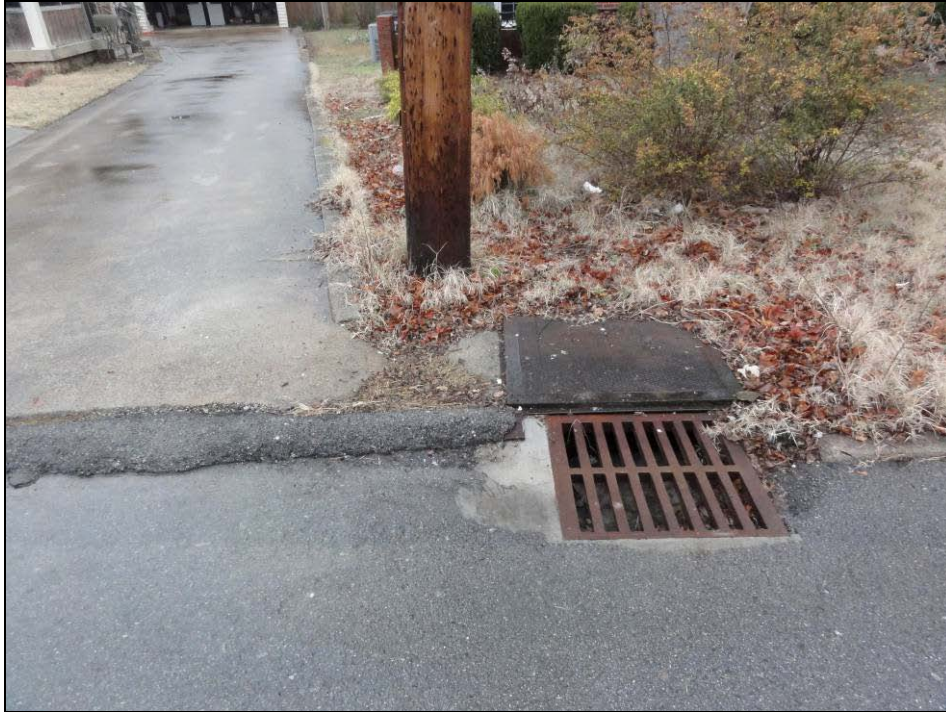
**Item 13 – 217 Cumberland Dr. Clean debris and sediment from under catch basin grate. Picture 2197.**

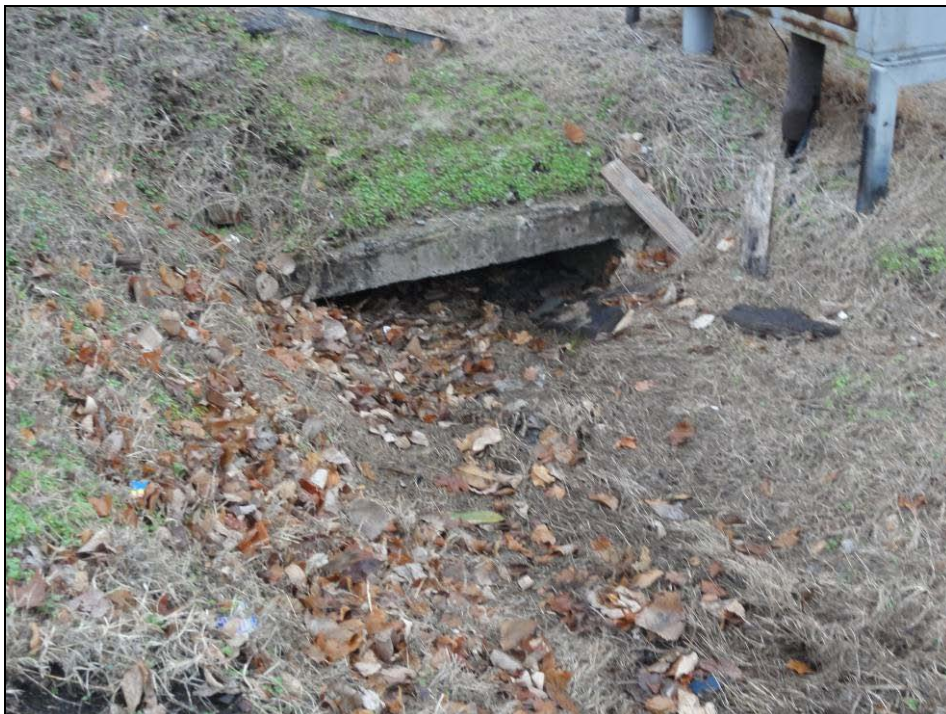
**Item 14 – W. Main St. and railroad. Clean sediment and debris from opening of 4' x 2' box culvert. Picture 2213.**

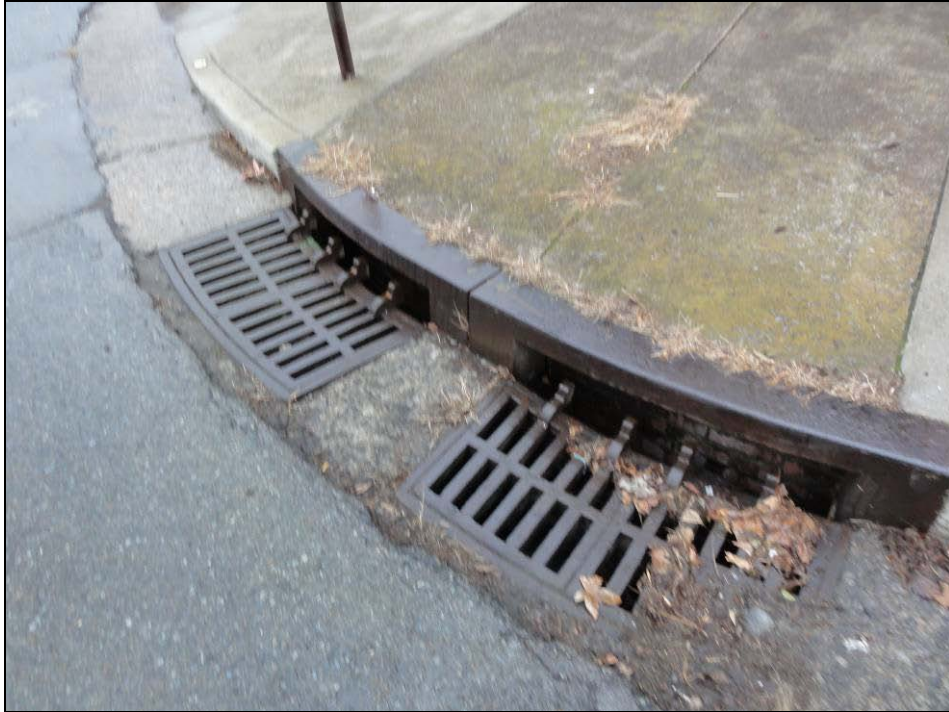
**Item 15 – W. Main St. and S. Hatton Ave. Clean debris from catch basin grate. Picture 2215.**

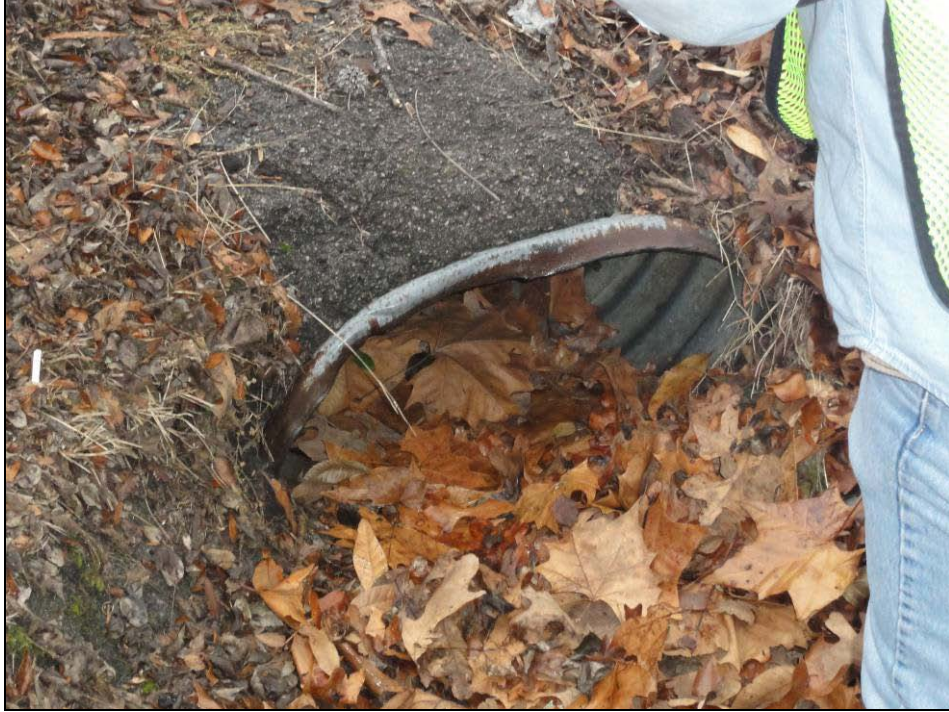
**Item 21 – W. Sprint St. and Pennsylvania Ave. Clean debris from 20” x 14” ellip. CMP. Picture 2234.**

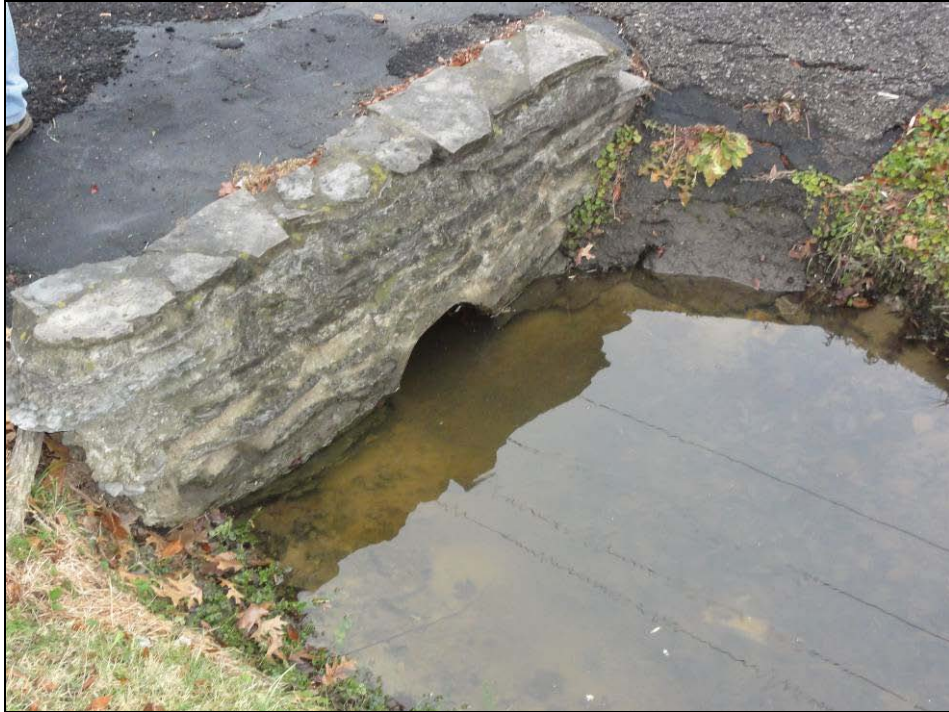
**Item 23 – 520 W. Spring St. 24” CMP clogged with debris and sediment. Flush pipe and remove debris from ditch. Picture 2235**

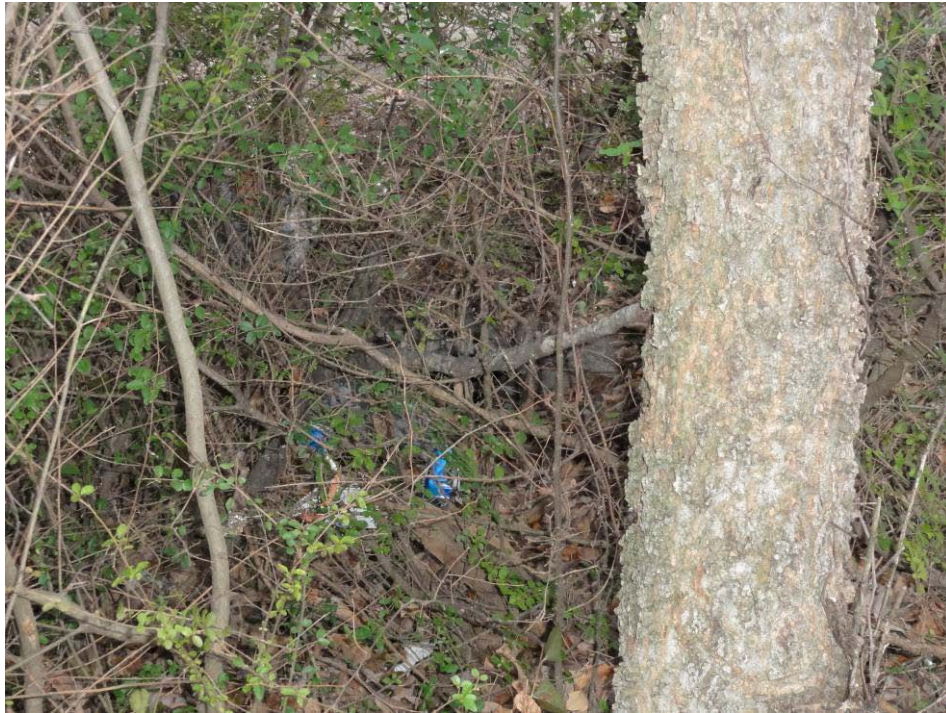
**Item 25 – 316 S. Maple St. Clear brush and debris from pipe opening. Picture 2268.**

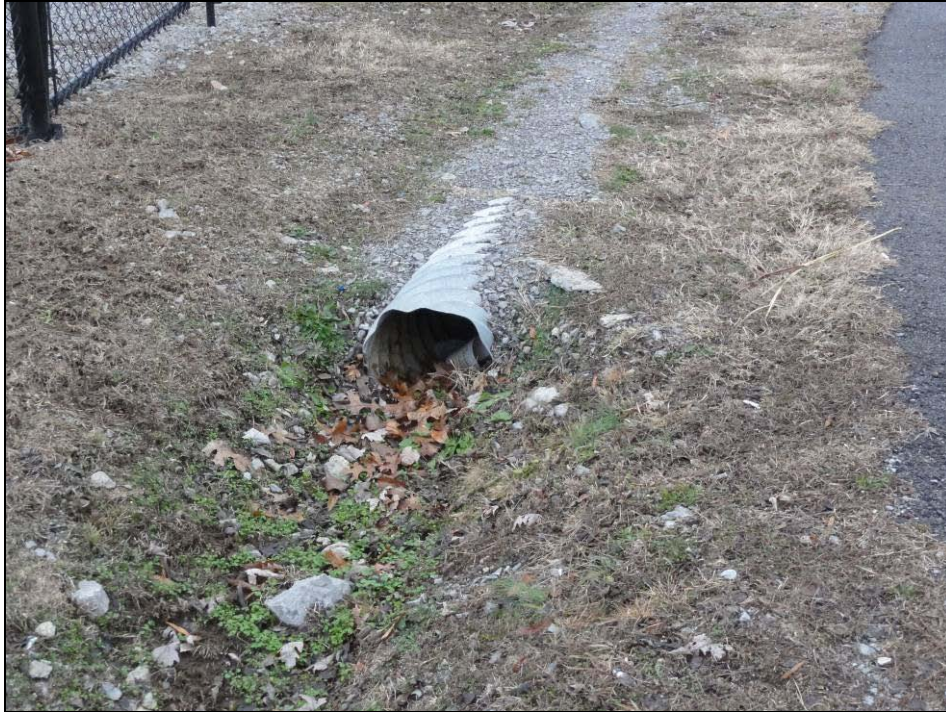
**Item 31 – East side of S. Tarver Ave. north of St. Frances Cabrini Catholic Church. Clear debris from 12" CMP. Picture 2311.**

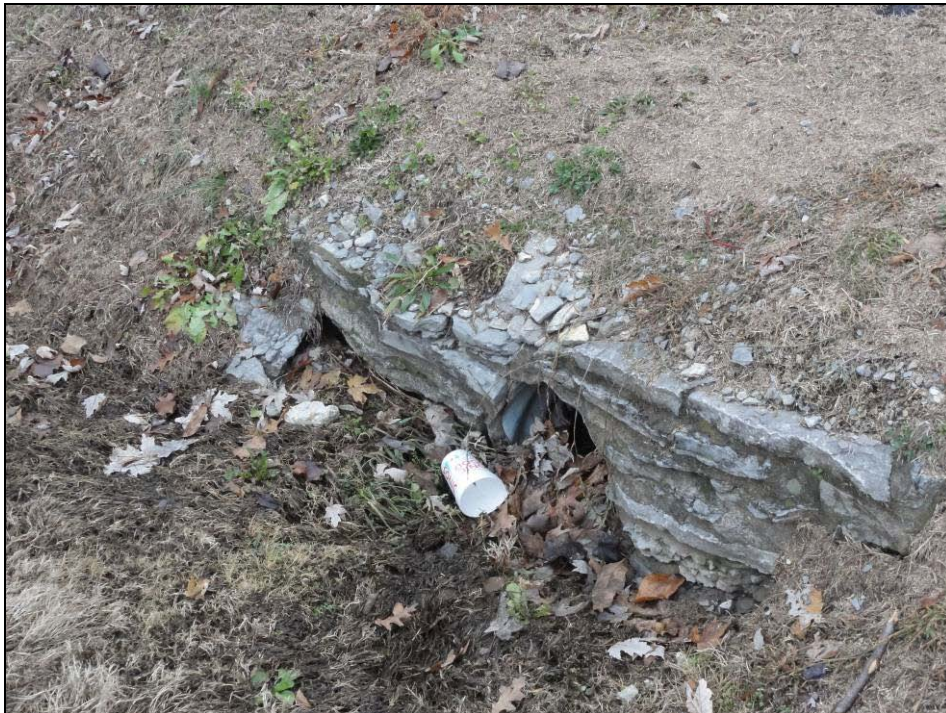
**Item 32 – S. Tarver Ave. north of St. Frances Cabrini Catholic Church. Clear debris and sediment from both ends of 12" CMP. Picture 2312.**

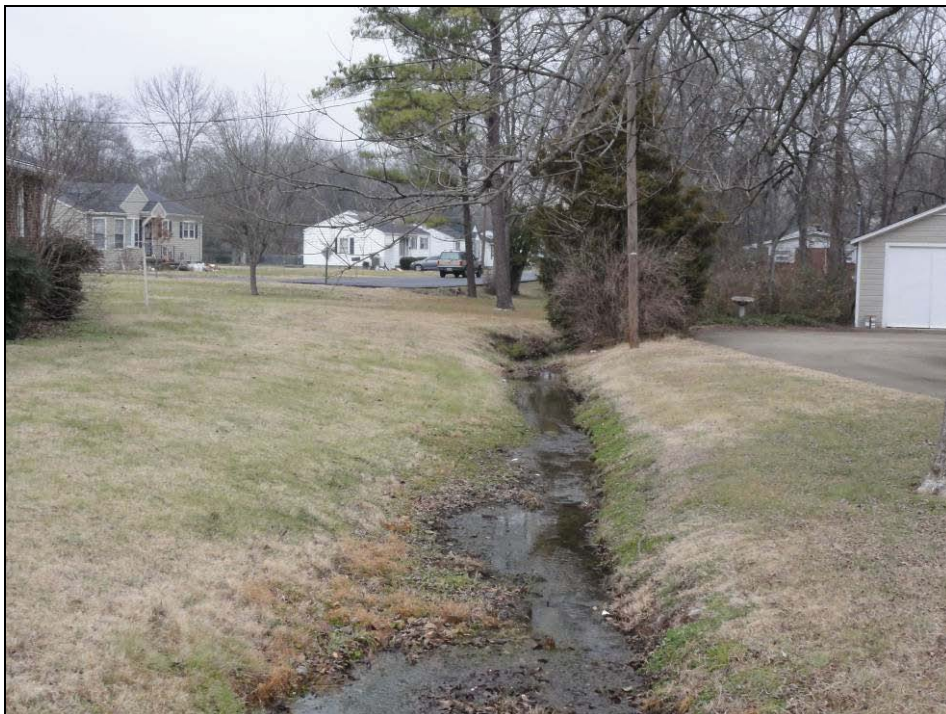
**Looking north. Picture 2382.**
