## ENGINEERING REPORT

### Cumberland University Drainage Improvements

**City of Lebanon Engineering Department**

**Neel-Schaffer, Inc.**

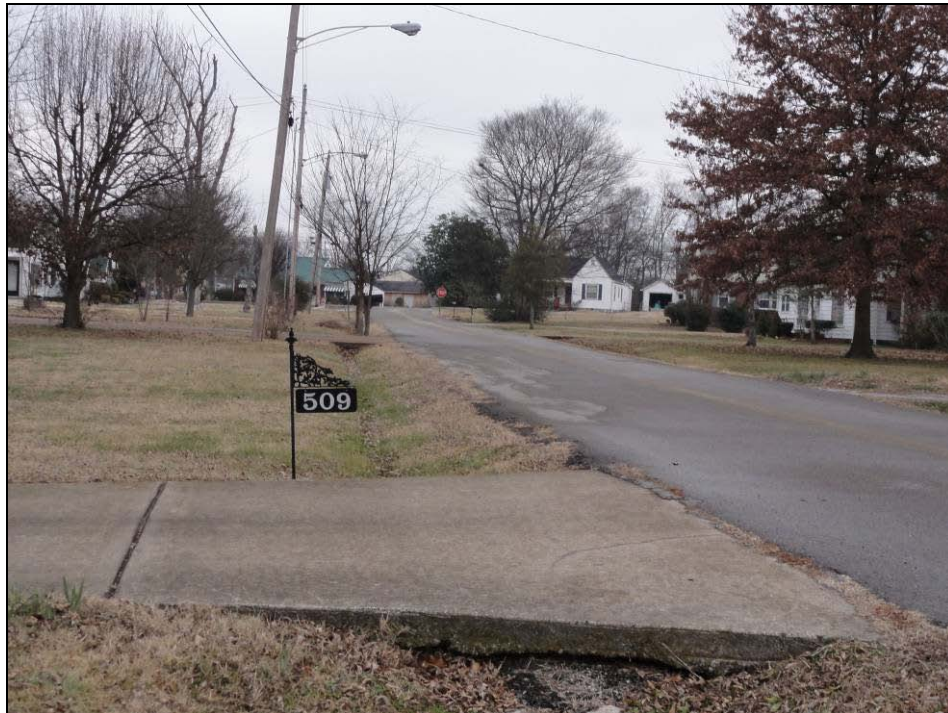
**Looking east towards S. Tarver Ave. Picture 2381.**

**Item 45 – W. Sunset Dr. from Pennsylvania Ave. to S. Tarver Ave.. Clean debris and sediment from roadside ditches and all driveway culverts. Approx. 860 LF each side of road.**

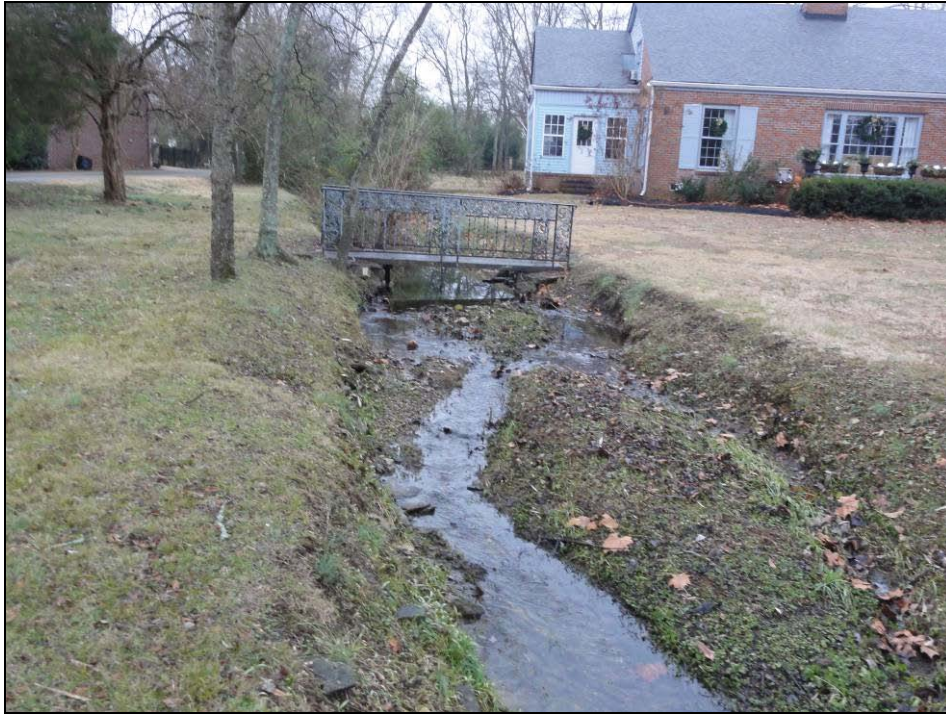
**Looking south from W. Spring St. Picture 2231.**

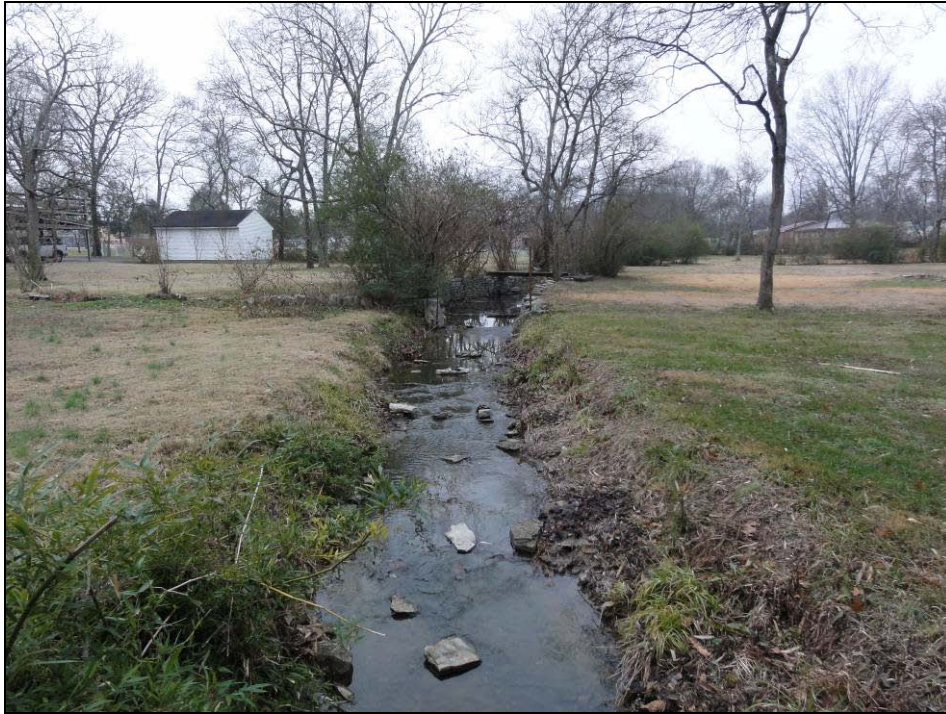
**Looking south from 214 S. Tarver Ave. Picture 2282.**

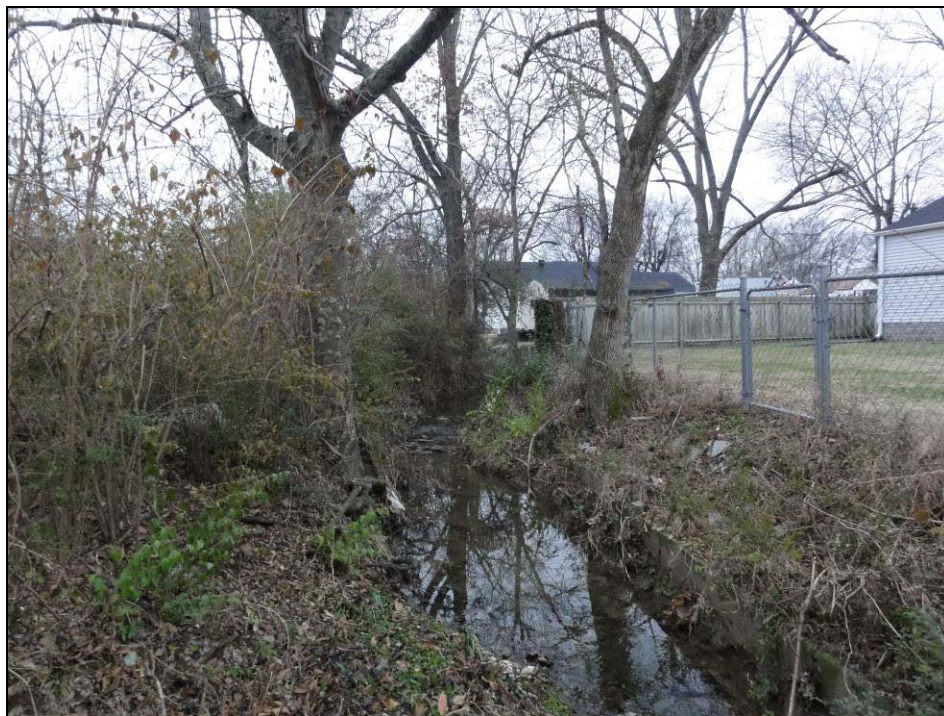
**Looking south from 302 S. Tarver Ave. Picture 2296.**

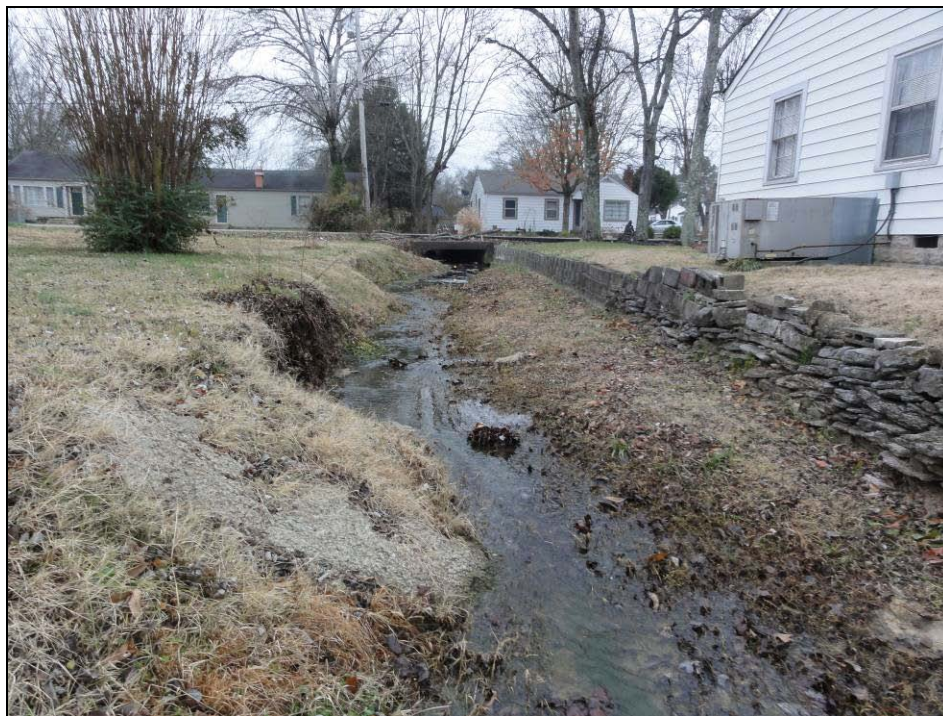
**Looking south from 431 Martin Ave. Picture 2298.**
